RE: Assessment of the City of Alameda Storm Drain Pump Stations

**FINAL REPORT**  
**STORM DRAIN PUMP STATION ASSESSMENT**  
**CITY OF ALAMEDA**

July 12, 2011

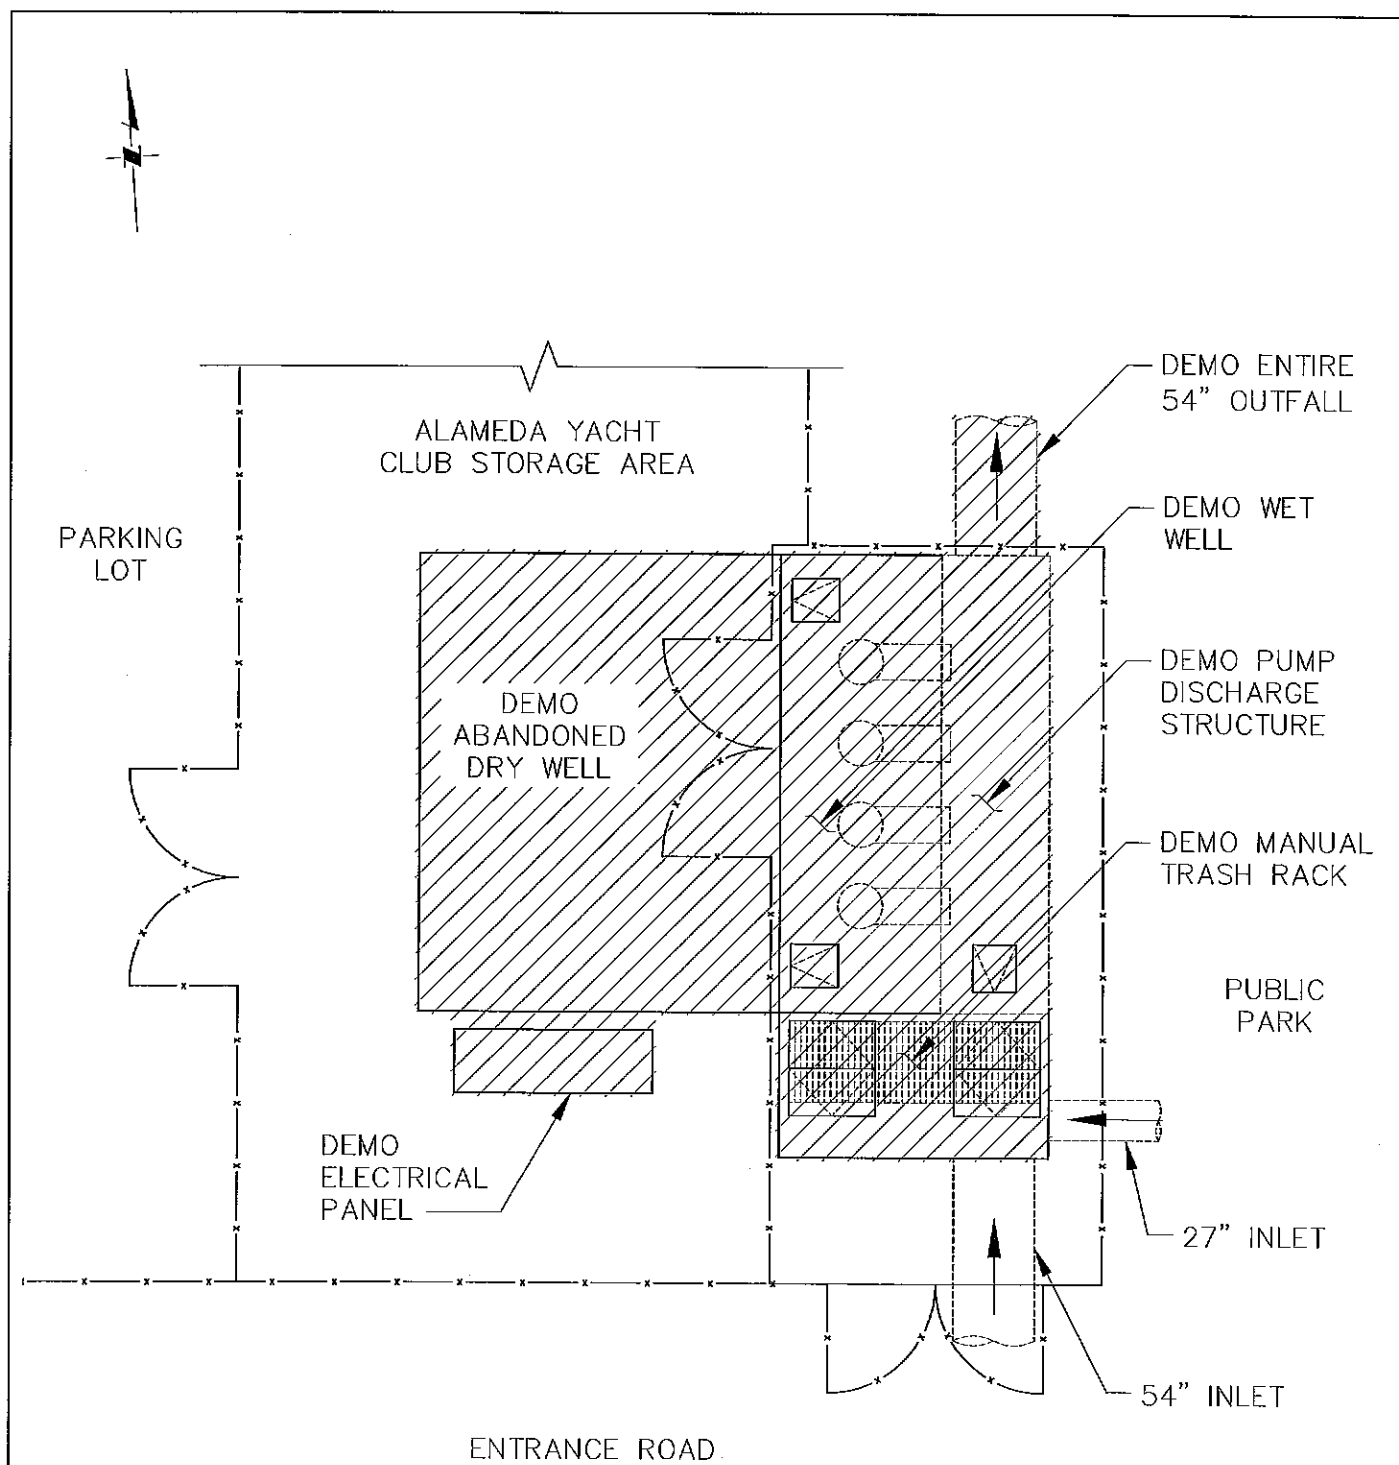
P S O M A S	CITY OF ALAMEDA	EXISTING ARBOR PUMP STATION	FIGURE NO.
	STORM DRAIN PUMP STATION ASSESSMENT REPORT		6-1
			JOB NO. 6ALA010100

exceed to avoid flooding. A completely new pump station and upsized outfall (72-inches) is recommended for the following reasons:

- Pumping capacity is inadequate to convey the design 10-year storm inflow.
- The existing pump barrel (30-inch) must be increased to 48-inch for the size pump required to convey the design storm water volume. The size of the station can not accommodate barrels of this size without compromising the integrity of the pump deck (only 6-inches of concrete would remain between pump barrels in the current configuration).

- The hydraulics of the pump station are not ideal. Influent enters the wet well perpendicular to the pumps and is not evenly distributed to the pumps. This can cause vortexing and/or other issues, which affects the efficiency of pump operation.

Evaluation Criteria	Evaluation Summary	Recommended Improvement
Pumping Systems and Capacity	The existing pump capacity is insufficient to handle the flow from a 10-year storm.	Provide new pump station (see Chapter 3).
	The existing 54-inch outfall does not have capacity to handle the flow from a 10-year storm at the current 10-year high tide or anticipated future high tide.	Provide new 72-inch outfall pipe (see Chapter 3).
Reliability and Redundancy	The station does not have standby power capabilities.	Provide new standby power generator. A 400 kilowatt (KW) generator was assumed for estimating purposes.
	The 30-inch pump barrel for pump 1 was recently replaced. Barrels for the other three pumps are corroded and in poor condition.	New pump barrels provided with new pump station. Inspect and salvage 30-inch barrel for future City projects.
SCADA System	SCADA system is in overall good condition.	Perform regular upgrades to the Wonderware system and radio communication upgrades to digital per Section 5.10.1.

Electrical and Instrumentation	An electrical junction box located between pump 3 and 4 makes access for maintenance purposes difficult. The box must be relocated in order to remove pump barrels.	Provide better access in design for new pump station.
	The existing pump controllers are old and it is hard to find spare parts.	Provide new pump "Vision" or pump commander controls with new pump station. Include electronic pressure transducers/ level transmitters to replace existing bubbler type level sensors.
	The main switchboard has inadequate clearance in front of it per NEC (< 42 inches).	Design new pump station's electrical switchgear to have the required minimum clearances per NEC.

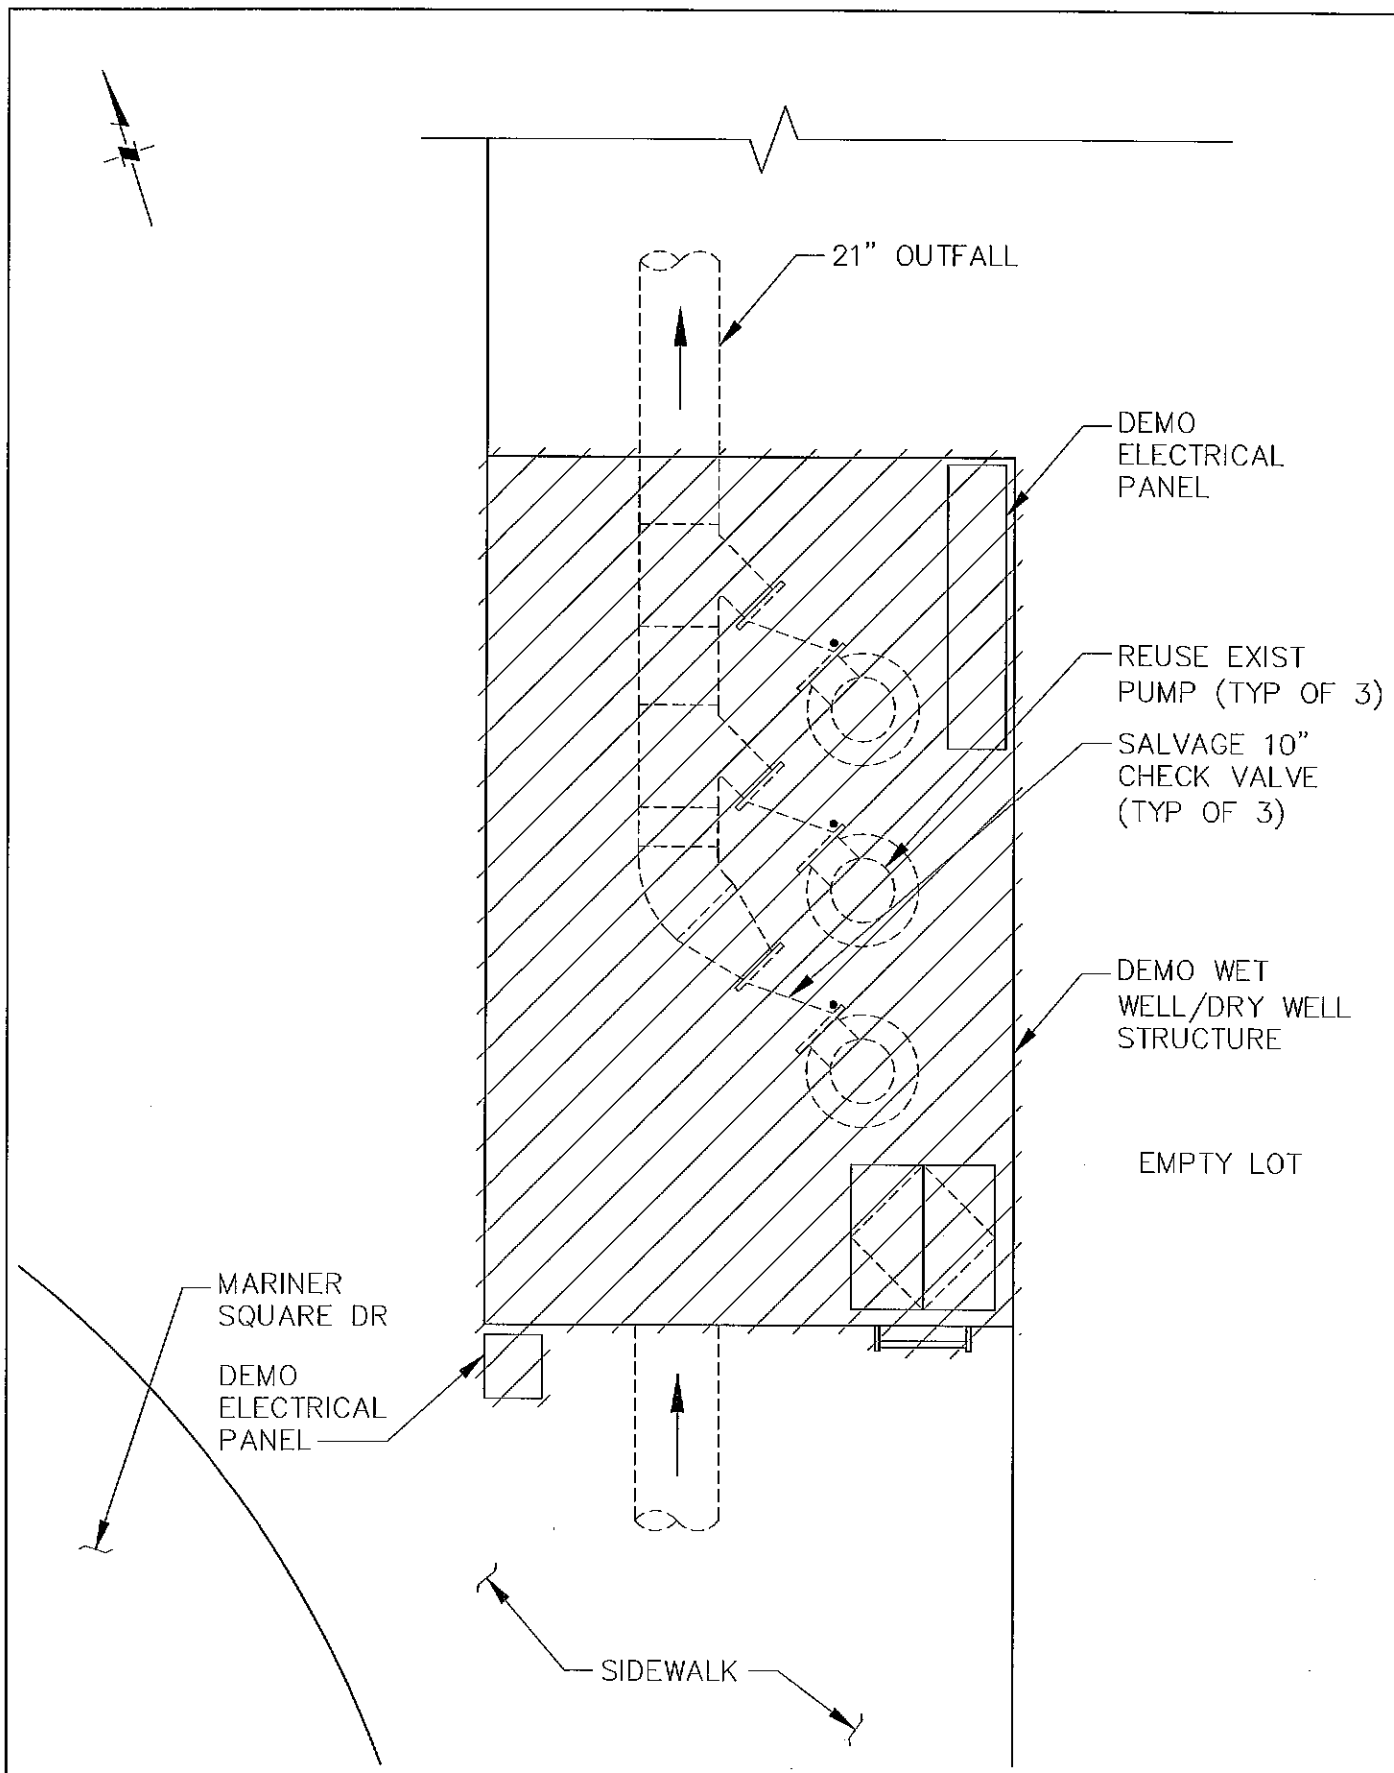
P S O M A S	CITY OF ALAMEDA	EXISTING WEBSTER STREET PUMP STATION	FIGURE NO.
	STORM DRAIN PUMP STATION ASSESSMENT REPORT		6-5
			JOB NO. 6ALA010100

Although the pumps and forcemain capacity are sufficient for the design 10-year storm water flow at current 10-year and future high tides, a completely new pump station is recommended due to operations and maintenance and safety deficiencies at the station (see Chapter 5).
