**GEOTECHNICAL RECOMMENDATIONS REPORT
SHORELINE EROSION RESTORATION PROJECT
2905 SEA VIEW PARKWAY
ALAMEDA, CALIFORNIA**

BSK PROJECT NO.: G00000635

APRIL 26, 2023

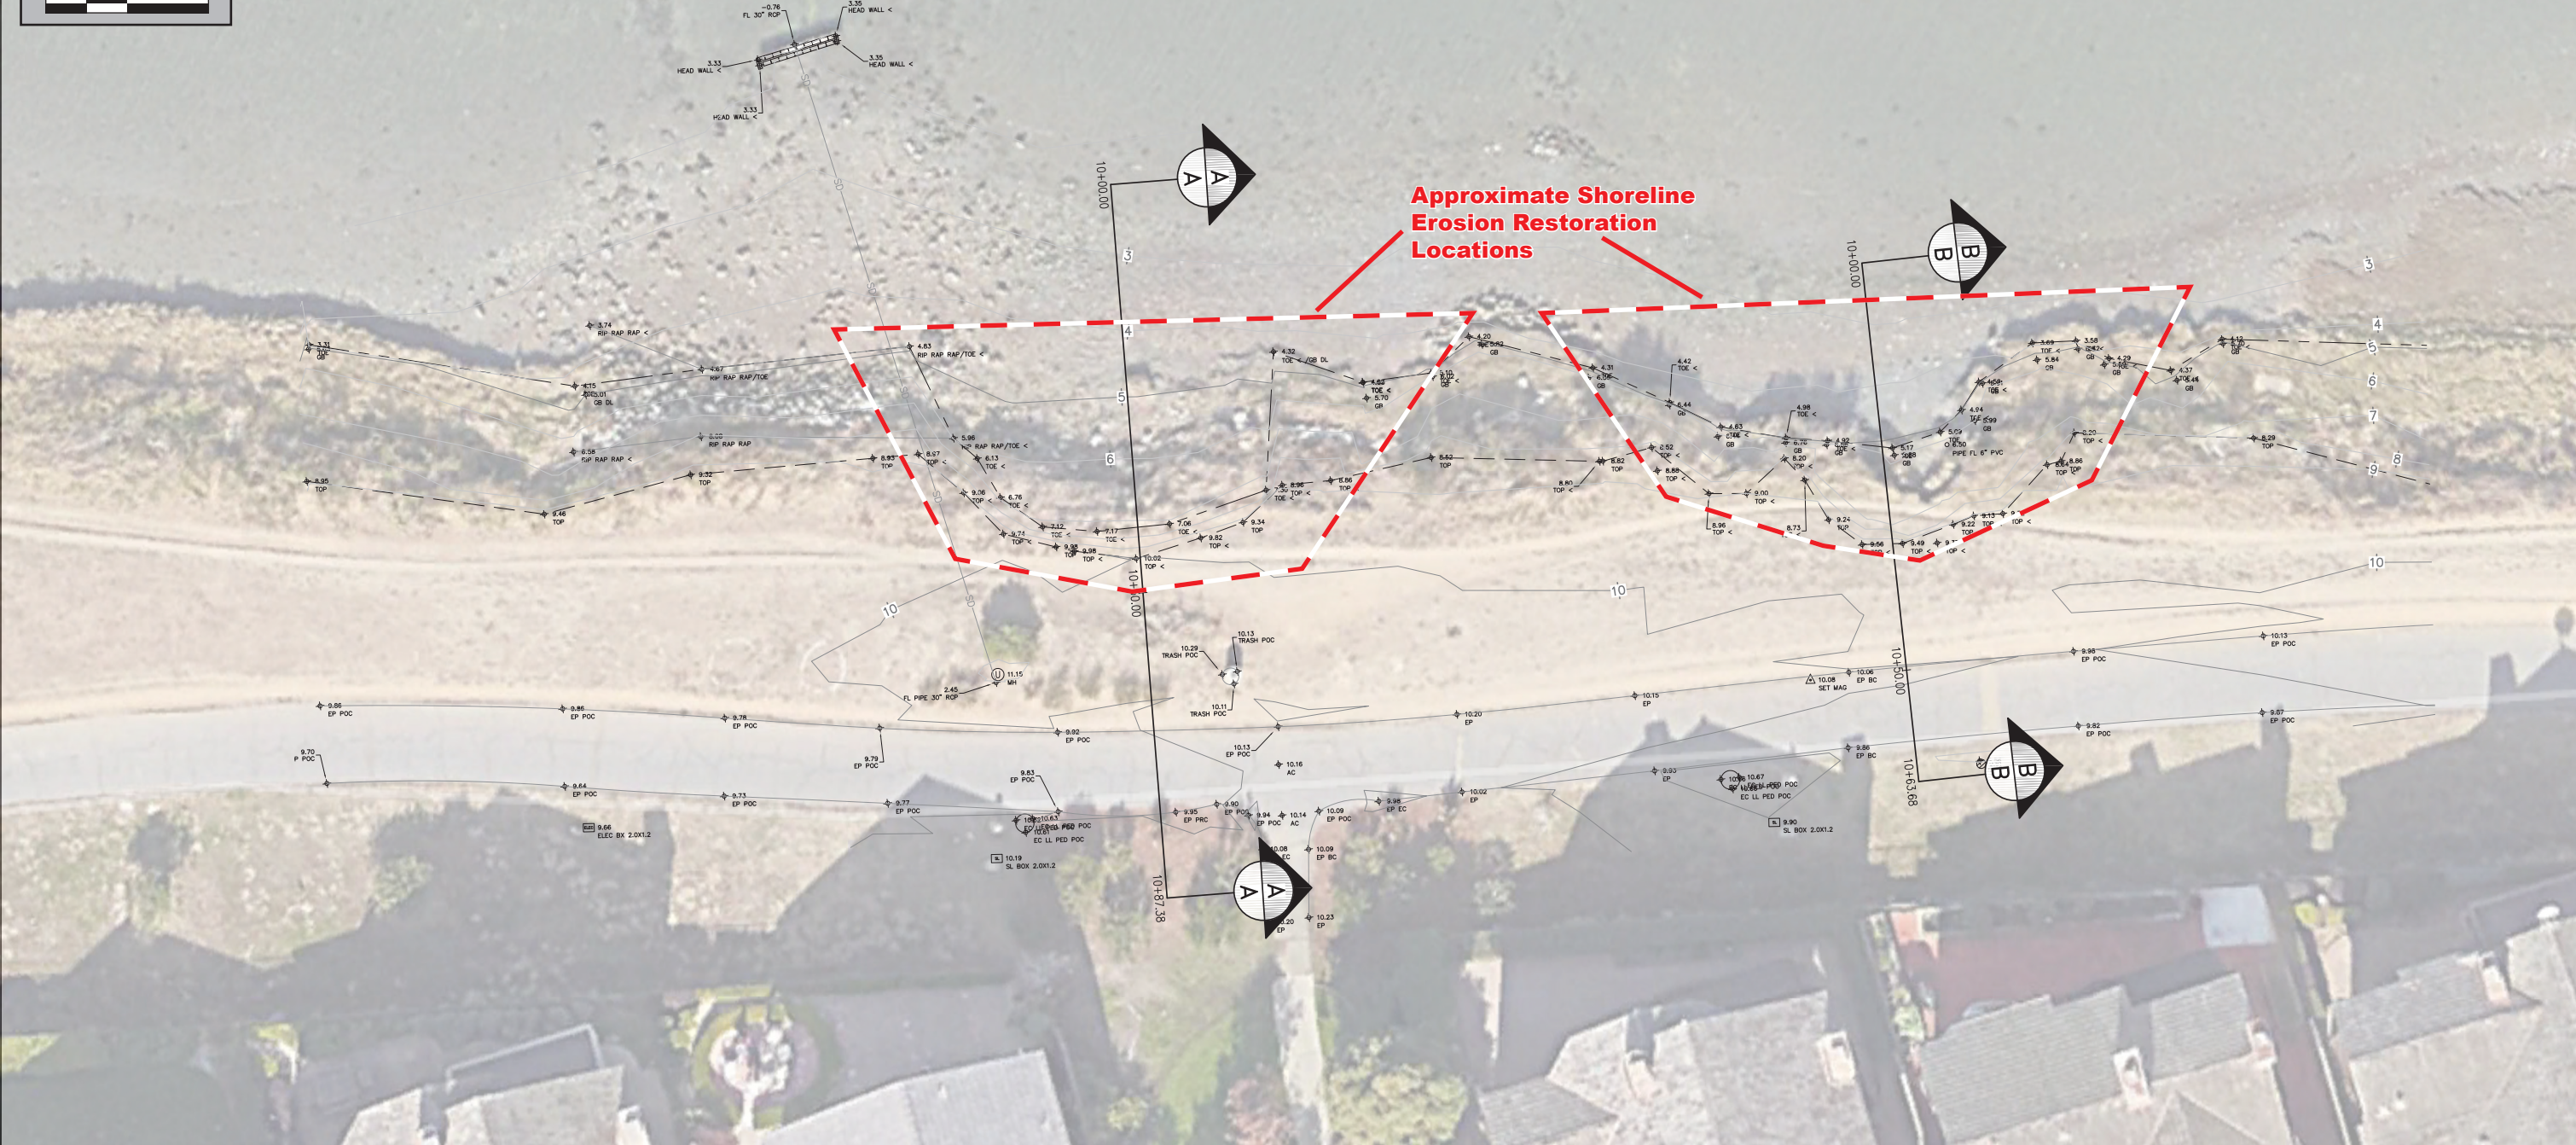
RESTORATION SITE PLAN

The project consists of evaluating and developing repair recommendations for two localized areas of severe shoreline erosion located along the north shore on Bay Farm Island in Alameda, California. The localized erosional areas are located on the shoreline north of the 2905 Sea View Parkway and 2901 Sea View Parkway properties immediately north of the Bay Trail. The shoreline erosion is starting to encroach on the existing unpaved pedestrian pathway portion of the Bay Trail that is adjacent to the shoreline. The approximate shoreline erosion areas are shown on Figure 2, Restoration Site Plan.

Based on our data review and site reconnaissance, we conclude that the main cause of localized erosion occurring at the Site is tidal wave action in combination with the lack of shoreline protection during periods of high wave energy such as storm events. Due to the heavy rainstorms during the past 2022-2023 winter, it appears erosion at the Site has worsened in a short time and has fully-encroached the unpaved pedestrian pathway. The two localized shoreline erosional features should be reconstructed seaward to match the adjacent, relatively intact natural shoreline edges and protected against high energy tidal wave action to reduce the potential for further erosion. Due to the overall conditions of the natural northern Bay Farm Island shoreline, consideration should be given to protecting the entire exposed length of the shoreline (i.e., well beyond the two embankment erosion features discussed herein) to reduce future erosion in the future along the entire shoreline. However, as previously stated, the focus of the recommendations presented in this report is just the restoration of the two shoreline erosional features shown on Figure 2.
