**PUBLIC WORKS
CITY OF ALAMEDA**

12 December 2012
Project No. 750513310

Subject: Geotechnical Evaluation of Erosion at Alameda Shoreline Park
Alameda, California

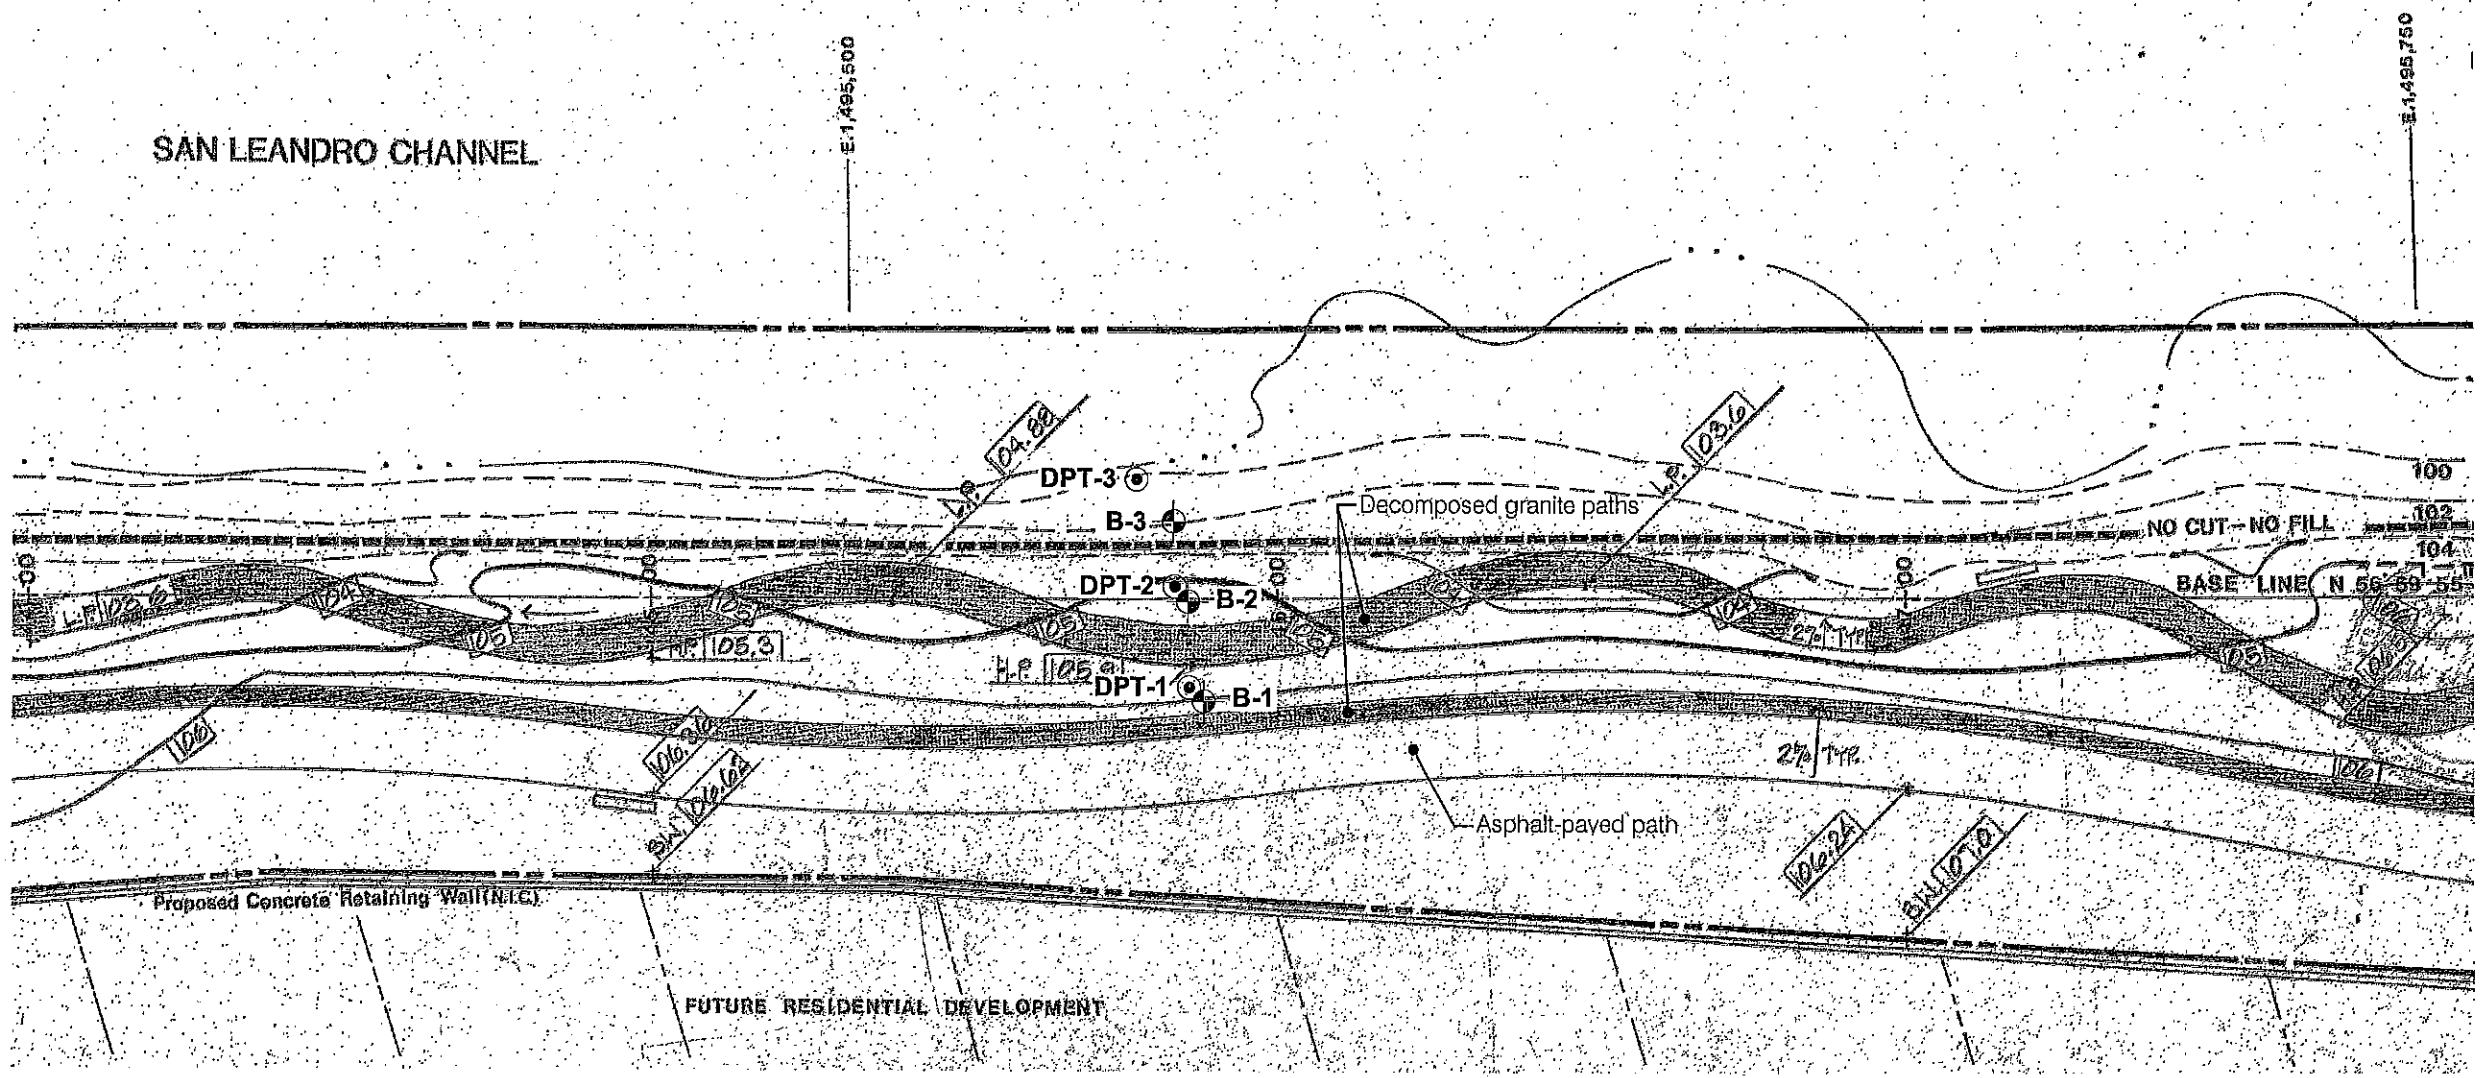
EROSION AT ALAMEDA SHORELINE PARK Alameda, California		
SITE PLAN		
Date 12/10/12	Project No. 750513310	Figure 2
Treadwell & Rollo A LANGAN COMPANY

Subsurface conditions at one area of erosion were explored by drilling three borings, designated B-1 through B-3, and performing three DPTs, designated DPT-1 through DPT-3. The approximate locations of the borings and DPTs are shown on Figure 2.

On the basis of our field investigation and our review of the subsurface information available for the site vicinity, the site is underlain by up to about 8 feet of loose to dense sandy fill, which decreases in thickness toward the shoreline. Between the jogging path and the shoreline, erosion has occurred in the sand fill; in localized areas, scarps on the order of 2 to 2-1/2 feet high have developed in the fill.
