On September 1, 2026, I performed a visual inspection of a Coast Live Oak (*Quercus agrifolia*) located on the right side of the residence at 1716 Tregloan Court, Alameda, California.

Demolition Certificate of Approval  
Supplemental Application (Misc. Resource/Accessory Structure)

# PLN26-0599 – 1716 Tregloan Ct.

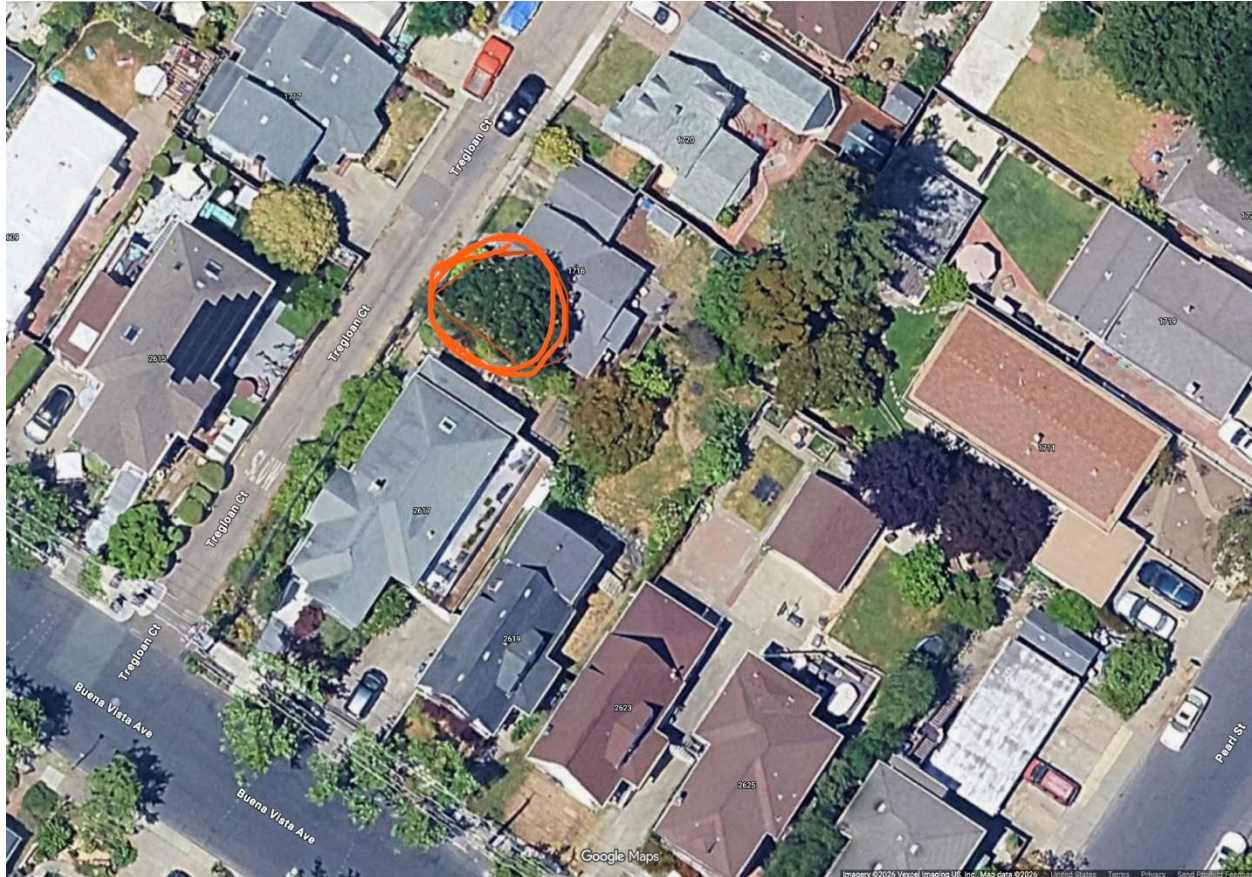
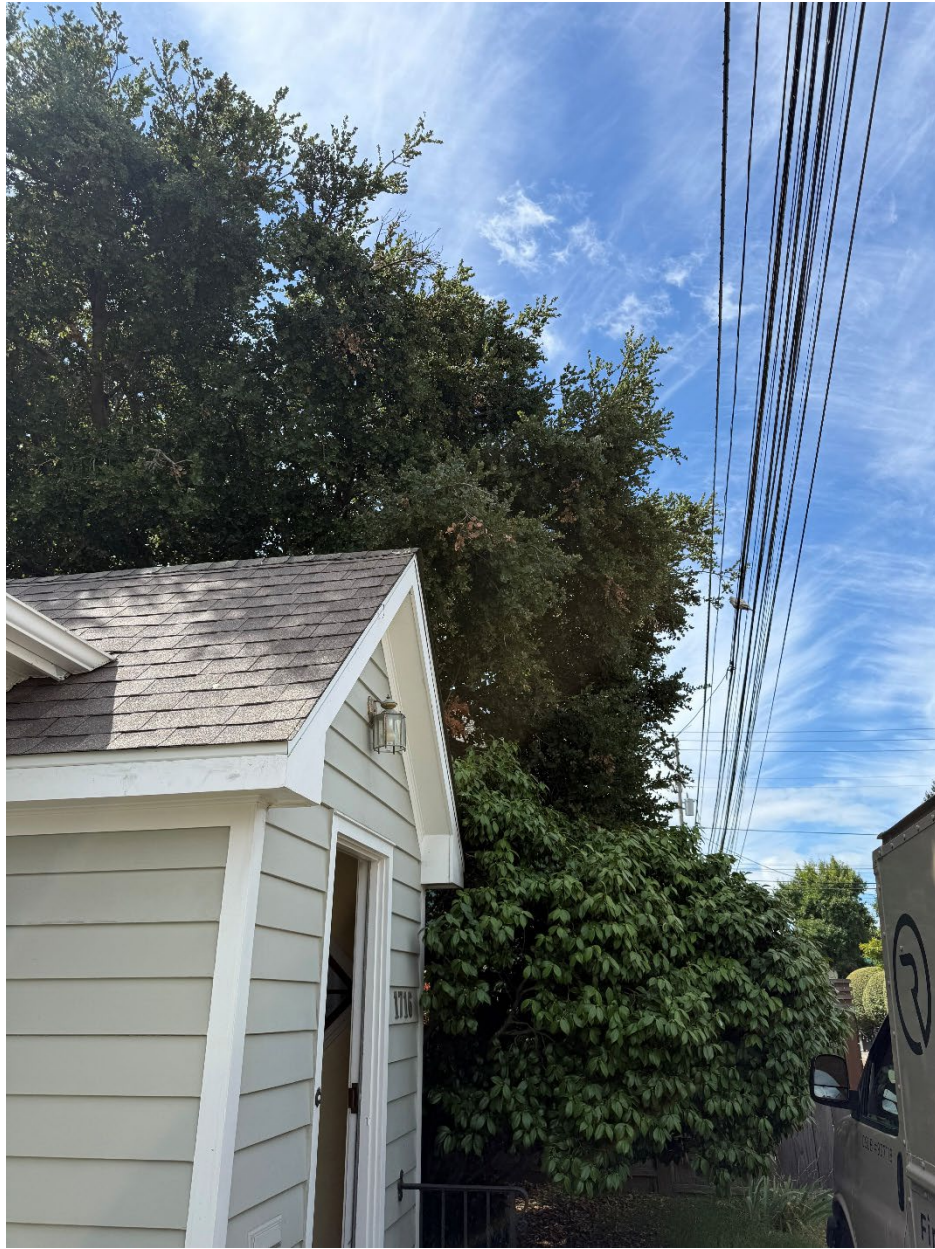
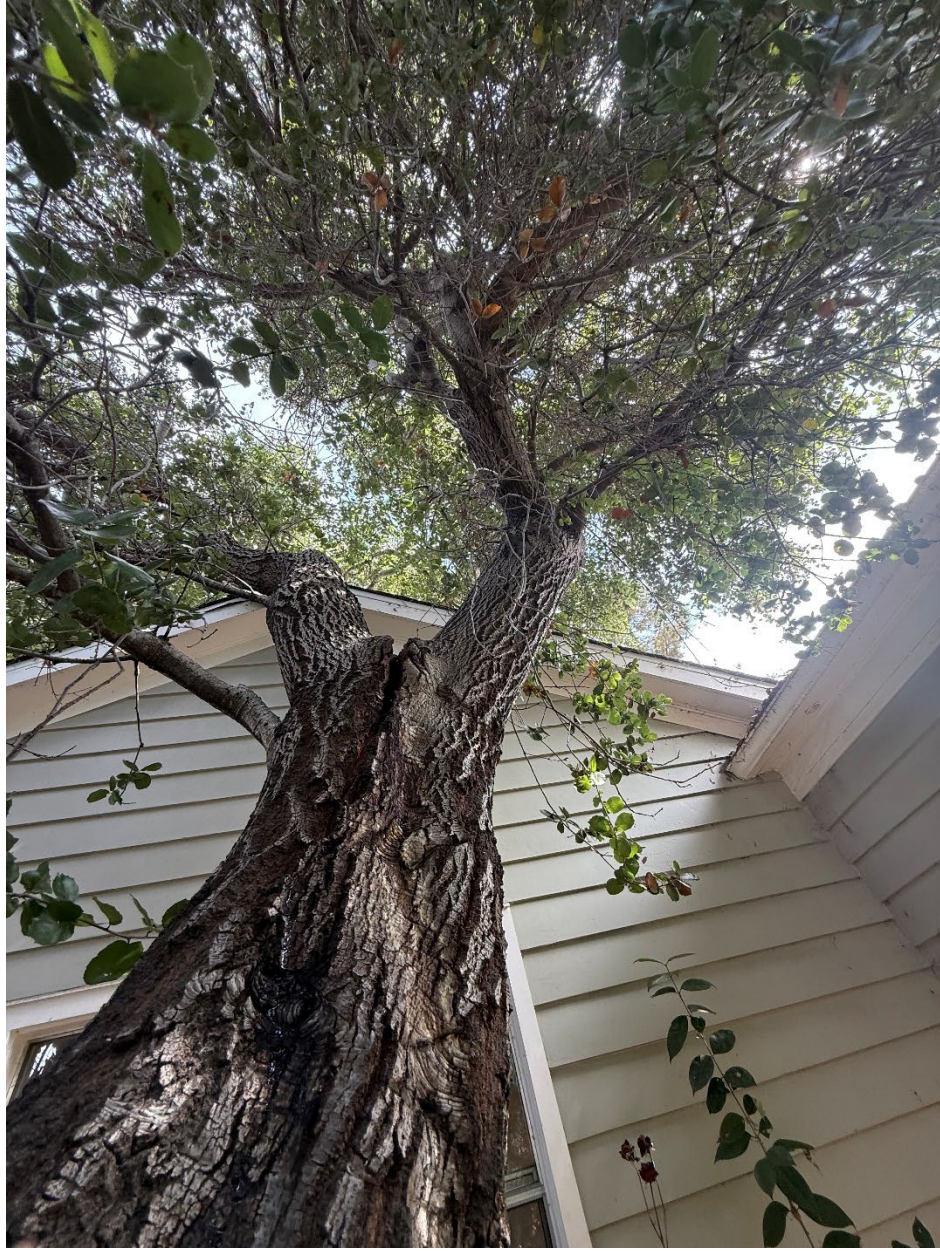
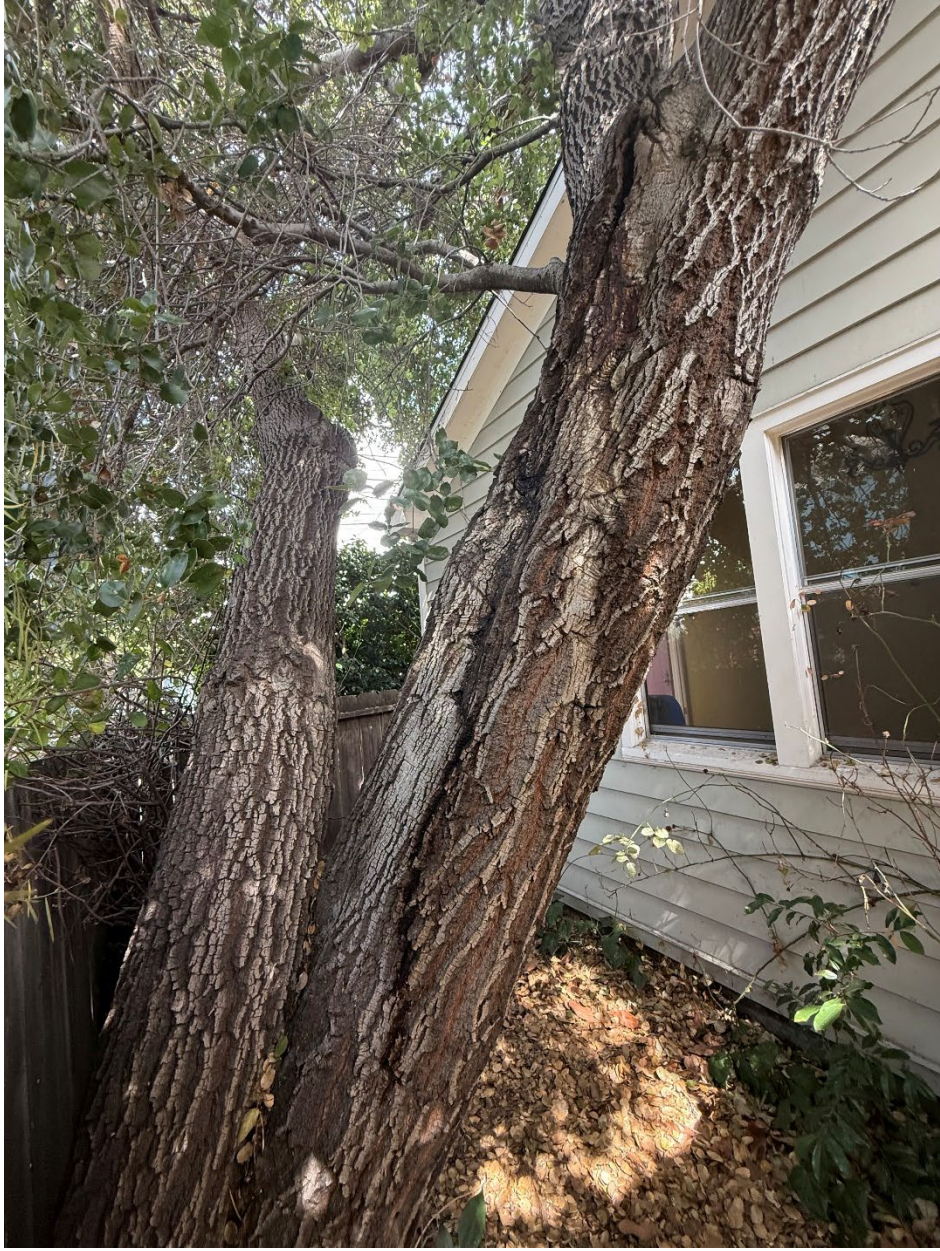
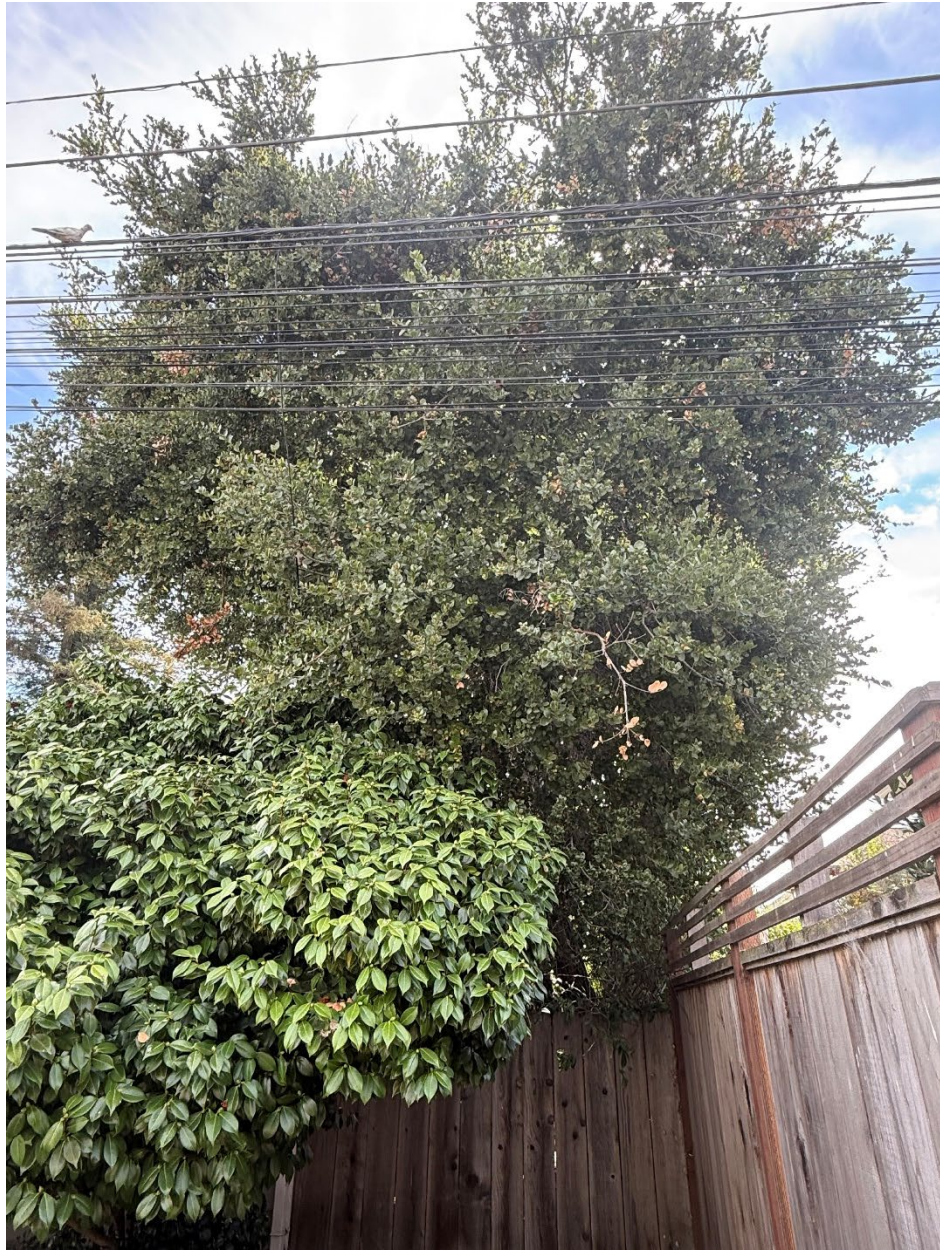
## Site Photos

Coast Live Oak tree with co-dominant trunks, located against property side fence,  
with a lean towards the house. Tree has structural weaknesses, including a failed  
secondary Y-union 10 feet above grade on a co-dominant leader, with a crack  
approximately 3 feet in length and up to 2 inches in width. Portion(s) of tree are in  
direct contact with roof at gutter line, with roof appearing to provide support that is  
limiting further movement of tree.

The severe lean towards the house, along with the failed leader at the cracked Y-union  
observed to be making direct contact with the house, presents as a high risk situation. An  
ISA certified arborist has stated in an arborist report that any further shifting of the leader  
or another portion of the tree, could result in significant property damage to the home, and  
create a hazardous condition, and should be removed expeditiously.
