Arborist Report Memorandum

SUBJECT: Tree #1538
2927 Gibbons Drive, Alameda

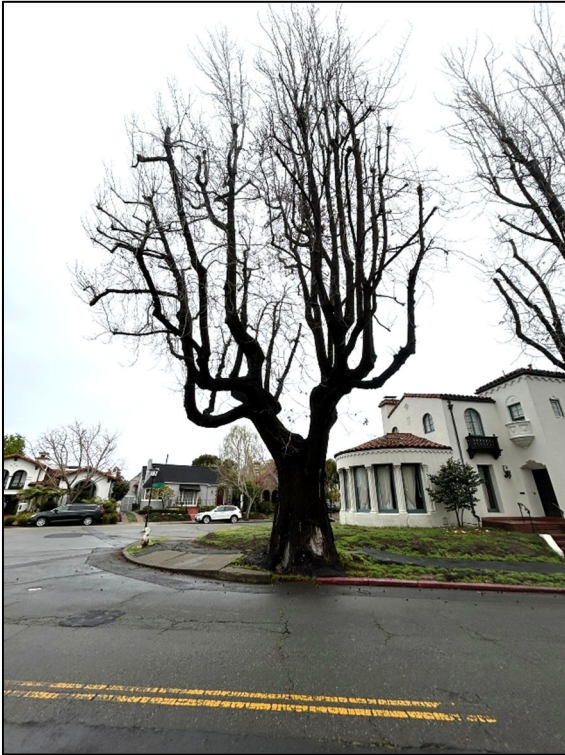
LOCATION: 2927 Gibbons Drive, tree #1538
SPECIES: Sweetgum (*Liquidambar styraciflua*)
TRUNK DIAMETER: 43 inches
CONDITION: Poor. Two large scaffold branches arose from a codominant attachment at ~8 – 10 feet. The attachment was wide and had a cavity in the center in the tension wood where loading forces would be greatest. A central column of decay appeared to connect from this cavity to a decaying wound at the base of the south side (~20% circumference). Foliage on the south side was thin and yellow. Surface roots filled the available growing space. See photos 1 – 4, next page.
SIDEWALK DAMAGE: Significant. Severe displacement throughout street corner.
CURB DAMAGE: Significant. The curb was lifted and bowed into the street.

Photo 1 (top left): Looking north at tree ##1538.
Photo 2 (top right): Closeup of cavity in main attachment.
Photo 3 (bottom left): Looking north at the base.
Photo 4 (bottom right): Looking southeast at the base.

RECOMMENDATION: Remove the tree.
REMOVAL CRITERIA: See City of Alameda Tree Removal Policy Section D – All Other Tree Removals, Subsection 2C.
