008 – Dublin Pump Station

Summary

017 – Willow Pump Station

025 – 8th Portola Pump Station

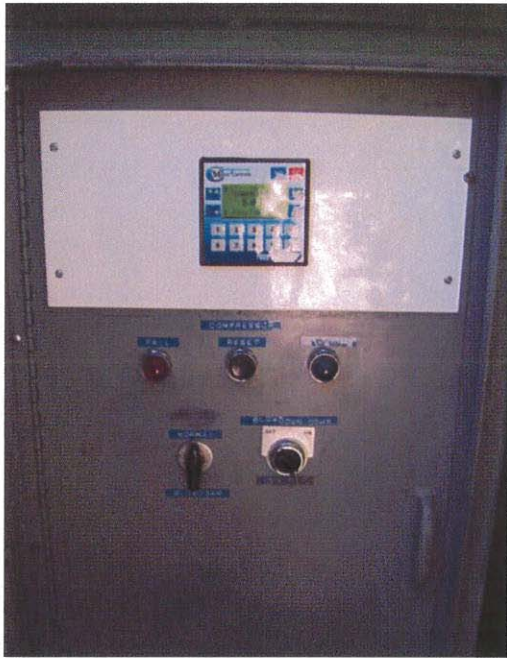
Photo 008-3: Electrical Panel
(Exterior)

• Panel bottom area corroded	3

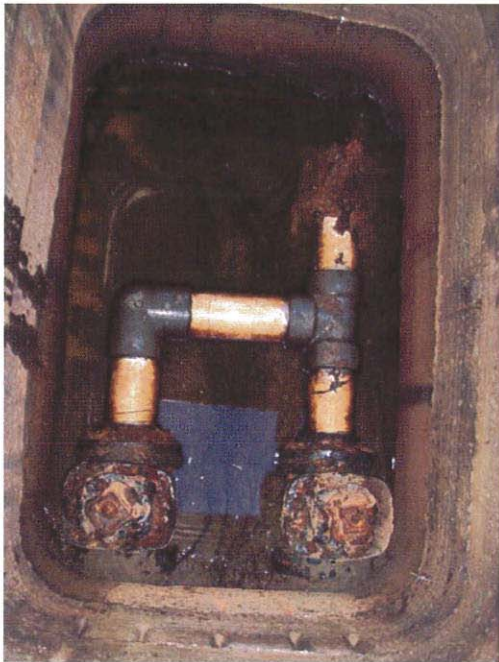
Photo 008-5: Valve Box

At the time of inspection there was standing water in the valve vault, the valve vault should either be replaced, or a drain should be added to the existing small valve vault.

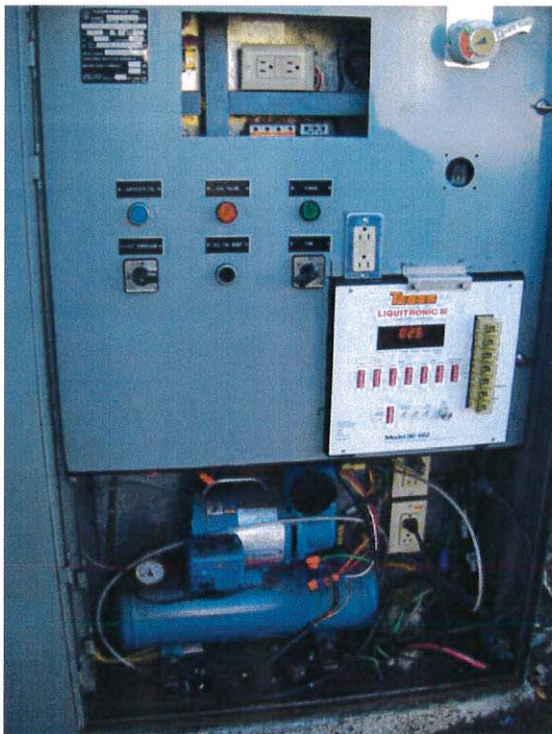
Photo 017-5: Electrical Panel (Exterior)

• Some panel areas corroded	3

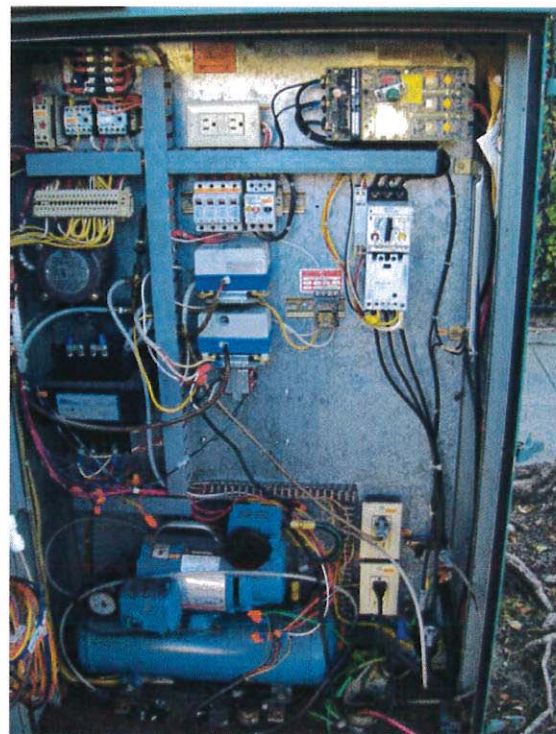
Photo 017-6: Electrical Panel (Interior)

• Pump motor cables routed through the conduit seal fitting make it difficult to pull them out for pump/motor repair	3
Others	• Panel interior dirty and dusty	3

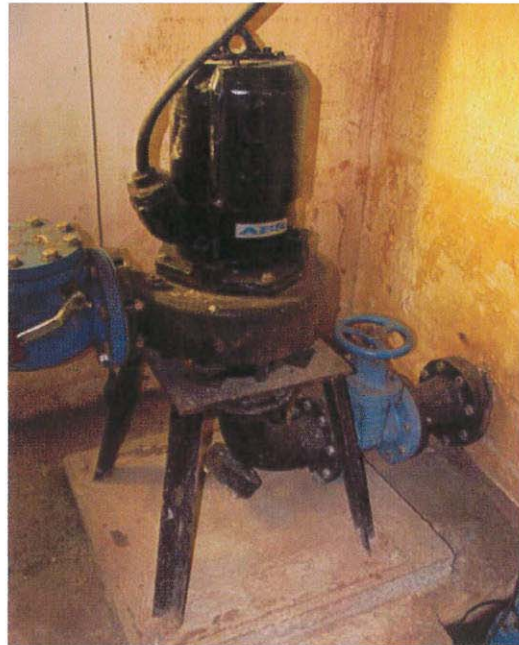
Photo 025-5: Pump

Structurally, the 8th Portola Pump Station is in good condition. The structures' walls and access ladders are in good shape and the pumps are adequately anchored. The SCADA antenna is loose and there is some corrosion in and around the pumps as well as hydrogen sulfide exposure on the walls of the wet well. There is no fall protection and the ventilation was poor. Although the site is not supported by a deep foundation, the liquefaction hazard for this site is low.

We recommend checking the anchorage of the SCADA antenna pole and providing fall protection where necessary. We recommend removing areas of corrosion and repaint them with an appropriate Tnemec system. Any loose grout around the pumps should be removed and confirm the pumps are adequately bolted to their foundation.

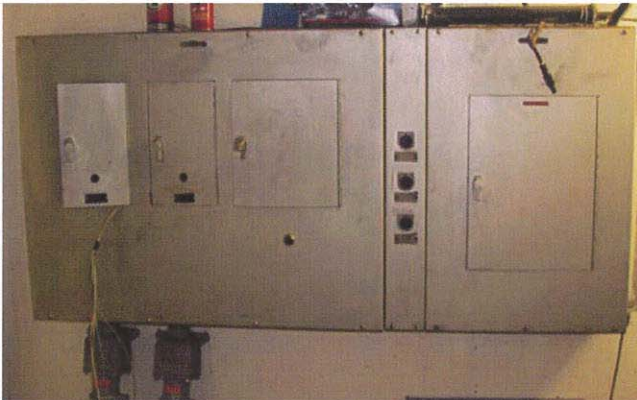
Photo 025-6: Inside Electrical Panel

• Pump motor cables routed through the conduit seal fittings makes it difficult to pull them out for pump/motor repair	3
	• Panelboard located below grade in the dry well	3
Others	• Panel interior dirty, dusty and covered with cobwebs	3

• Panel bottom area and conduit stub-up corroded	3

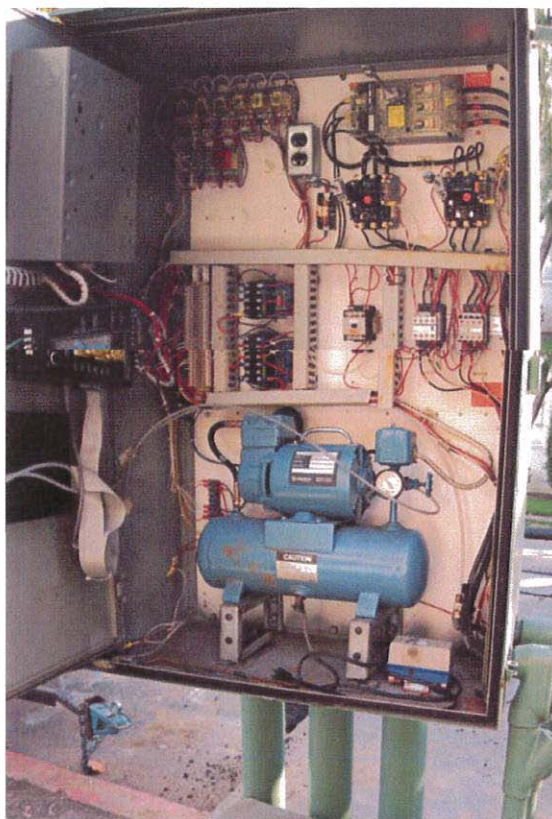
Photo 026-4: Electrical Panel (Interior)

• One common panel for the 2 pump starters	3
	• One common junction box for the 2 pump motor conductors and receptacle/plug units	3
Operations/Maintenance	• No separate compartments for pump starter, level/pump controls, and bubbler compressors	3
Others	• Panel interior slightly dirty and corroded	3

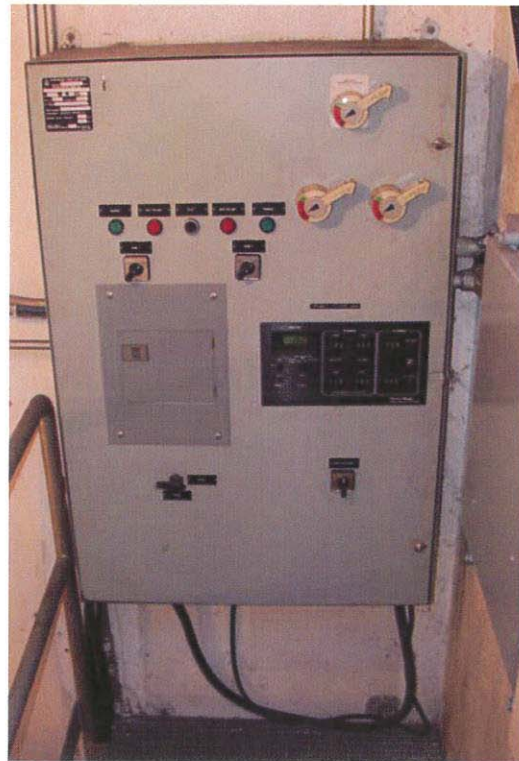
Photo 027-5: Electrical Panel

• Panel interior dusty, dirty and corroded, especially the abandoned mounting holes for the compressor	3
	• Light fixtures and conduits severely corroded and filthy in the wet well	2

We recommend relocating the pump control panels and electrical enclosures above ground during the next rehabilitation. Converting the pump station to a wet well pump station with submersible pumps should be considered during the next rehabilitation.
