EXISTING HOUSE WITH FIRE DAMAGE TO REPAIR AND SECOND FLOOR

SECOND STORY ADDITION w/CONVERSION TO DUPLEX 802 BUENA VISTA AVE. ALAMEDA CA 94501-2206

Architectural Survey Memorandum [25134 – 802 Buena Vista Avenue, Alameda]

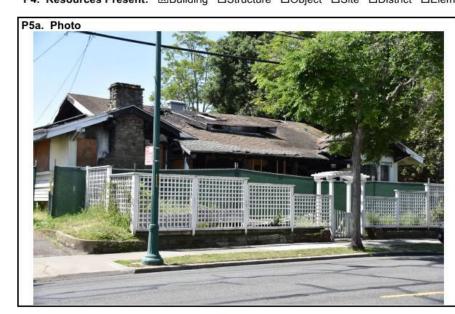
P5b. Photo: (view and date) View of the primary façade, view

\*Date May 2, 2025 bases. However, substantial portions of the original materials, particularly wood and stucco members of the front porch and of the entire upper level of the front façade, have been irreparably damaged by fire.

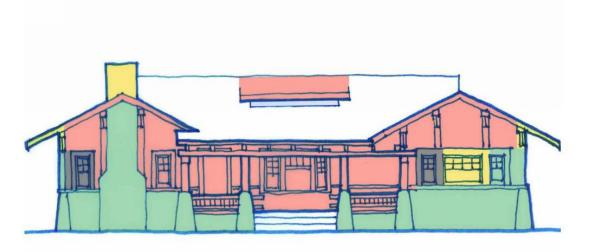
EXISTING ELEVATION 1 (FRONT, NORTH)
BUENA VISTA AVENUE

The main entrance to the building is on the north façade that faces Buena Vista Avenue (Figure 1). This façade exhibits the most fire damage of all exterior walls. The wood entry porch structure and railings are in poor condition and likely cannot be repaired (Figure 4). The shed roof dormer on the gable slope above the porch is in a state of collapse (Figure 9). Most of the wood triangular knee braces supporting the roof eaves are in poor condition like the porch. The stucco cladding is largely missing (Figure 2). The wood clapboard siding within the porch is in poor condition (Figure 6, Figure 7). Many of the window and door openings on this façade are covered by plywood and are presumed to be in poor condition based on the condition of the adjacent wall surfaces. Where the adjacent walls are in fair condition, removal of the plywood covers for assessment of the windows is recommended.

The fieldstone features are generally in good condition, including the chimney, piers, and porch facing. Select stones at the tops of the porch piers are missing (Figure 5). The chimney above the roofline is in fair condition and exhibits cracks and loose mortar (Figure 3). Paint coatings at the

porch piers appear to be trapping moisture and may be deteriorating the stone. The wood clapboard siding on either side of the porch is in good condition with some smoke damage. Two original window sashes are visible at the west end of the north façade; one window appears to be in good condition, while the other appears to be in fair condition and may be repaired by selectively replacing components like the bottom rail (Figure 8). As the building was not assessed from the interior, it is unknown whether the windows were burned beyond repair on their interior surfaces.

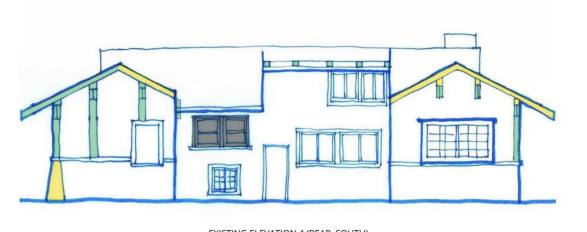
EXISTING ELEVATION 4 (REAR, SOUTH)

16). The wood braces are generally in good condition (Figure 14, Figure 17); the braces and fascia of the east gable are in fair condition and exhibit weathering (Figure 18). The wood soffits are in fair condition with smoke damage, particularly at the center of the façade.
