# FEASIBILITY STUDY OF SIX PUBLIC ACCESS PATHWAYS ON FERNSIDE BLVD. AND EASTSHORE DR.

ASSESSMENT REPORT

AUGUST 31, 2018

**City of Alameda, California**

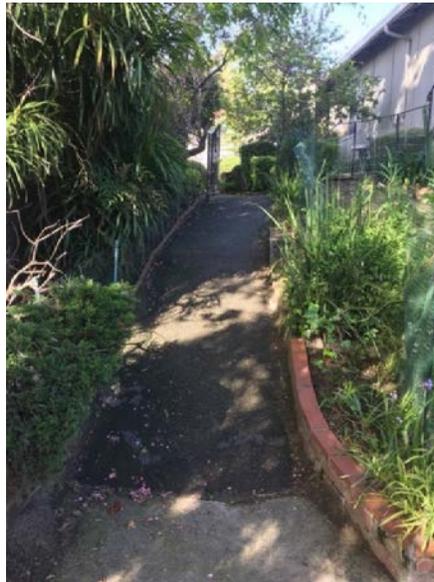
Encroachments from adjacent properties include the iron mesh fencing, wooden fencing, wooden deck, and private landscape area. A privately owned boat dock appears to be placed in public land. These encroachments have reduced the current effective size and shape of the undeveloped land. The concrete platform and gate seem to have been erected by an abutting landowner. The gate could restrict access to the water if the private property owner locks it.

*Figure 11: Asphalt pathway and metal gate at 3227 - 3229 Fernside Boulevard*

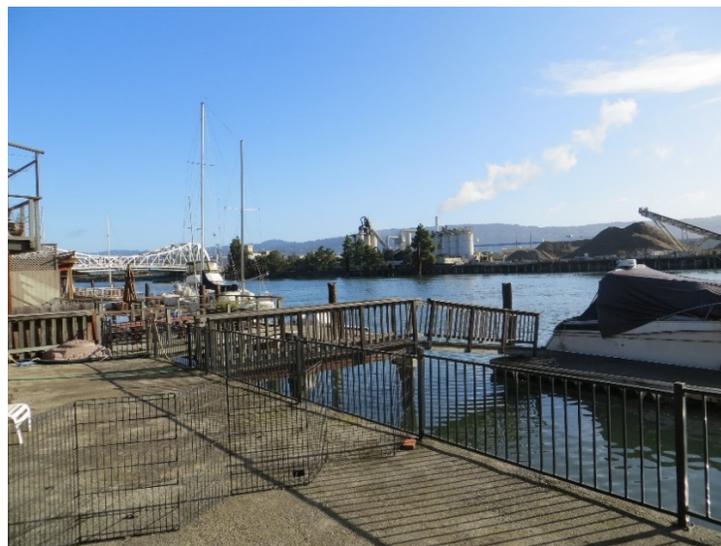
*Figure 12: Concrete platform at east end of public access at approximately 5 feet above water surface*

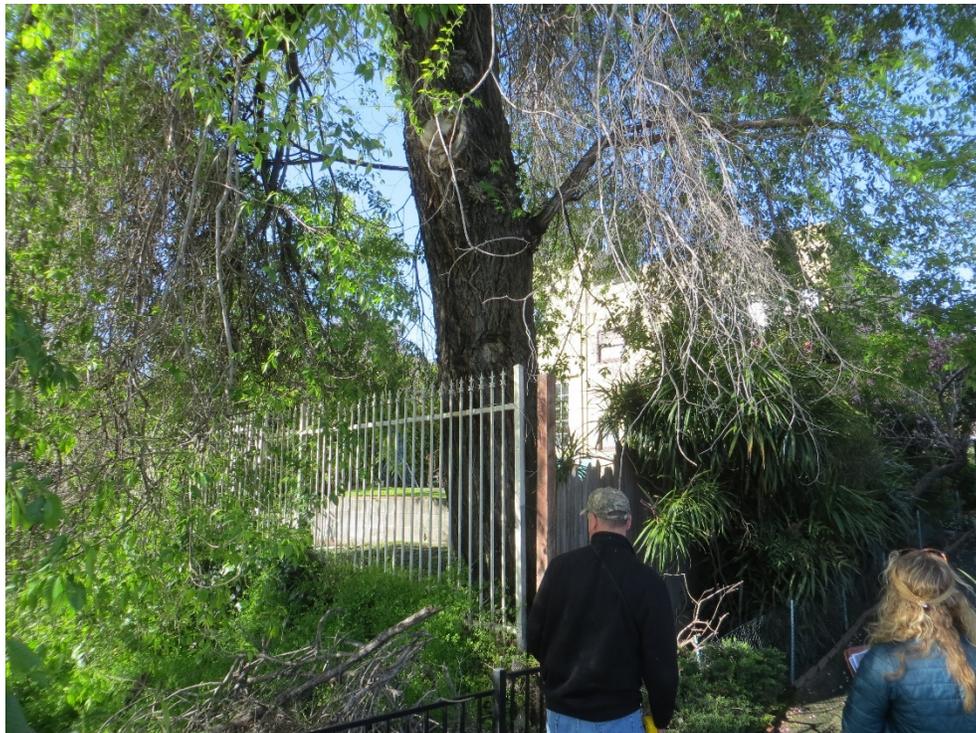
*Figure 14: Dense Vegetation at Southeast Corner of the Access Point*

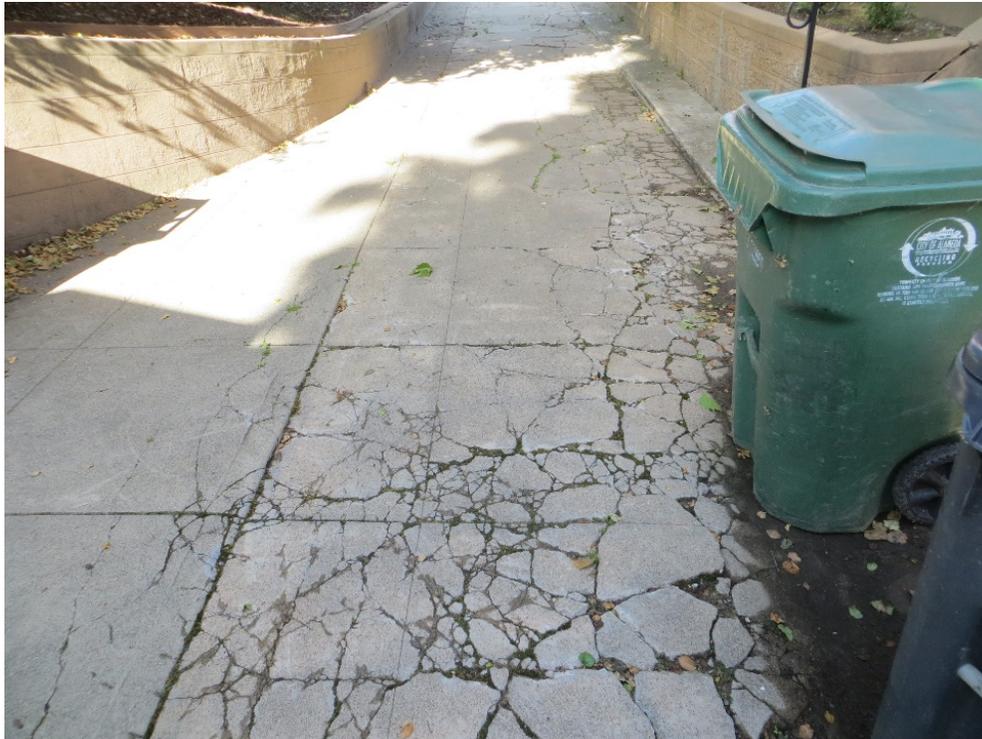
*Figure 19: The Concrete Pathway is Deteriorated due to Vehicular Use*

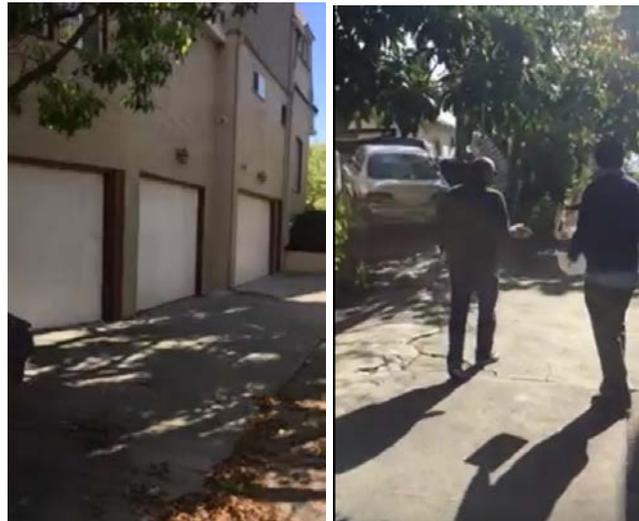
*Figure 24: Property Currently Serves as a Driveway to Both Abutting Properties.  
(3 existing garages to the south and one secondary driveway to the north)*

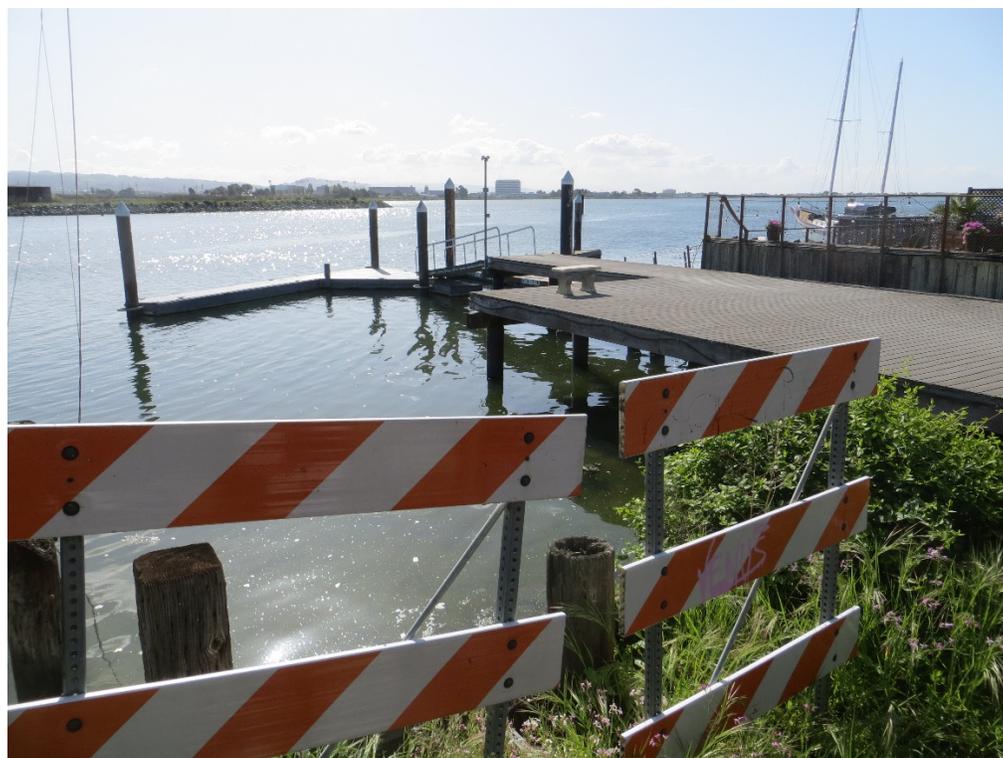
*Figure 26: Private Boat Dock on Extended from Adjacent Property*

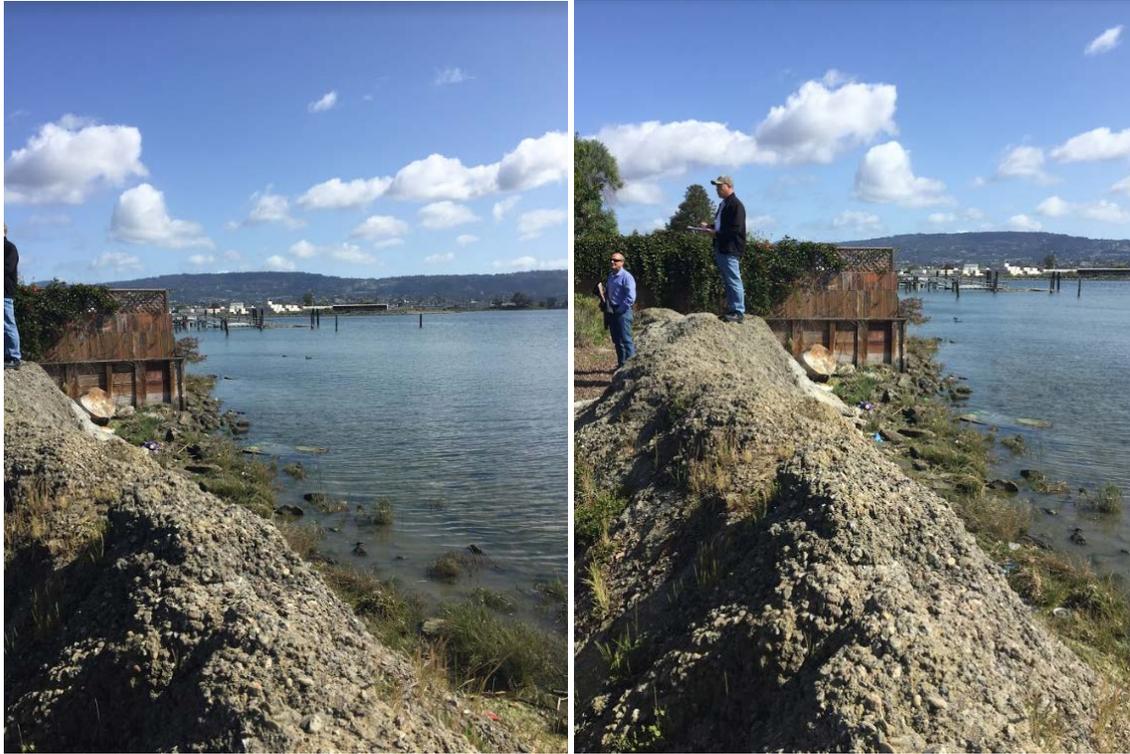
*Figure 34: Shotcrete Coated Earthen Berm at Water's Edge*

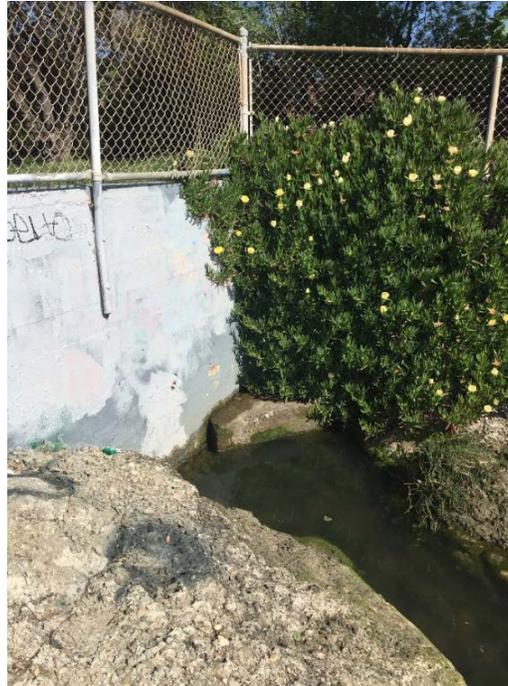
*Figure 40: Stormwater Outfall Location, Outfall Underwater at High Tide*

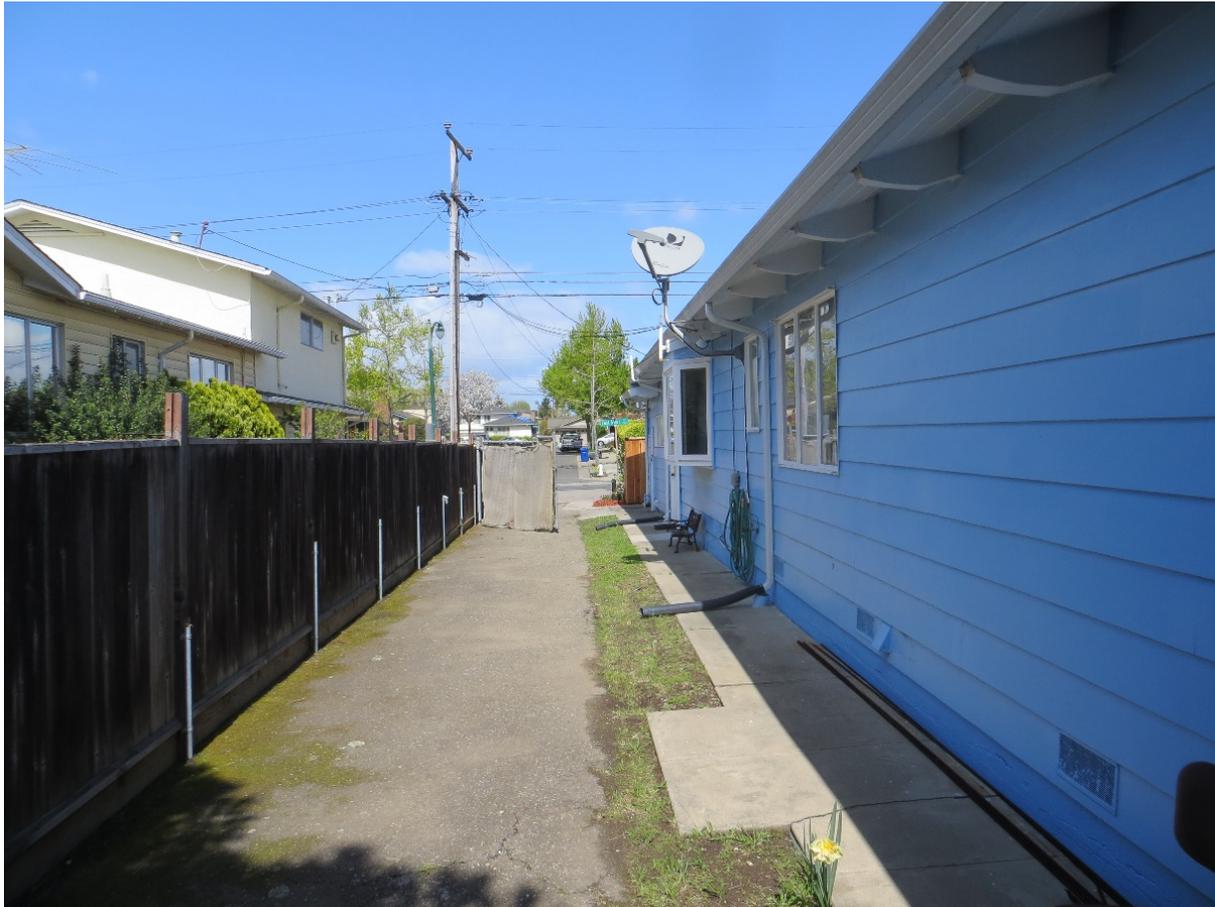
fence appears to be located on public property, dividing the two neighbors. All fences and gates are kept locked. Other encroachments from the neighbors include private asphalt pathway and limited landscaping area. One mature pinewood was seen at the end of the public access area. An overlook, pier for fishing and viewing, or other improvements would require removing this tree.

*Figure 45: Public Shoreline Access currently Occupied by Adjacent Neighbors*

Due to its existing condition, the City should consider transferring or leasing this public access pathway to adjacent private owners. This public access pathway has been inaccessible to the public for over 15 years and the cost to improve access outweighs the public benefit to reconstruct a narrow pathway when there are other public access pathways nearby. This option allows the City to avoid the demolition of privately built infrastructure and minimize recreational facility construction cost. The City shall adjust the property boundary and maintain a 20' by 20' space from the edge of the roadway. There will be minimum improvement cost under this scenario. Refer figure 48 for the property transfer option.

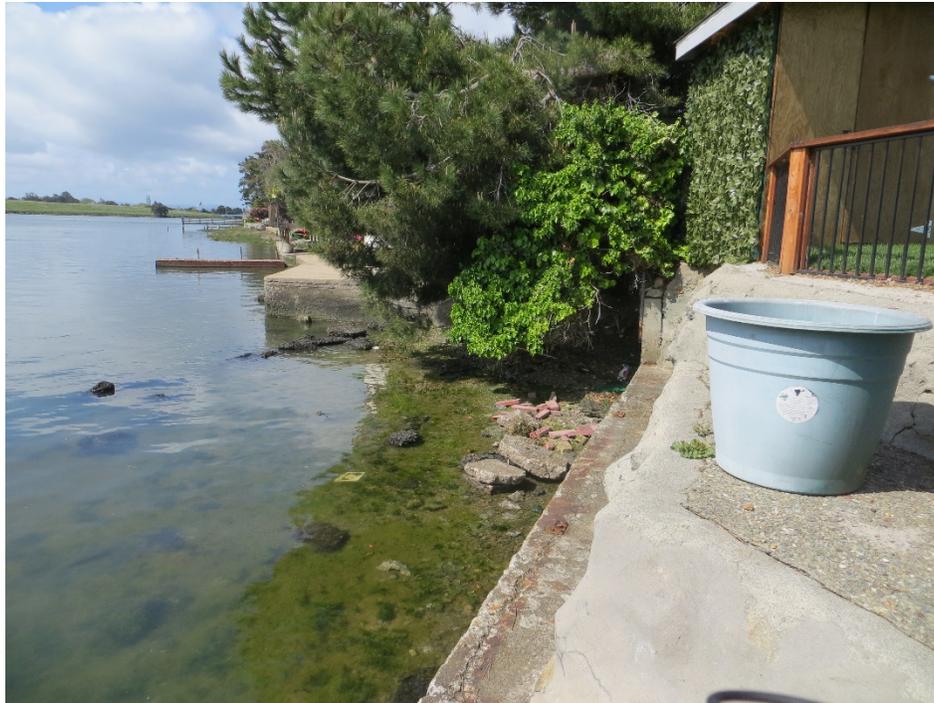
*Figure 46: Concrete Deck and Revetment to Water from Lawn Above*

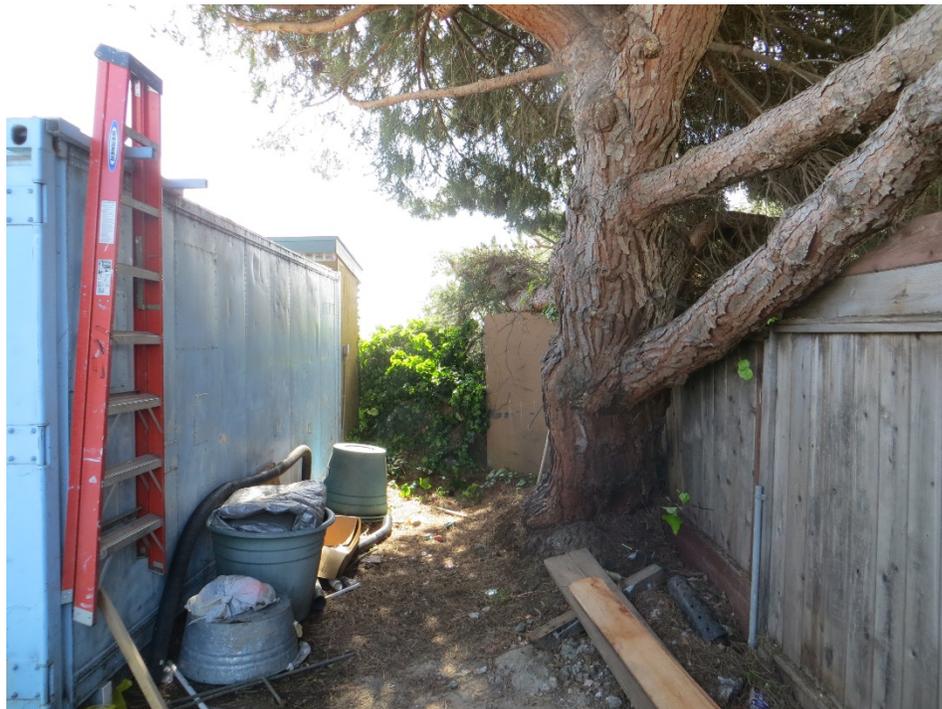
*Figure 47: Mature Pinewood at the End of the Access*
