# RFE Construction

I am a California licensed contractor, License No. 870788, and I have inspected the garage structure located at 1428 Union Street, Alameda, CA 94501.

Demolition Certificate of Approval  
Supplemental Application (Misc. Resource/Accessory Structure)

# PLN26-0566 – 1426 Union St.

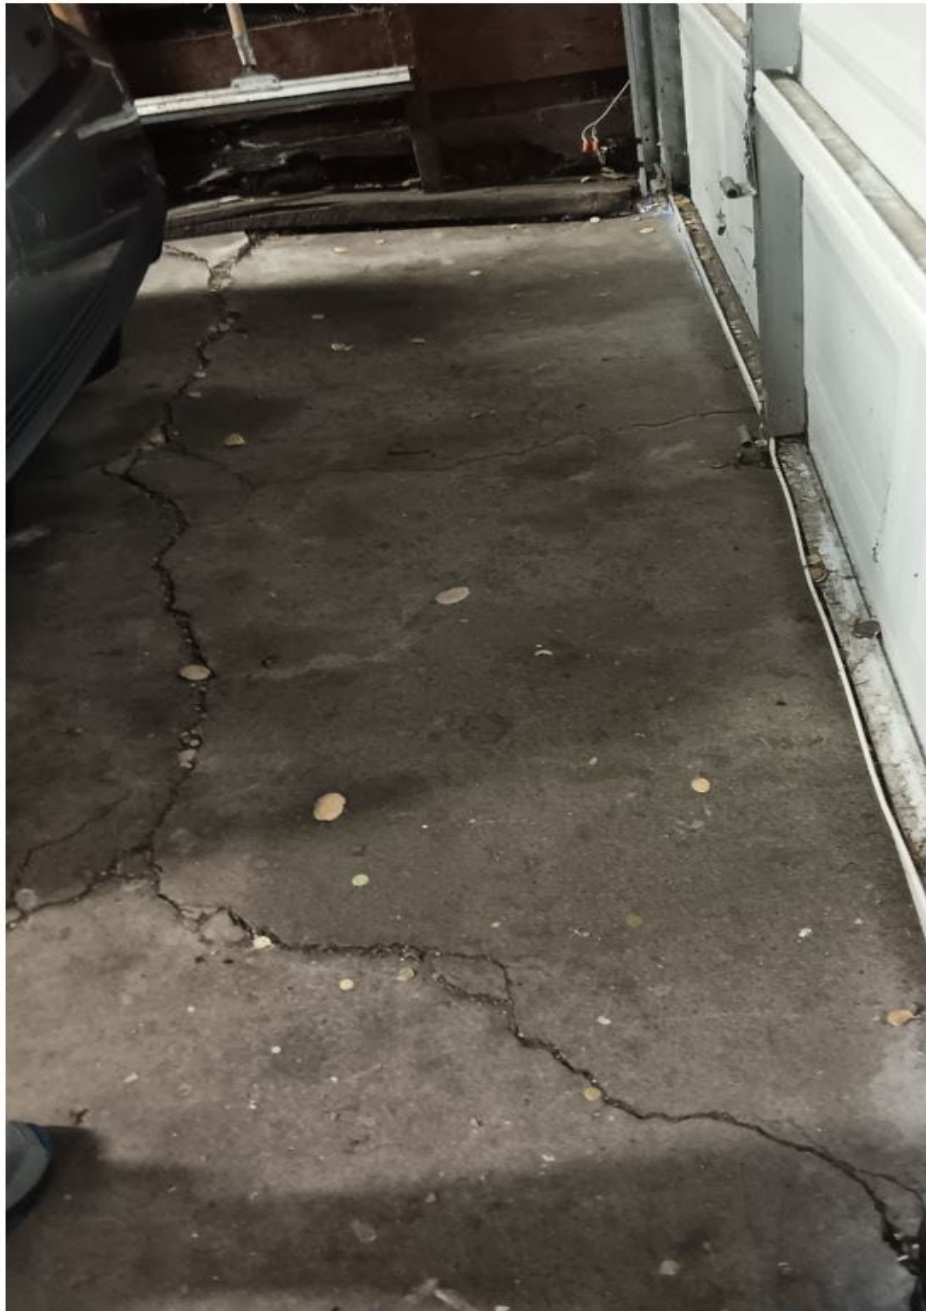
**Photo 3. Cracking of structure foundation**

In my professional opinion, the continued growth of the tree and its root system presents an ongoing risk of additional damage to the garage structure. Based on the conditions I observed, I believe that removal of the tree is necessary to prevent further structural damage and to allow for appropriate repair and stabilization of the garage structure. I respectfully request that the City consider and approve removal of the oak tree based on the structural damage and potential for continued damage to the garage. I am available to provide additional information regarding my inspection and observations if needed.

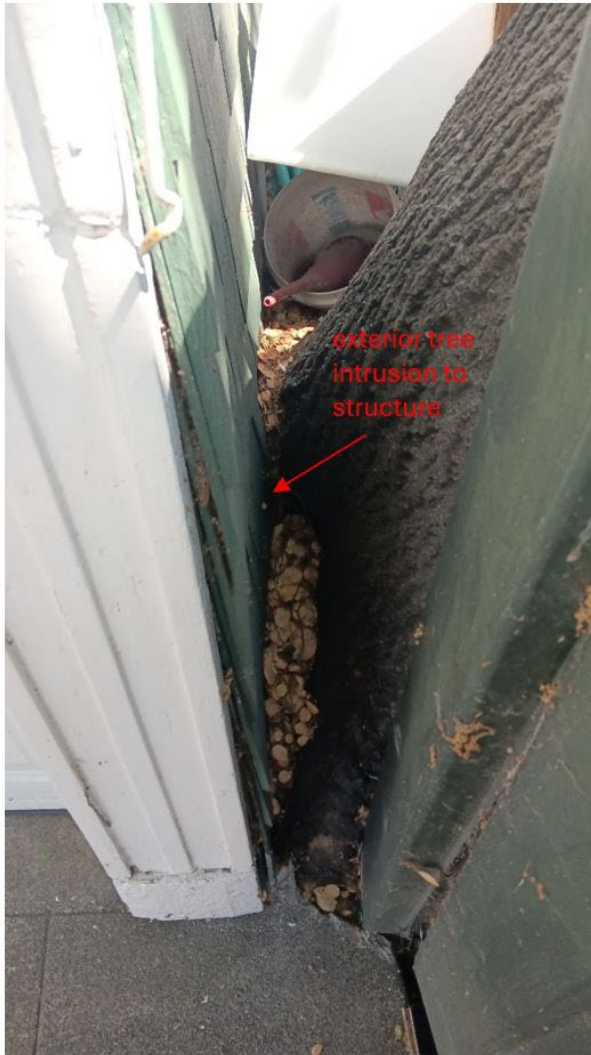
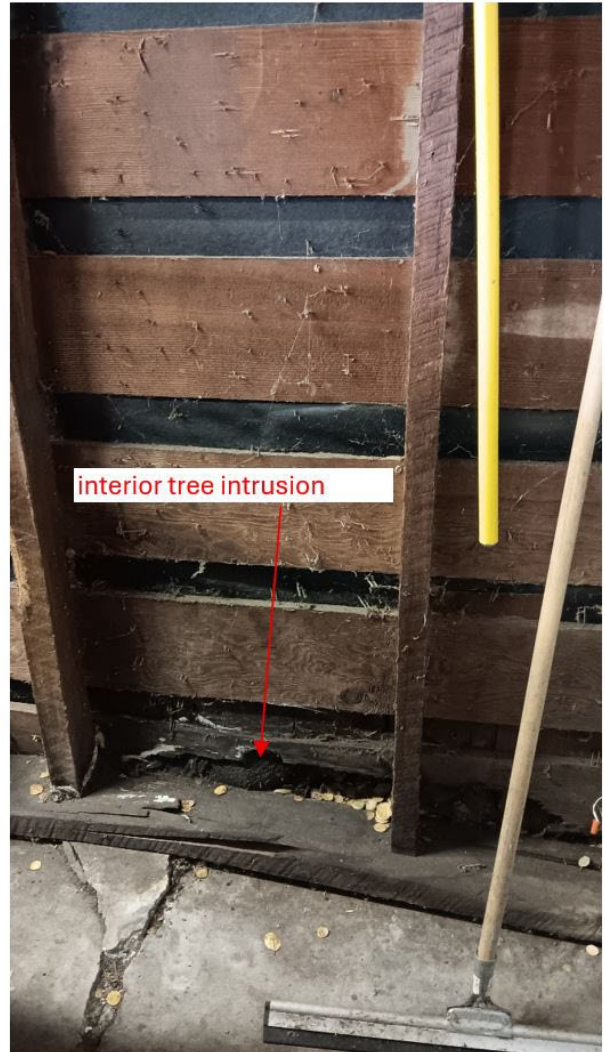
The oak tree penetrates the wall and is visible from the inside of the detached garage structure at 1428 Union Street. It is cracking the foundation and lifting the right side (when facing the structure, the southwest side) by at least 2 inches, but probably more. Also, the tree is leaning more than normal.

**Photo 2. Outside and inside structure view of tree intrusion to garage structure**

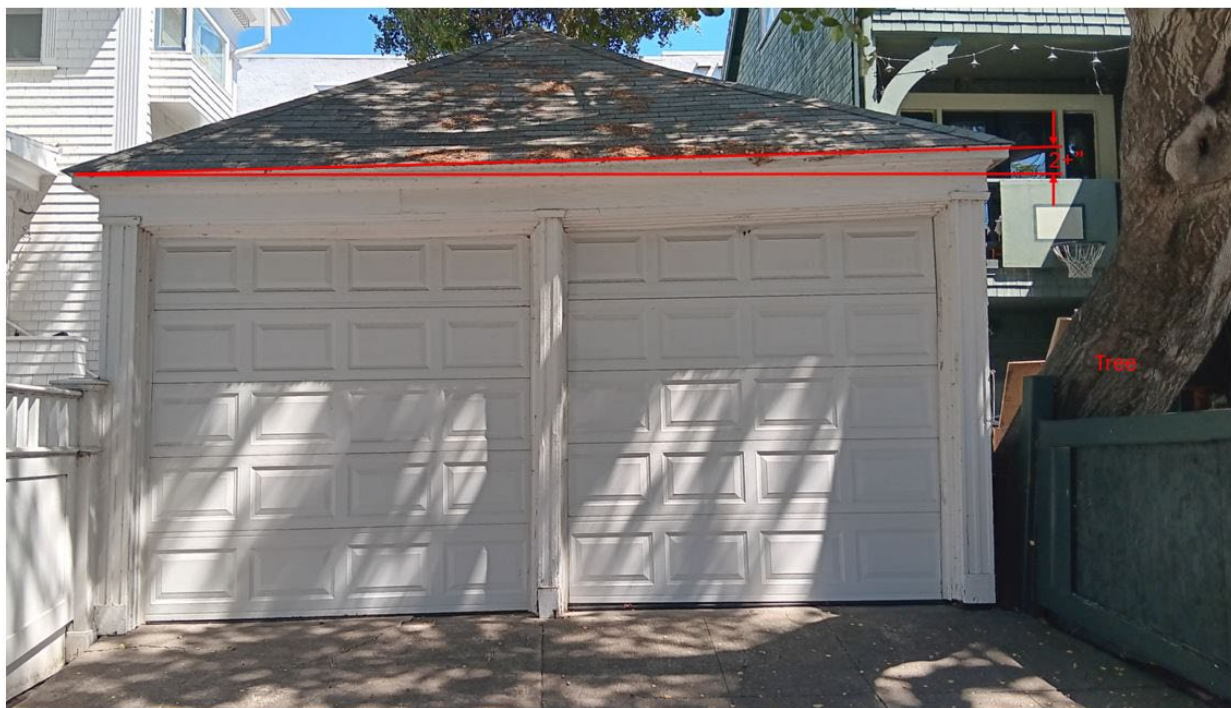
Based on my inspection and observations, I have determined that the tree and root system of the tree located on the northeast corner of the property at 1426 Union Street, adjacent to garage structure located on the southwest corner of 1428 Union Street, has caused and will continue to cause structural damage to the garage structure and its foundation. The tree and tree roots are impacting the garage foundation and structural components, resulting in intrusion into the garage walls and structure, cracking of the foundation, and vertical structure displacement of 2 or more inches across the width of the structure.

**Photo 1. Street view of garage structure, showing tree lean and garage vertical displacement.**
