RE: Assessment of the City of Alameda Storm Drain Pump Stations

**FINAL REPORT**  
**STORM DRAIN PUMP STATION ASSESSMENT**  
**CITY OF ALAMEDA**

July 12, 2011

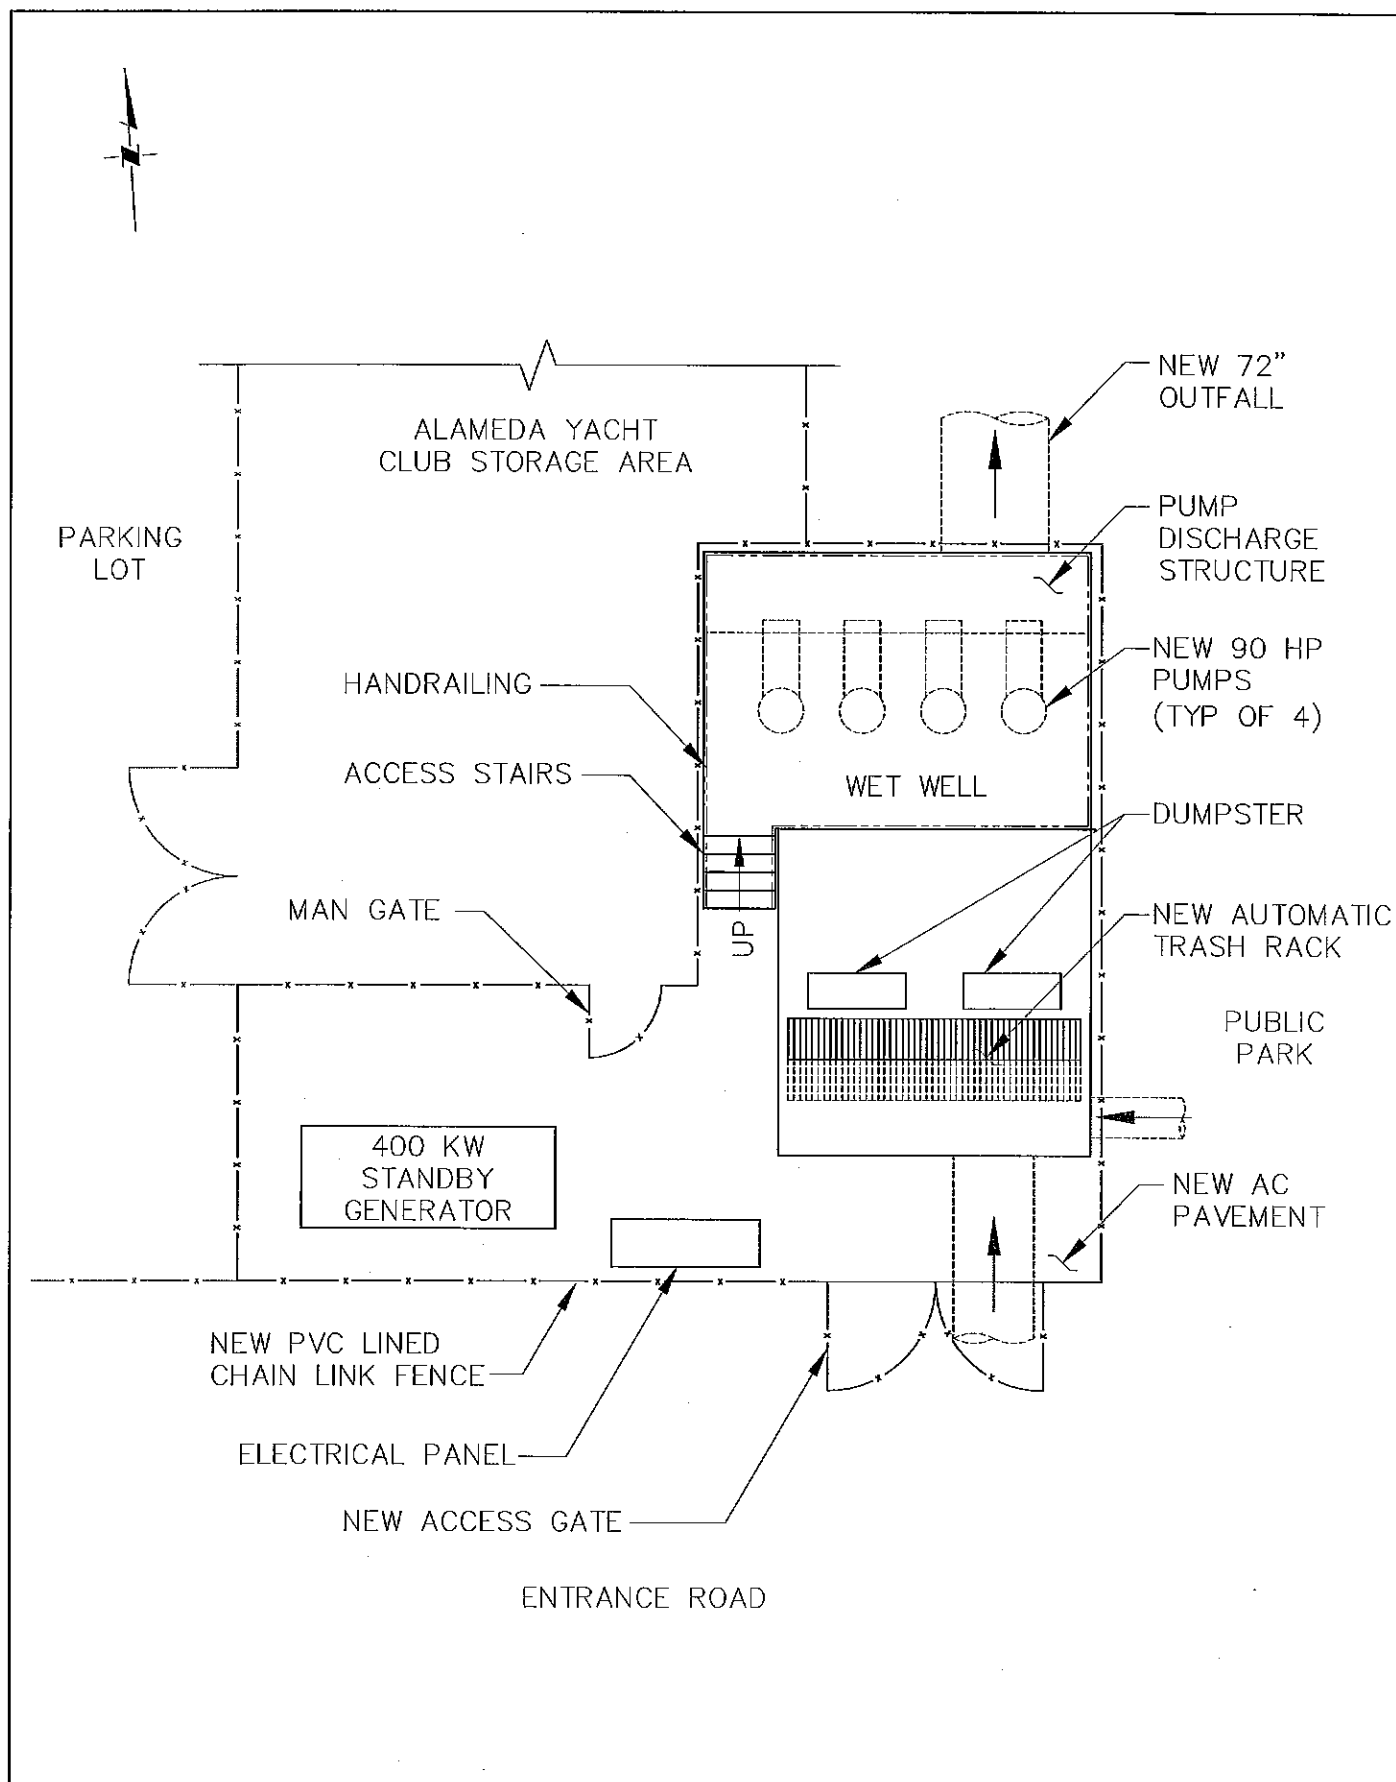
P S O M A S	CITY OF ALAMEDA	PROPOSED ARBOR PUMP STATION	FIGURE NO.
	STORM DRAIN PUMP STATION ASSESSMENT REPORT		6-2
			JOB NO. 5ALA010100

exceed to avoid flooding. A completely new pump station and upsized outfall (72-inches) is recommended for the following reasons:

- Pumping capacity is inadequate to convey the design 10-year storm inflow.
- The existing pump barrel (30-inch) must be increased to 48-inch for the size pump required to convey the design storm water volume. The size of the station can not accommodate barrels of this size without compromising the integrity of the pump deck (only 6-inches of concrete would remain between pump barrels in the current configuration).

- The hydraulics of the pump station are not ideal. Influent enters the wet well perpendicular to the pumps and is not evenly distributed to the pumps. This can cause vortexing and/or other issues, which affects the efficiency of pump operation.

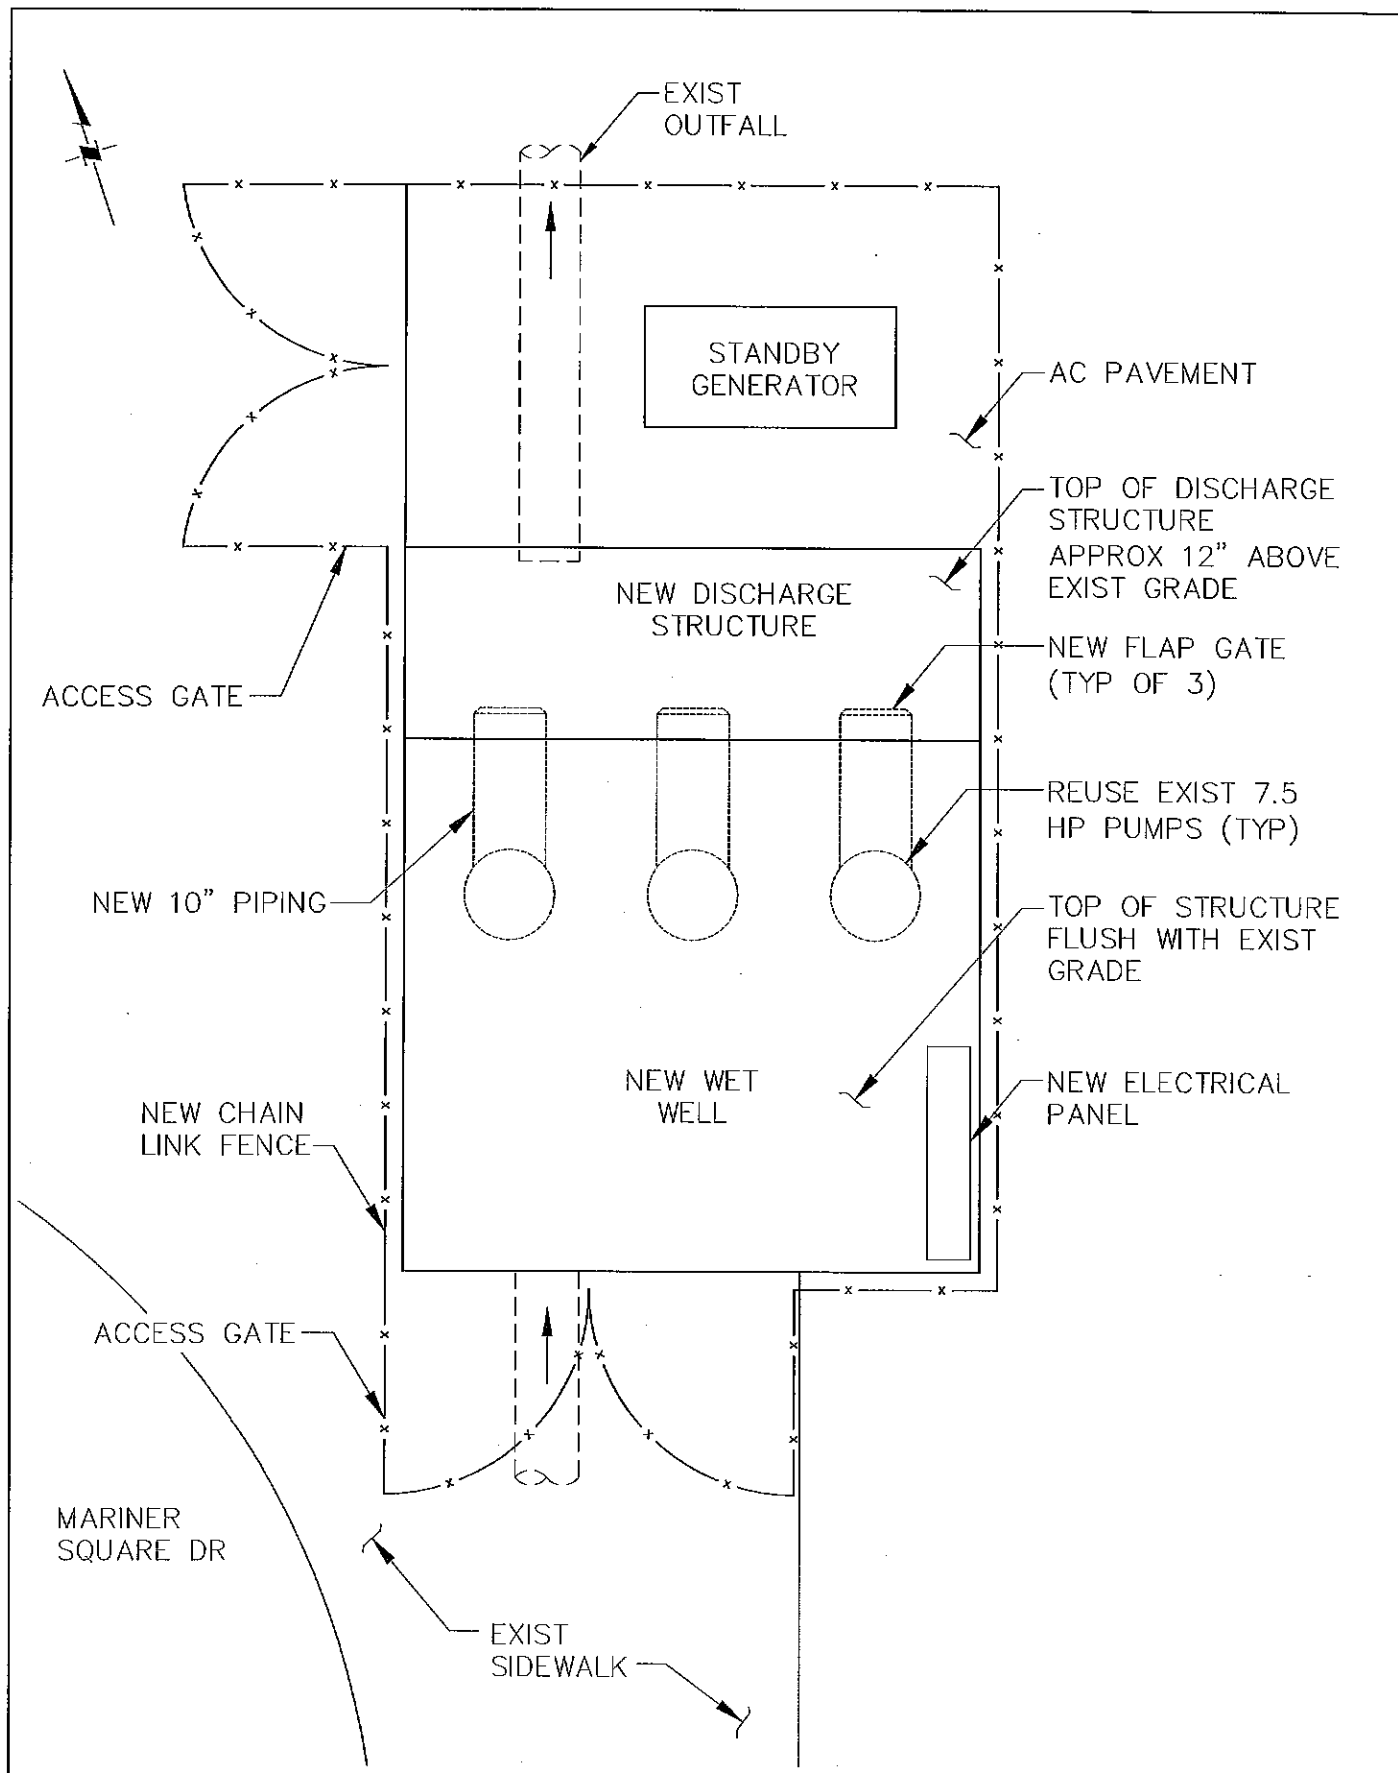
<b>PSOMAS</b>	CITY OF ALAMEDA	PROPOSED WEBSTER STREET PUMP STATION	FIGURE NO. <b>6-6</b>
	STORM DRAIN PUMP STATION ASSESSMENT REPORT		JOB NO. 6ALA010100

The Webster Street Pump Station is located on the northern side of Alameda at the end of Mariner Square Drive. The station was constructed in 1947 and consists of a concrete structure that extends partially above grade containing a dry well on top of a wet well. The station has three submersible pumps that discharge through a 21-inch forcemain into the San Francisco Bay. To prevent backflow into the wet well under high tide conditions, each pump discharge is provided with a 10-inch Val-Matic swing-flex check valve. Design criteria for the Webster Street Pump Station is summarized in Table 2-9.
