On September 1, 2026, I performed a visual inspection of a Coast Live Oak (*Quercus agrifolia*) located on the right side of the residence at 1716 Tregloan Court, Alameda, California.

Demolition Certificate of Approval  
Supplemental Application (Misc. Resource/Accessory Structure)

# PLN26-0599 – 1716 Tregloan Ct.

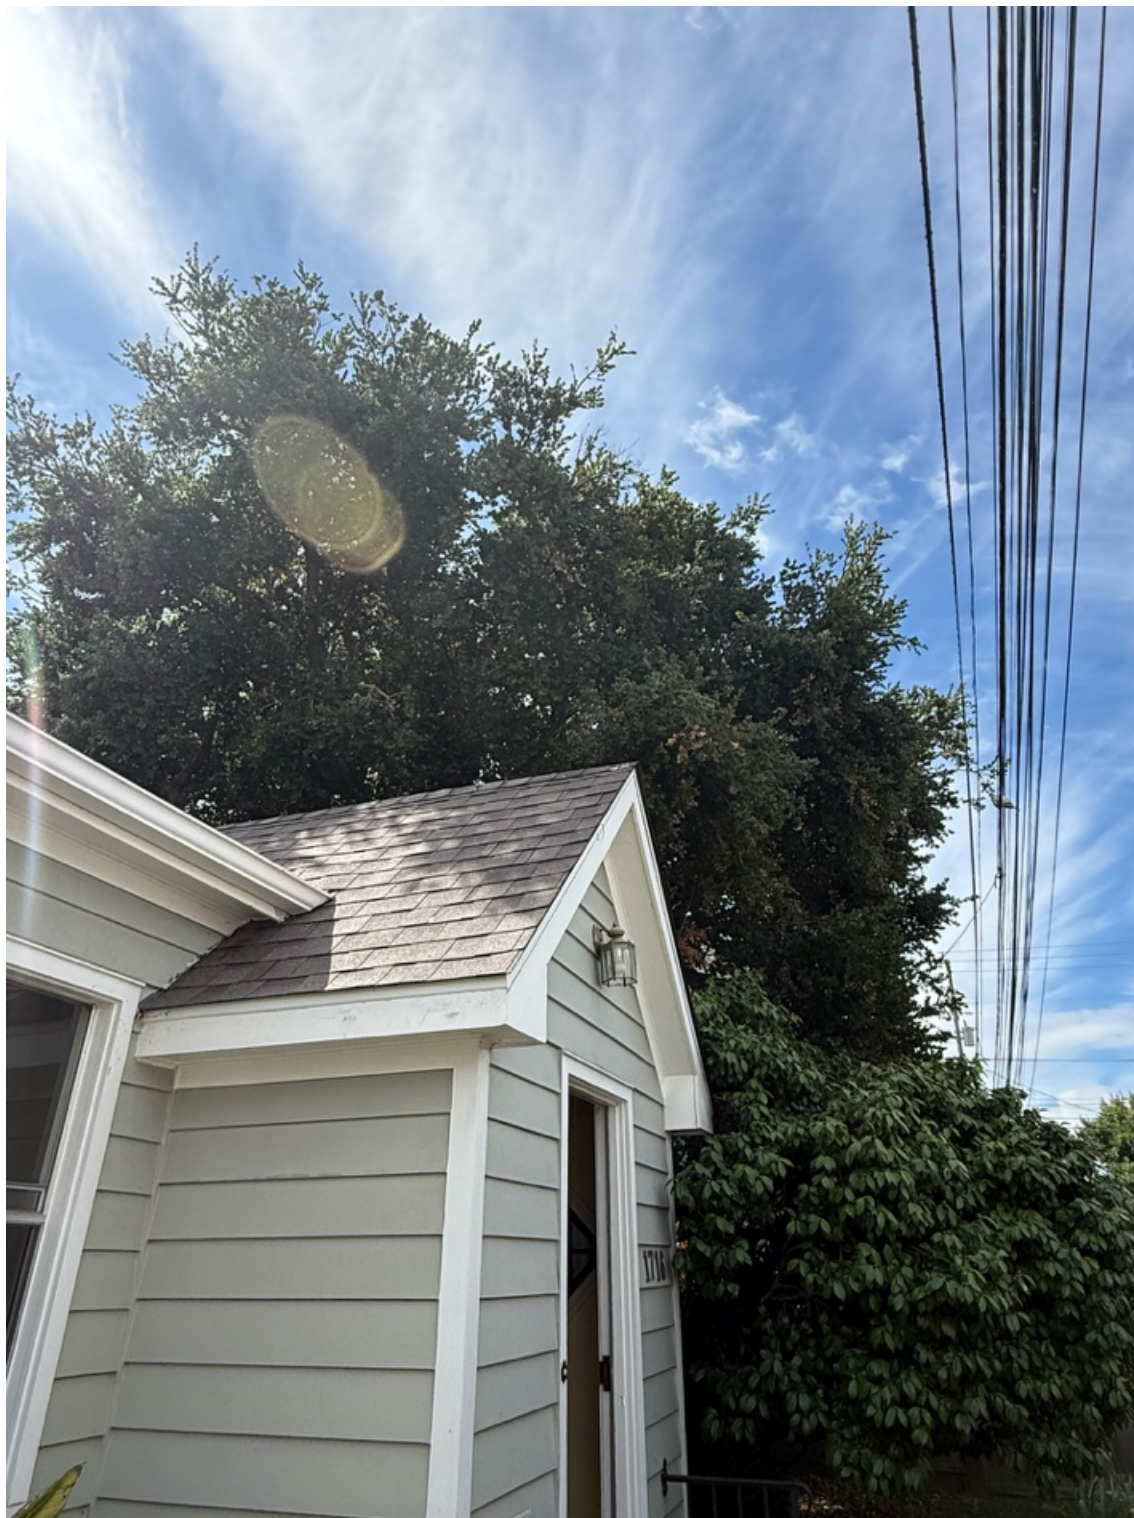
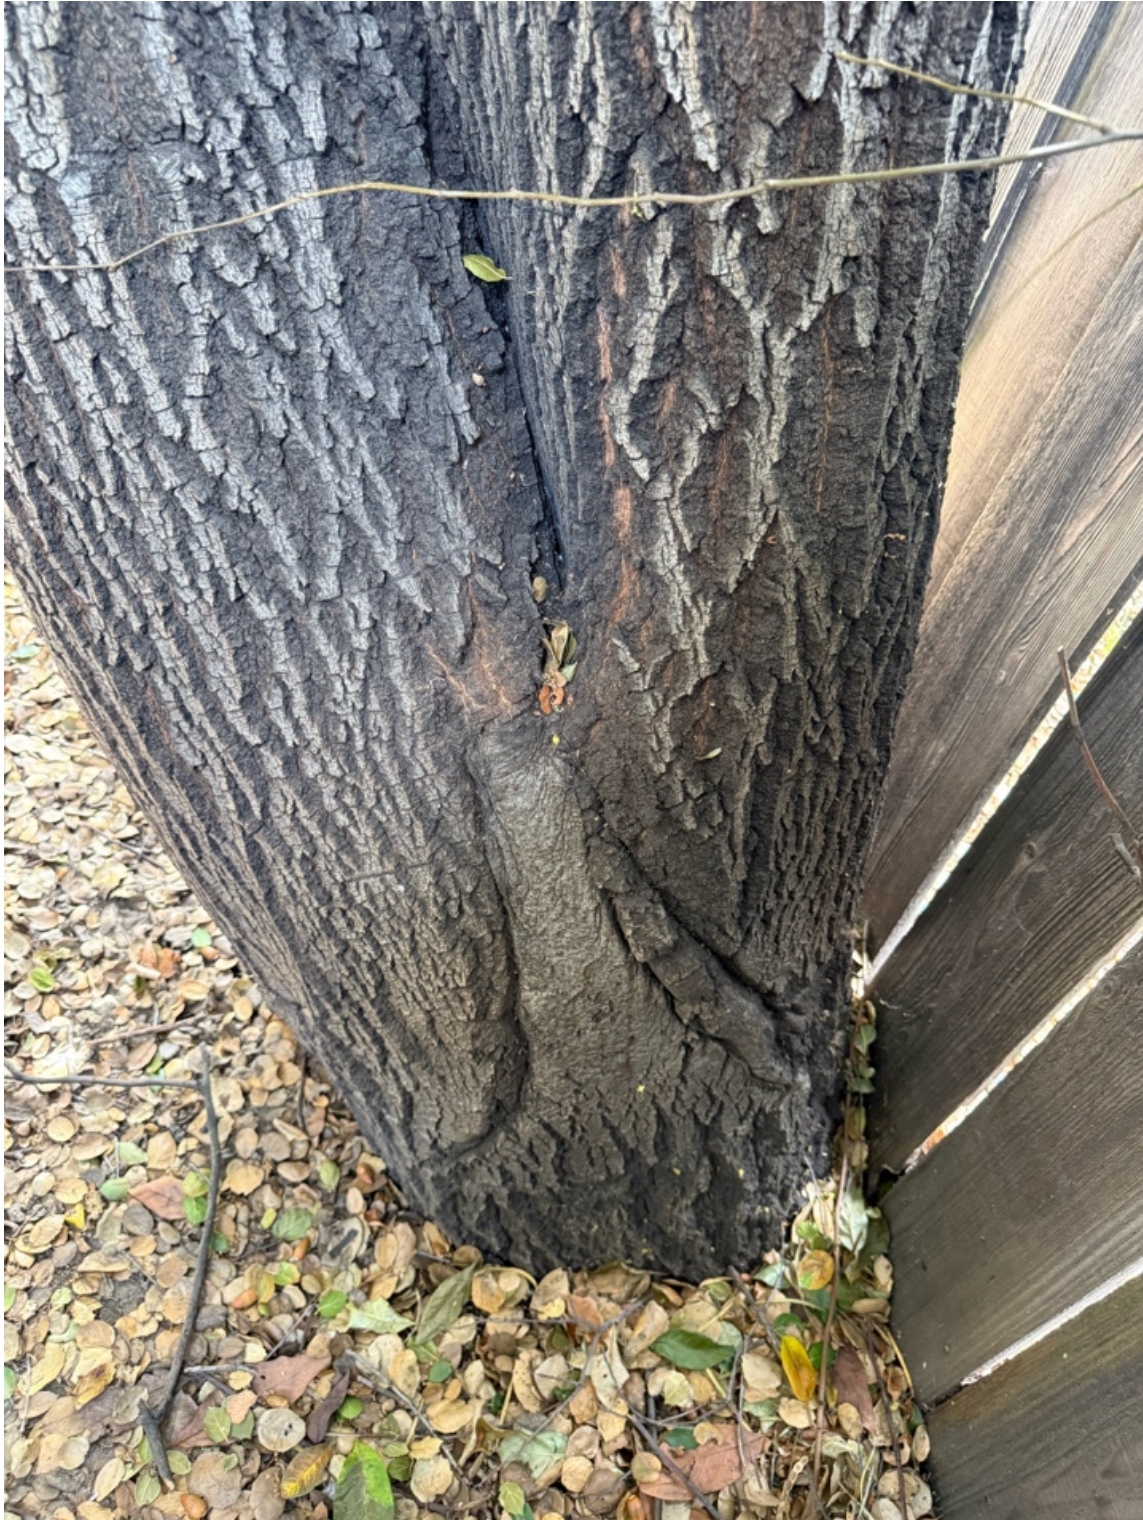
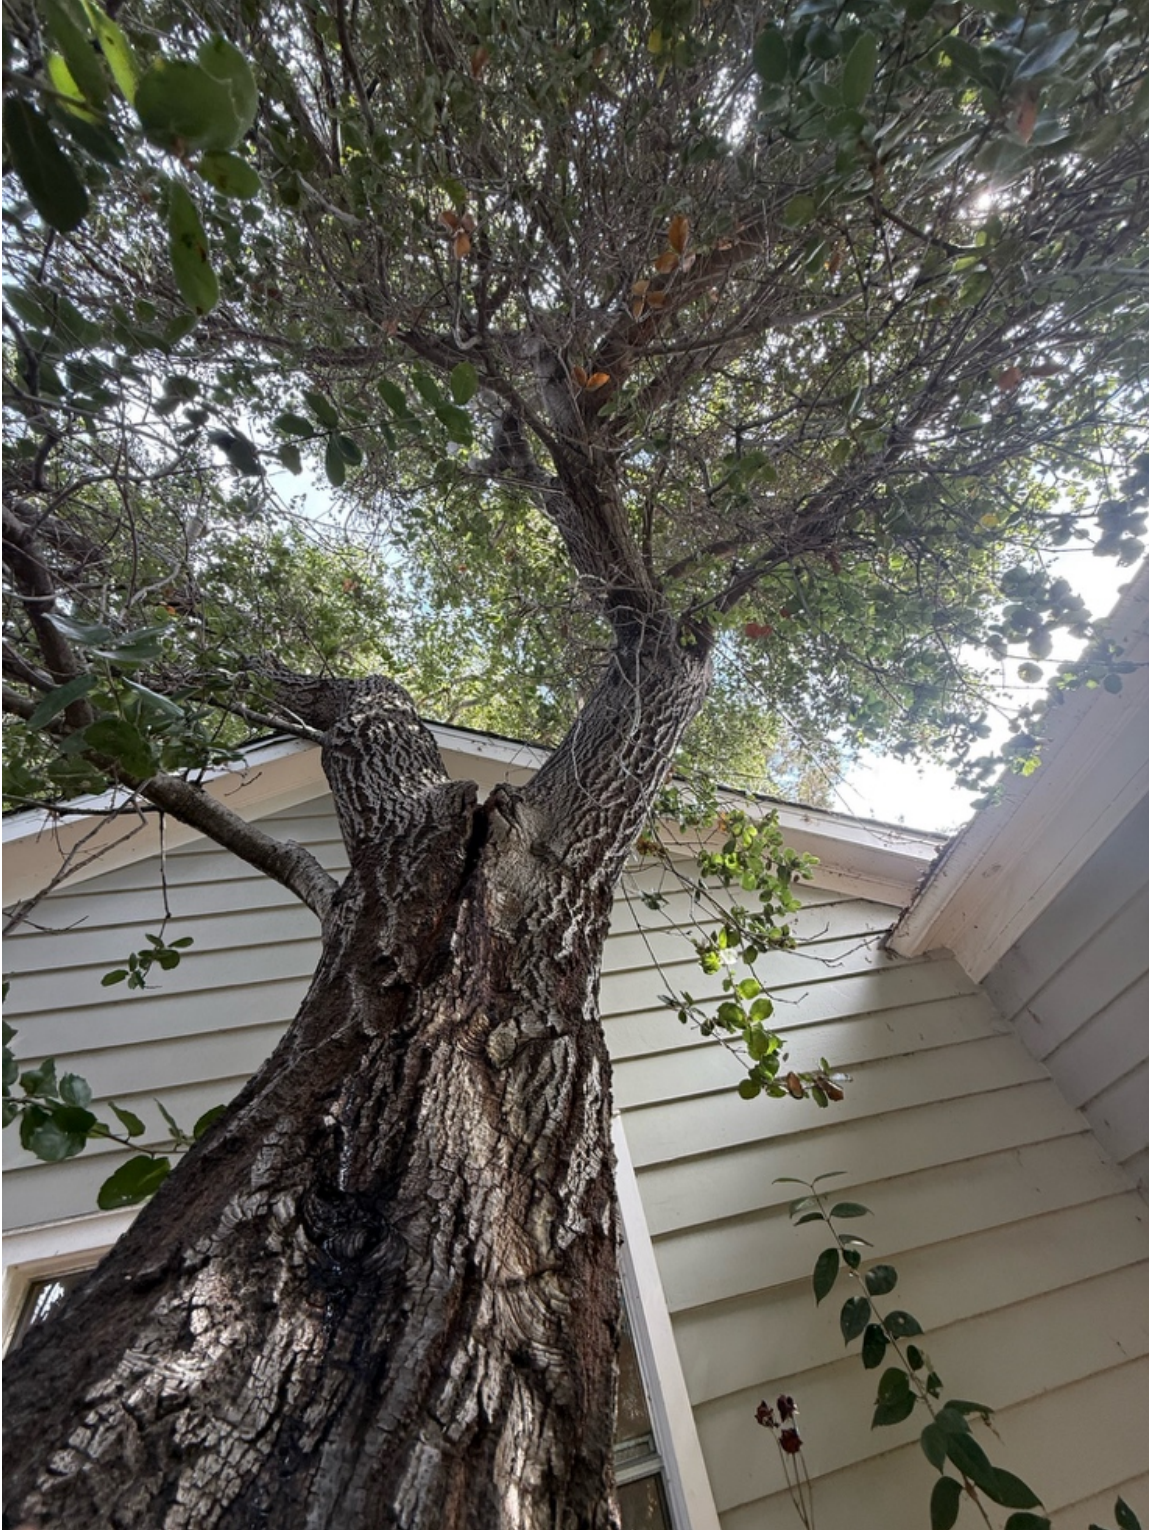
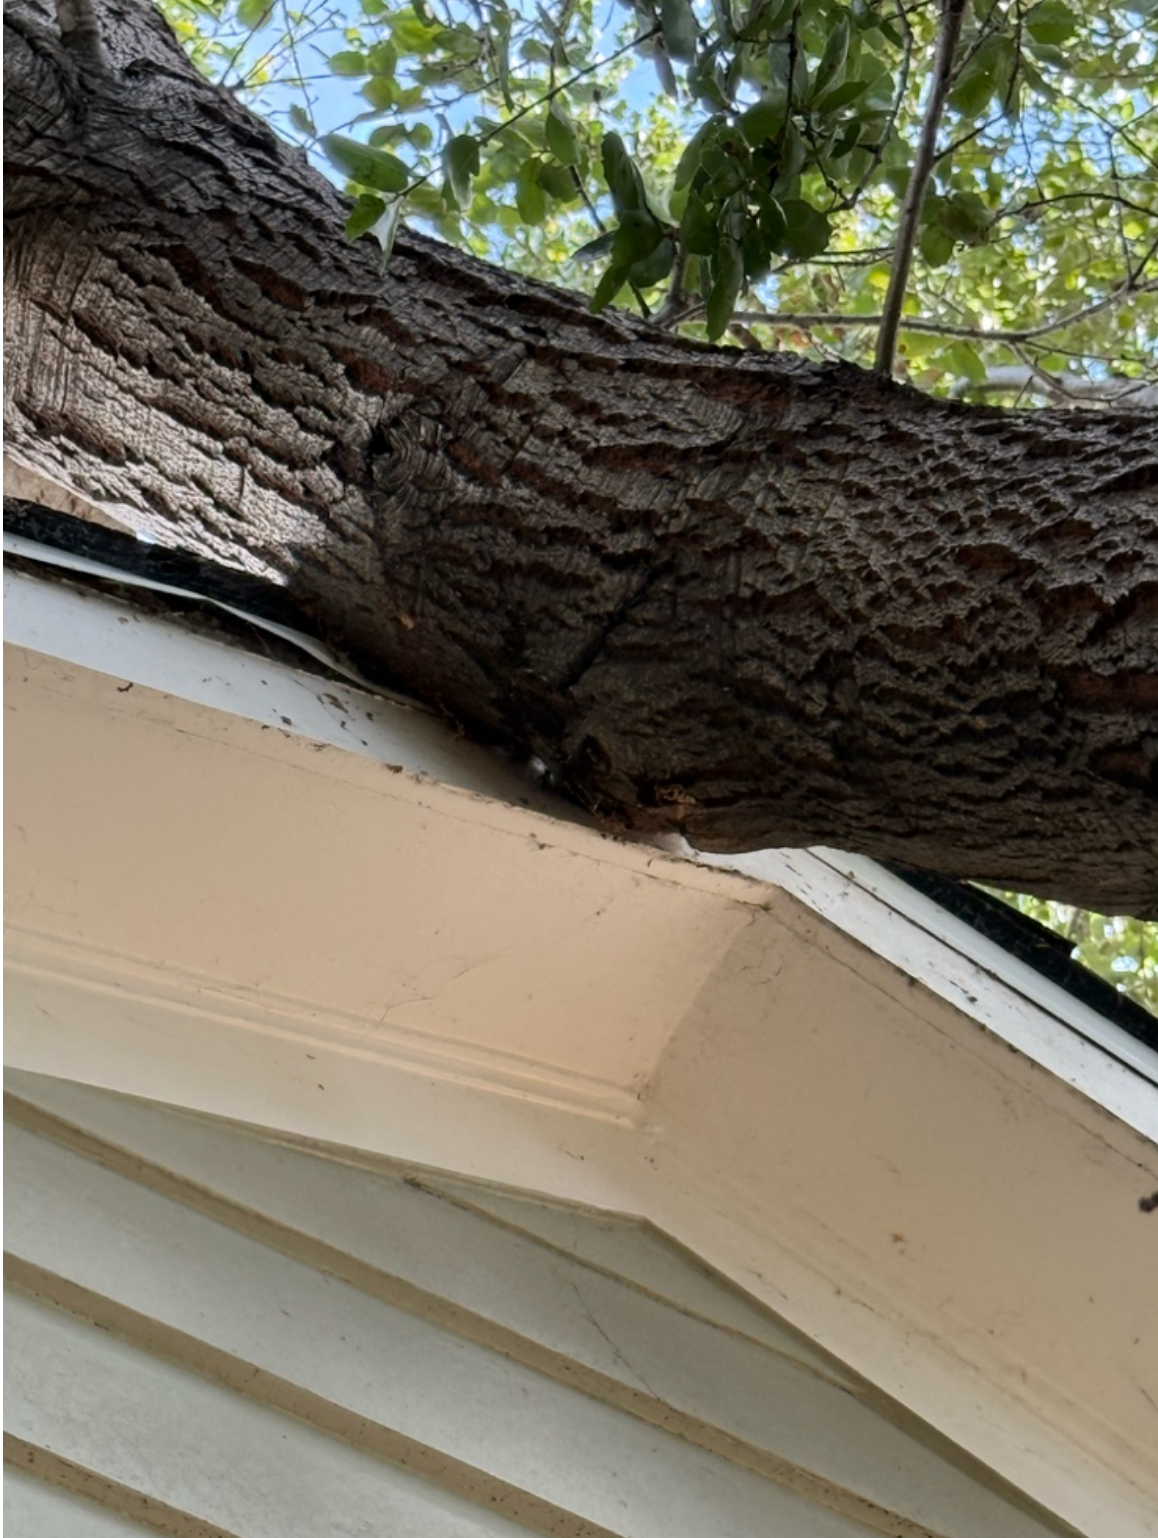
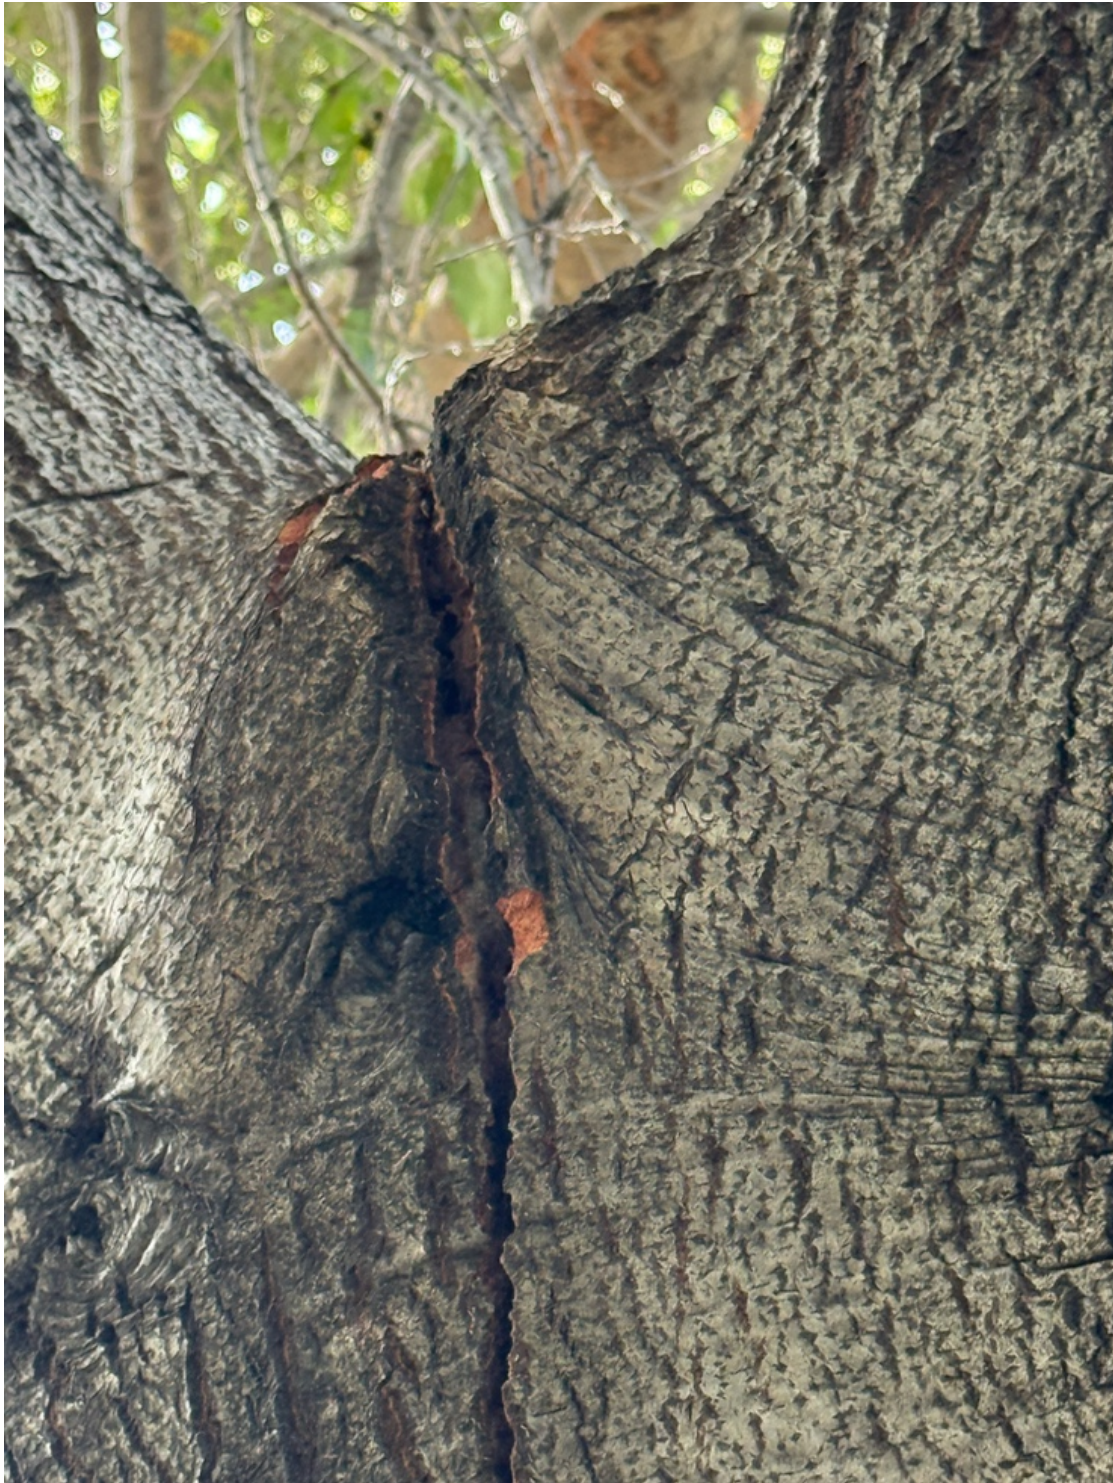
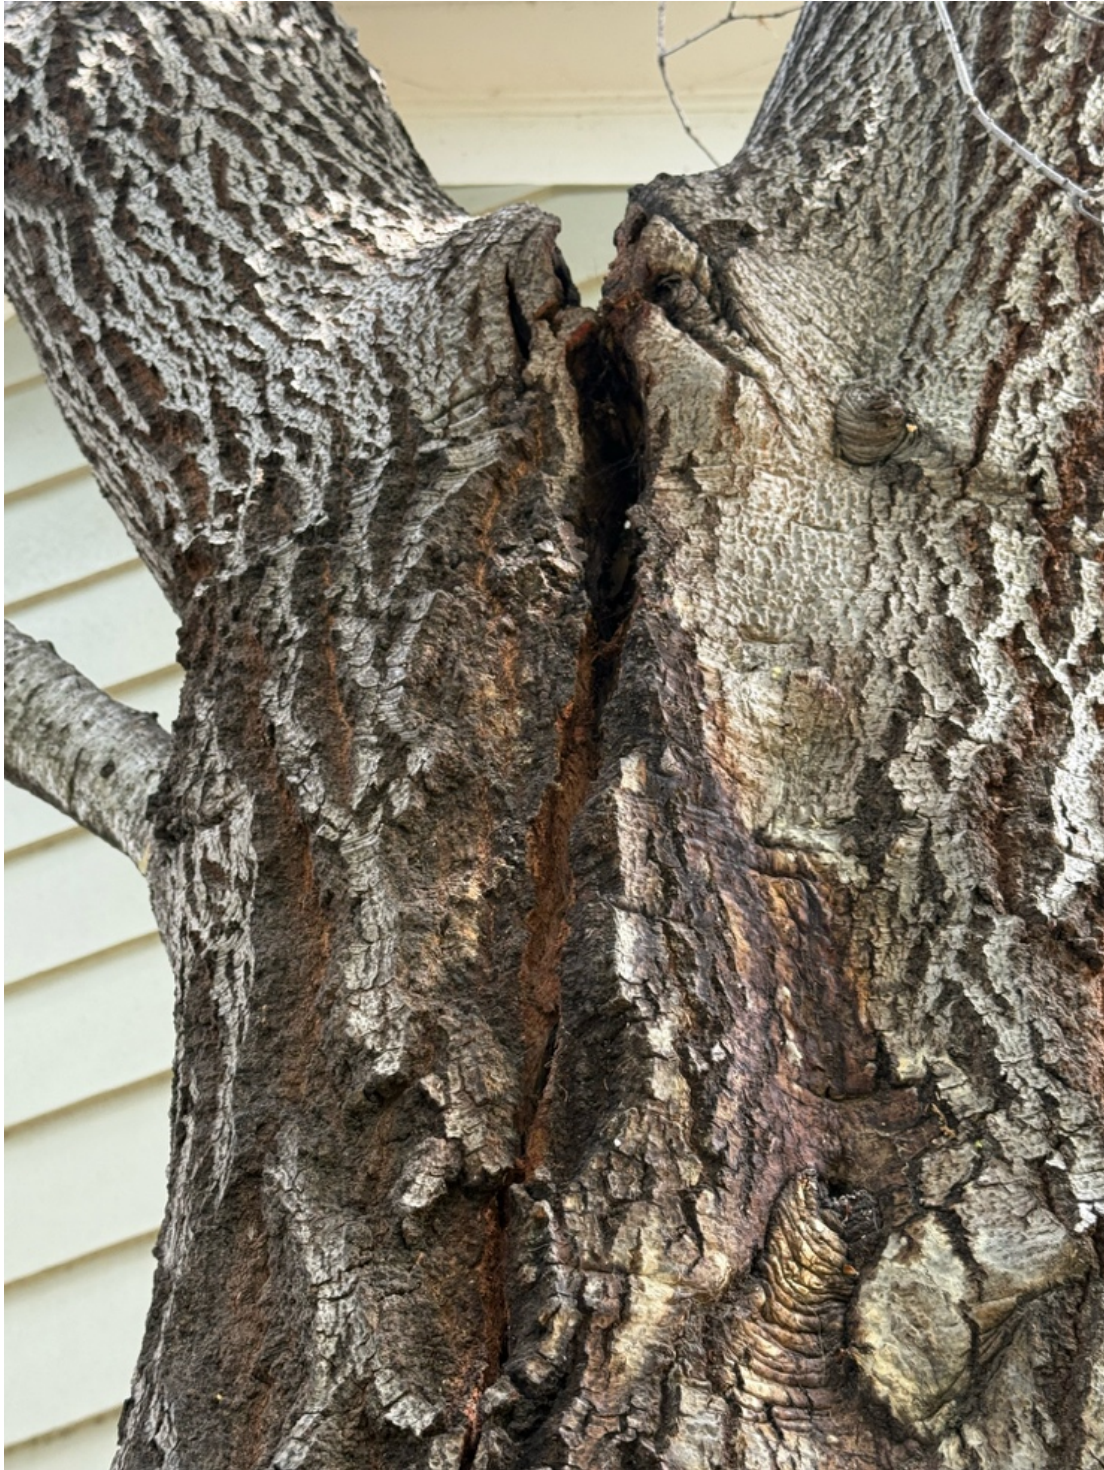
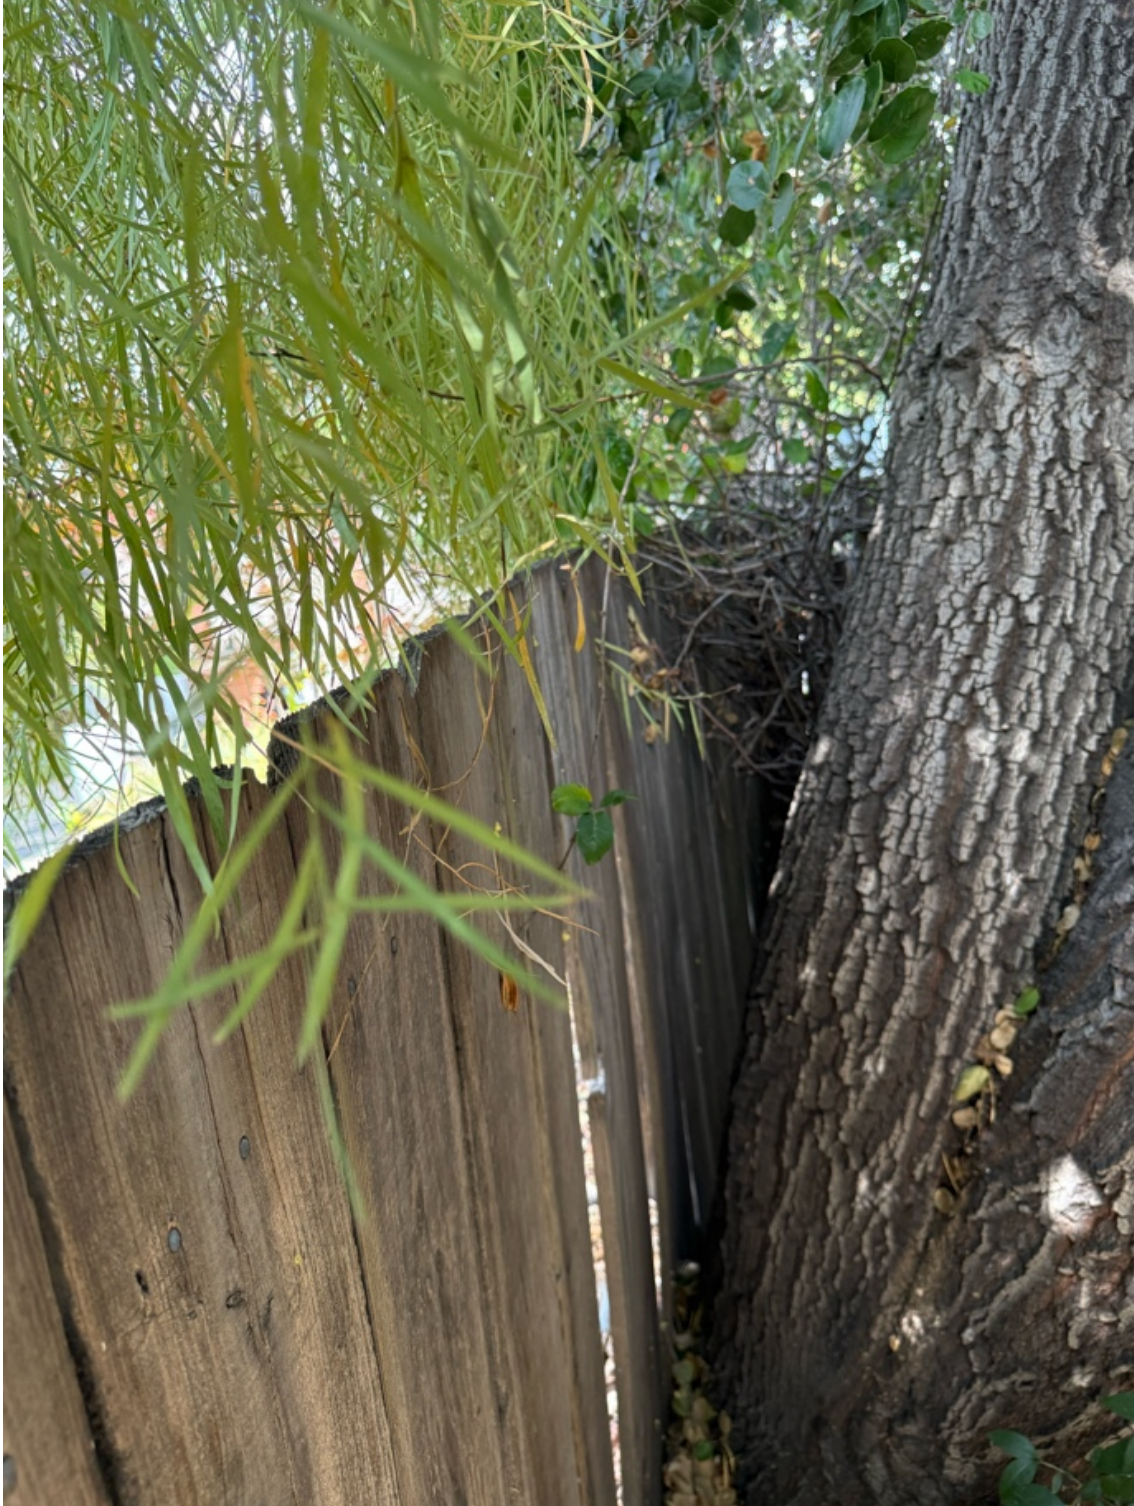
The purpose of my visit was to evaluate concerns that the tree was in contact with the house and required pruning to create clearance between the structure and the tree canopy. Upon arrival, I observed that the tree was leaning against the roof at the gutter level and appeared to be creating pressure on the roof structure.

The dominant 19-inch leader contains a secondary co-dominant "Y" union located approximately 10 feet above grade. This union has failed and it has a crack measuring approximately 3 feet in length with an opening of up to 2 inches. The defect is considered significant and indicative of structural failure potential.

The tree is located adjacent to the property line fence. Evidence of fence displacement was noted, which may be associated with tree movement, shifting, or root-related pressure.

It is my professional opinion that the compromised structure of the tree is considered HIGH risk. Further shifting or failure of either leader could result in significant property damage and create a hazardous condition.

Based on the observed structural defects, significant lean toward the residence, and direct contact with the roof structure, I recommend **removal of the tree**.
