# FEASIBILITY STUDY OF SIX PUBLIC ACCESS PATHWAYS ON FERNSIDE BLVD. AND EASTSHORE DR.

ASSESSMENT REPORT

AUGUST 31, 2018

**City of Alameda, California**

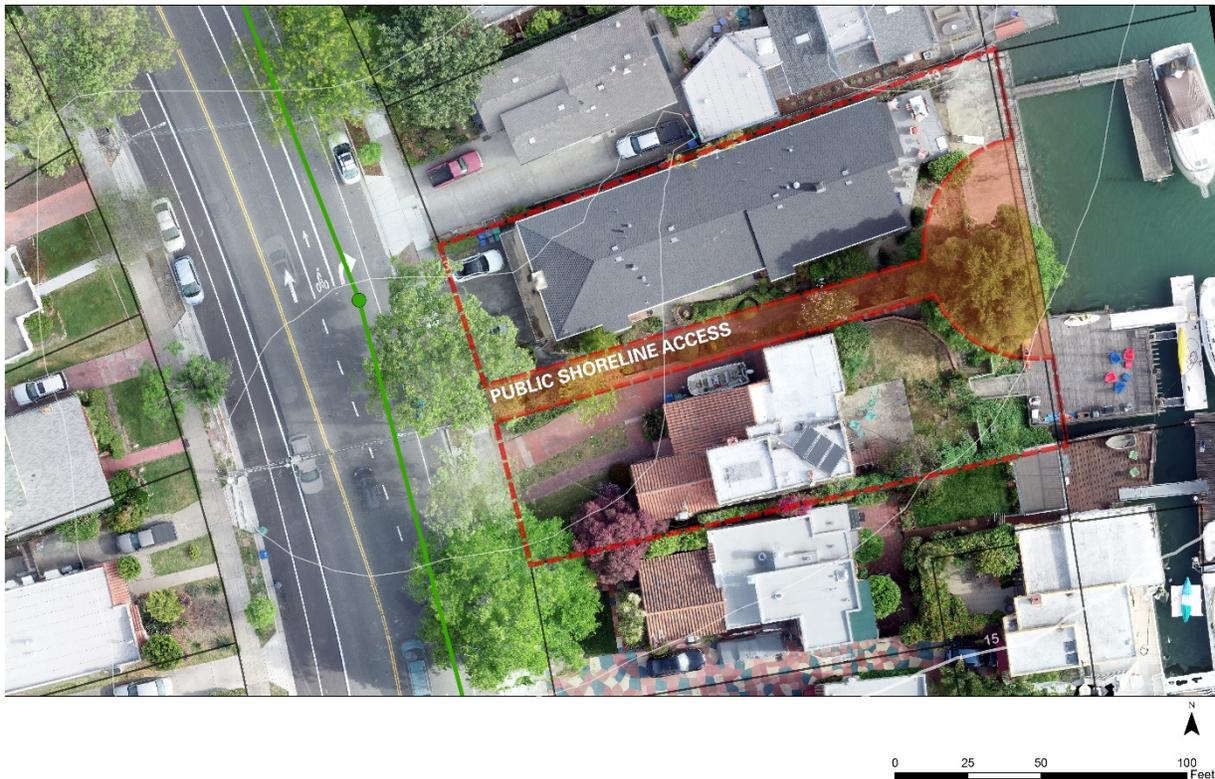
*Figure 10: 3227 - 3229 Fernside Boulevard Site*

Waterside Terrace map labeled 126—103 from 1912 indicates that the City property widens from a 10-foot linear path to a 30-foot radius semi-circle at the water's edge. Existing development adjacent to the site consists of two single-family residences, with private asphalt walkways and steps accessing the public pathway. The asphalt walkway and steps provide primary access to the residence on the north side of the public access pathway. Both residential parcels are occupied. The asphalt path from the street to the water is currently too steep to meet ADA path-of-travel compliance. Construction of low retaining walls will be required to provide an ADA accessible path plus stairs to maintain existing access for the residential units. Existing structures appear to encroach on the parcel, limiting the width of the pathway to under 10 feet. On both sides of the path is attractive landscaping which is presumably maintained by the landowners. There is thick vegetation south of the path.

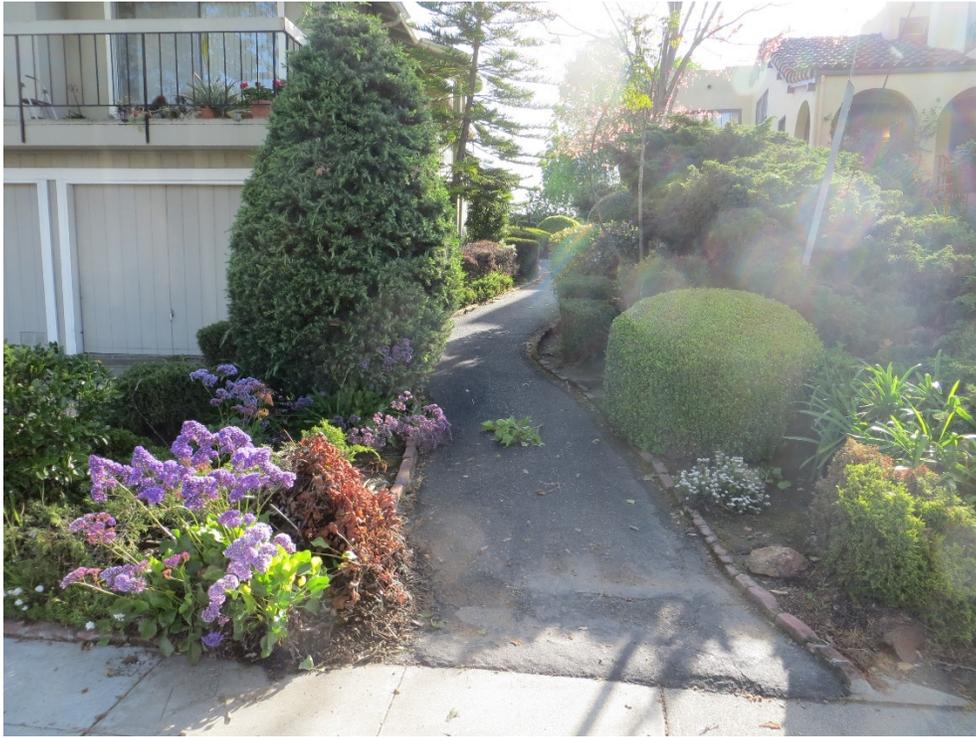
*Figure 13: Well Planted and Maintained Landscape from the Entry*

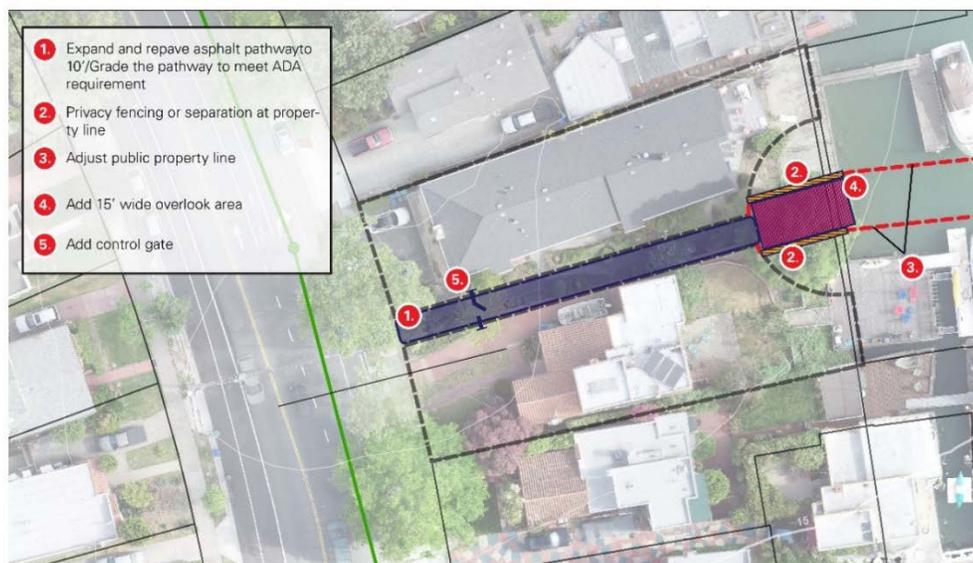
Figure 15: 3227-3229 Fernside Blvd Public Shoreline Access Improvement Concept

For water access, this site presents an opportunity for a fixed pier overlook. A launch dock is not considered feasible for two reasons: first, an accessible 80-ft gangway would require significant excavation at the shoreline and a retaining wall structure. Second, the presence of existing floating docks on each side results in limited space for an additional dock. Accordingly, this site is recommended to include a fixed pier overlook extending to the existing shoreline edge. The overlook has a dimension of 12' by 20', with a total area of approximately 240 square foot. See Figure 15 below for a plan view of the proposed site features.

The estimated construction cost for the pathway and added overlook area would be \$736,000.

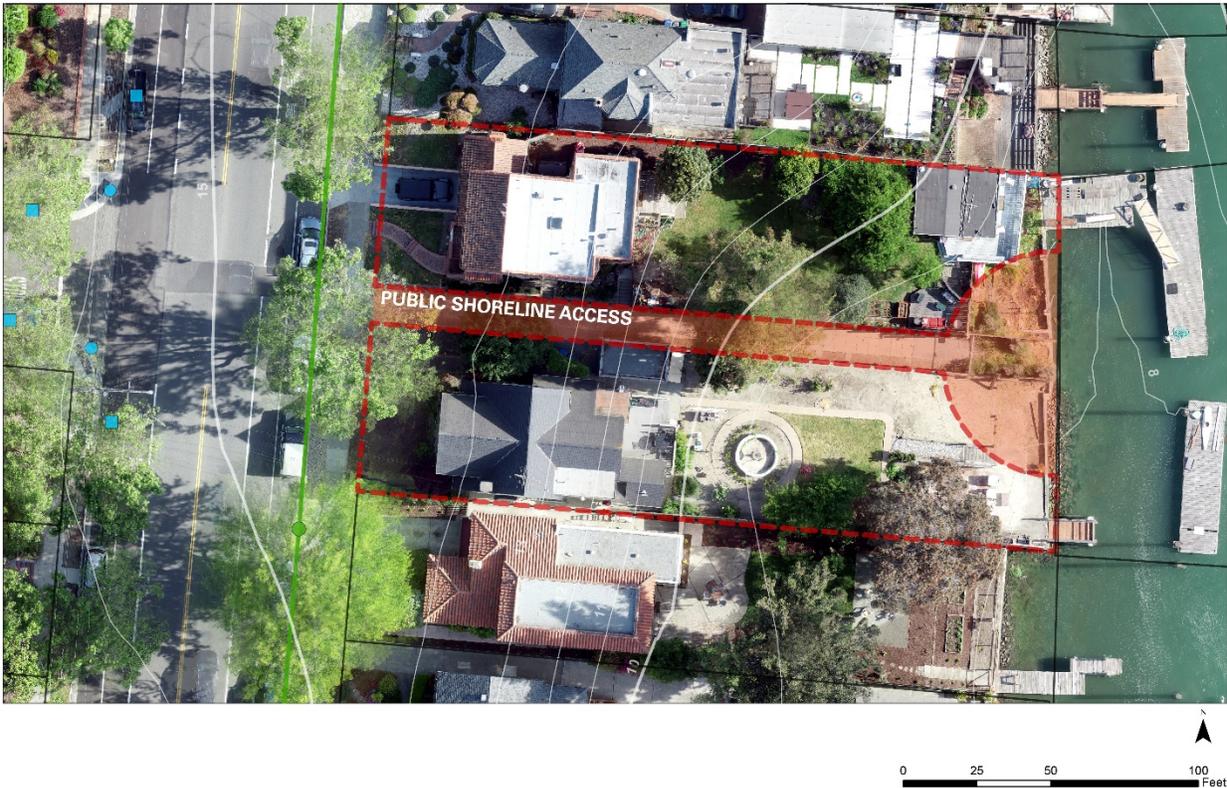
*Figure 16: 3267 - 3301 Fernside Boulevard Site*

The Waterside Terrace map labeled 126—103 from 1912 indicates that the City property widens from a 10-foot linear path to a 30-foot radius semi-circle at the water’s edge. Existing development adjacent to the site consists of two single family residences. The residence on the south uses the public access pathway as a driveway connected to their garage. Both residential parcels are occupied. Concrete pavement covers most of this public access area. There is limited landscaping area on site. However, privately planted trees provide adequate shade along the concrete pathway. Vegetated marsh beyond chain link fence exists at the end of the concrete path.

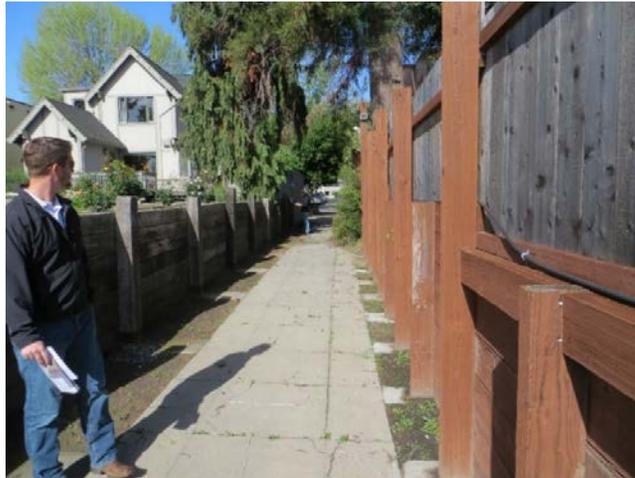
condition due to its current use as both a driveway and pedestrian walk. Since the public access is currently used as the driveway to private garage, there are vehicular and pedestrian conflicts in this corridor.

*Figure 17: Concrete Pathway at 3267 - 3301 Fernside Boulevard Site*

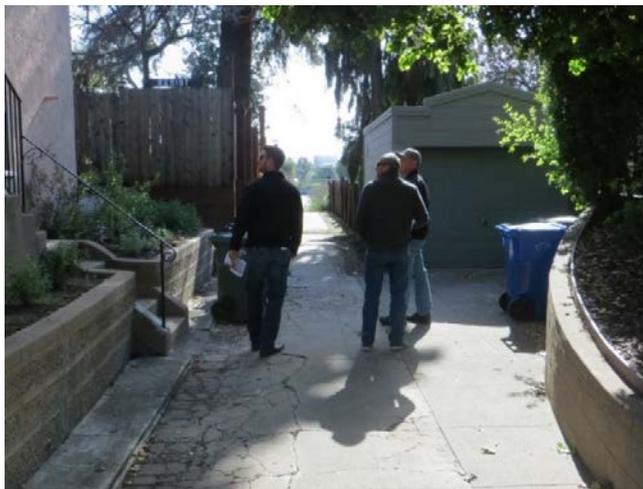
*Figure 18: Concrete Pathway Connected to Private Garage*

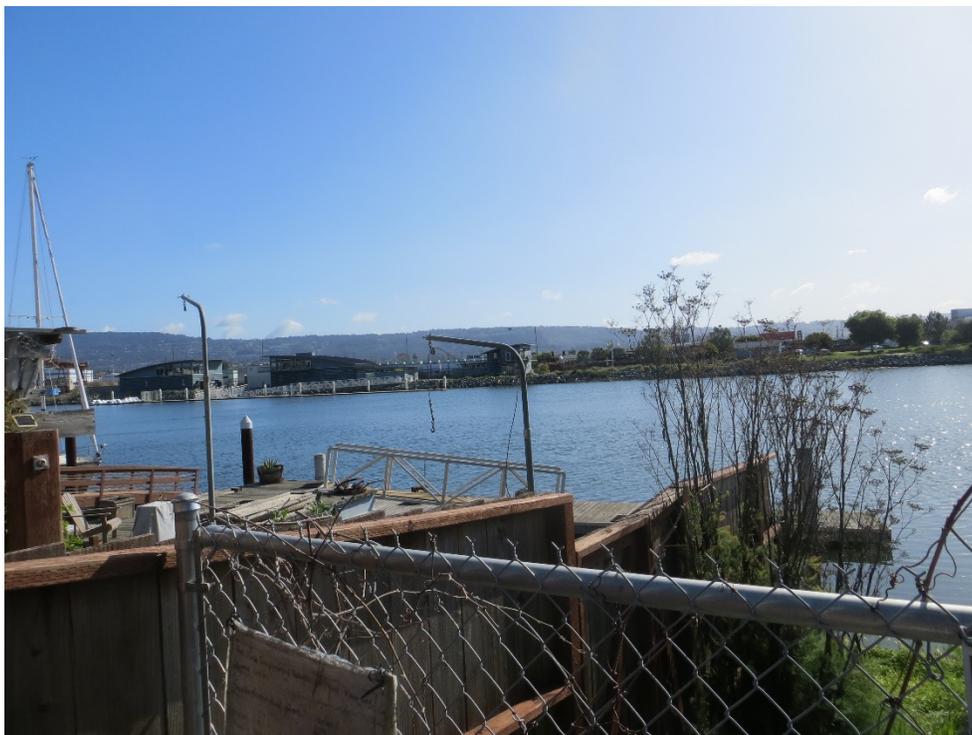
*Figure 20: View from Public Access Pathway to the Estuary*

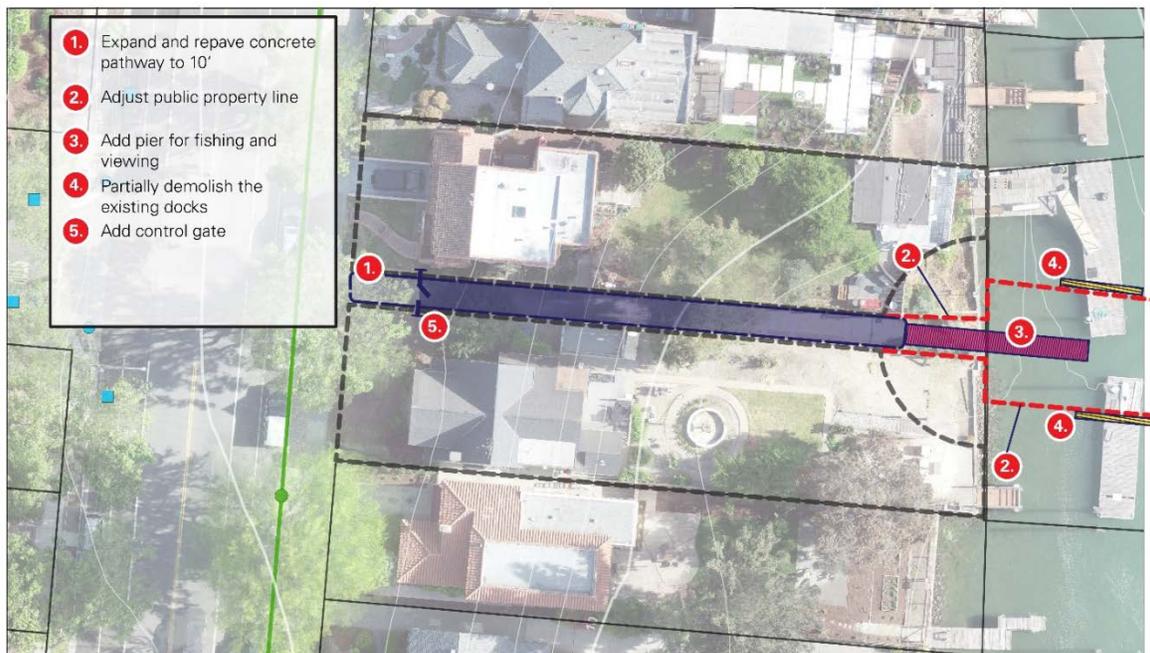
Figure 21: 3267 - 3301 Fernside Blvd Public Shoreline Access Improvement Concept

The study team recommends that the City adjust property boundaries and improvements at this site for public shoreline access. Land-based recreational amenities such as a walking path and overlook platform should be considered for future improvements. To address safety and accessibility, the team recommends enforcing the access as a pedestrian-only pathway. Under this scenario, the City and adjacent residences will avoid potential liability issue due to vehicular and pedestrian use conflicts. If not, the private residence south of the public access pathway would need to either use street parking or relocate their driveway and garage if feasible. A controlled gate with safety lighting is recommended at the entry. In the scenario the City intended to implement all land recreational features, the estimate construction cost would be \$206,000.

This site presents an opportunity for a fixed pier for fishing and viewing due to the deep water relatively close to the shoreline. In addition, there is only one existing garage located along the pathway, so there is a lower degree of potential conflict between vehicles and users. The study team does not recommend a kayak launch dock for the following reasons: first, the site is constrained by the narrow space (approximately 11-ft) between existing floating docks. A portion of existing docks would need to be removed to allow the construction of a kayak launch. Second, visibility for vehicles are poor when pathway users are carrying a kayak or stand-up paddle board. Installation of a new floating dock would require modification or relocation of the existing private docks to accommodate a newly proposed dock. Furthermore, there is inadequate space for an accessible 80-ft long gangway at this location; as a result, while a gangway to deep water is possible, the gangway slope would not meet ADA accessibility requirements during low tides. Additional research is required during the design and implementation phase as to determine whether a kayak launch dock is feasible based on BCDC permitting standards.

Alternatively, the study team recommends adding a pier structure for fishing and viewing. To implement all land recreational features and a pier structure, the estimate construction cost for 3267 - 3301 Fernside public access would be \$566,000.

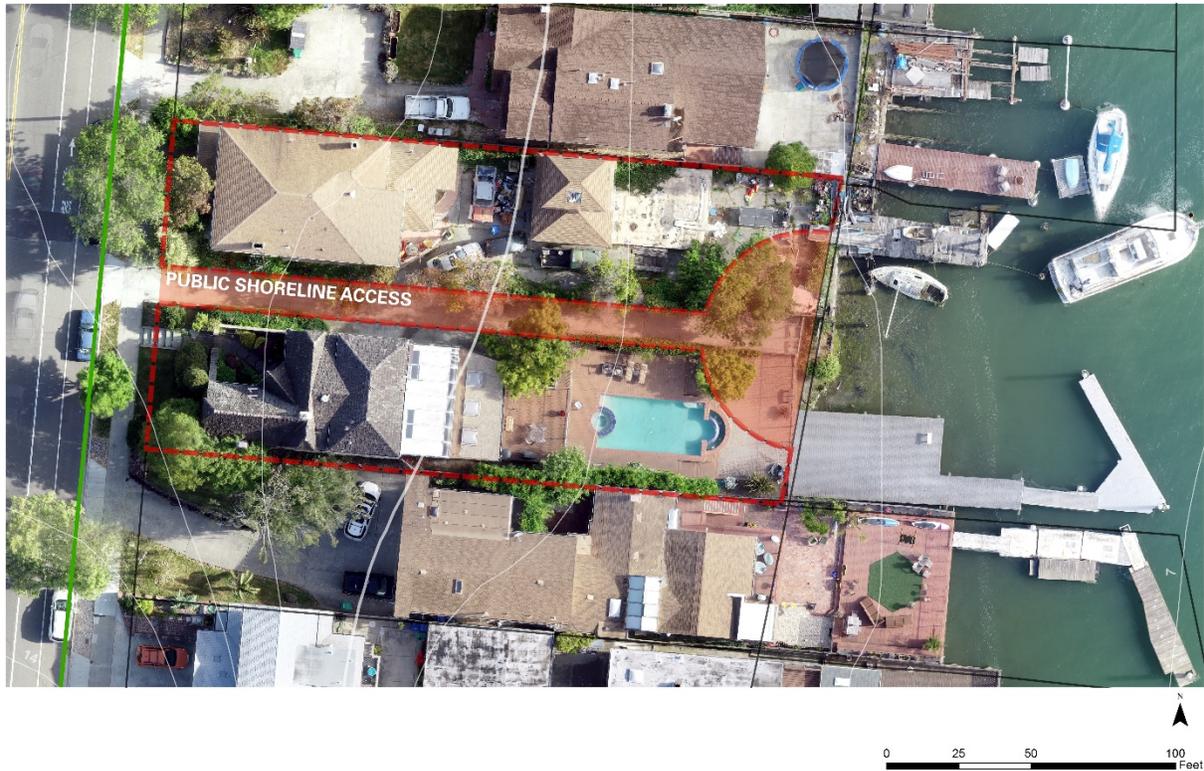
*Figure 22: 3335 - 3341 Fernside Boulevard Site*

The Waterside Terrace map labeled 126—103 from 1912 indicates that the City property widens from a 10-foot linear path to a 30-foot radius semi-circle at the water’s edge. Existing development adjacent to the site consists of two single family residences, with driveways and paths entering the public access. Both residential parcels are currently occupied. The entire public access area from the road to the water’s edge, is covered by concrete pavement and is a consistent grade. ADA-compliant access to the top of the waterfront embankment without significant modification is possible. There is approximately 12 - 24 inches of elevation change with 40 feet long retaining walls from the edge. The concrete pathway is in poor condition due to excessive use as a driveway. Also, as the public access pathway is currently used as a driveway to both residences, there are vehicular and pedestrian conflicts in this corridor.

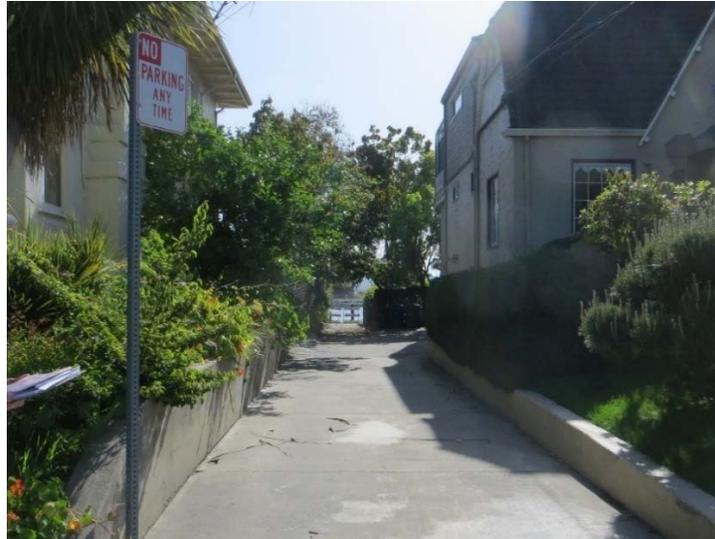
The pathway terminates at a chain link fence. The water level at high tide is approximately 3 feet below the concrete pathway. A dock would be required to allow direct access to the water.

*Figure 23: View to the Waterfront at 3335 - 3341 Fernside Boulevard Site*

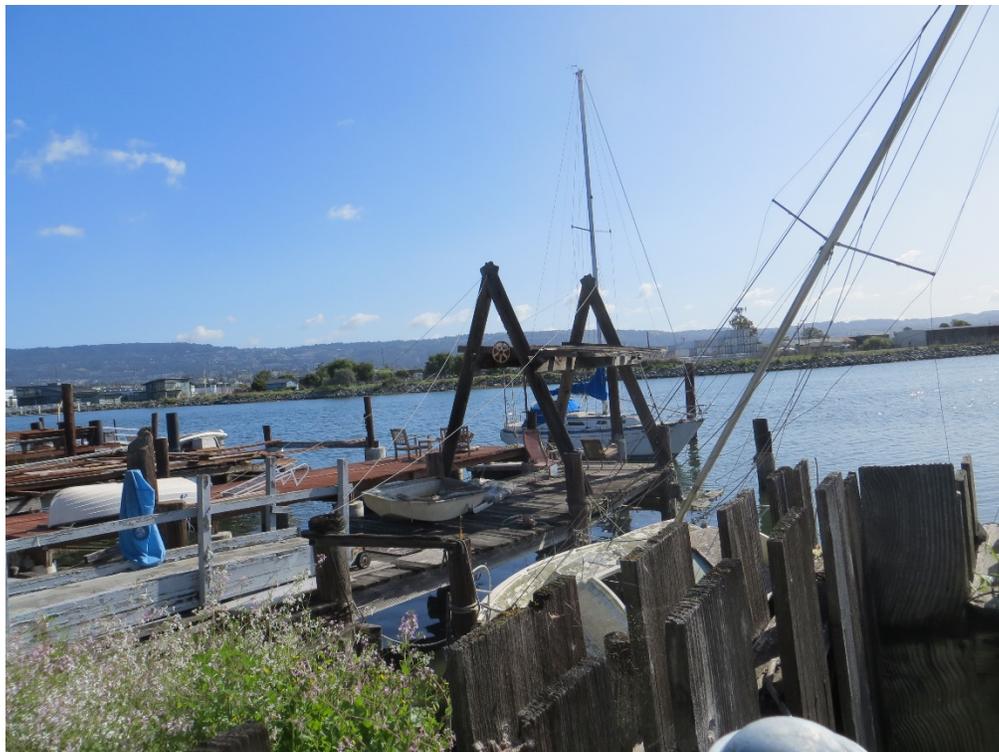
*Figure 25: View from Public Access Pathway to the Estuary*

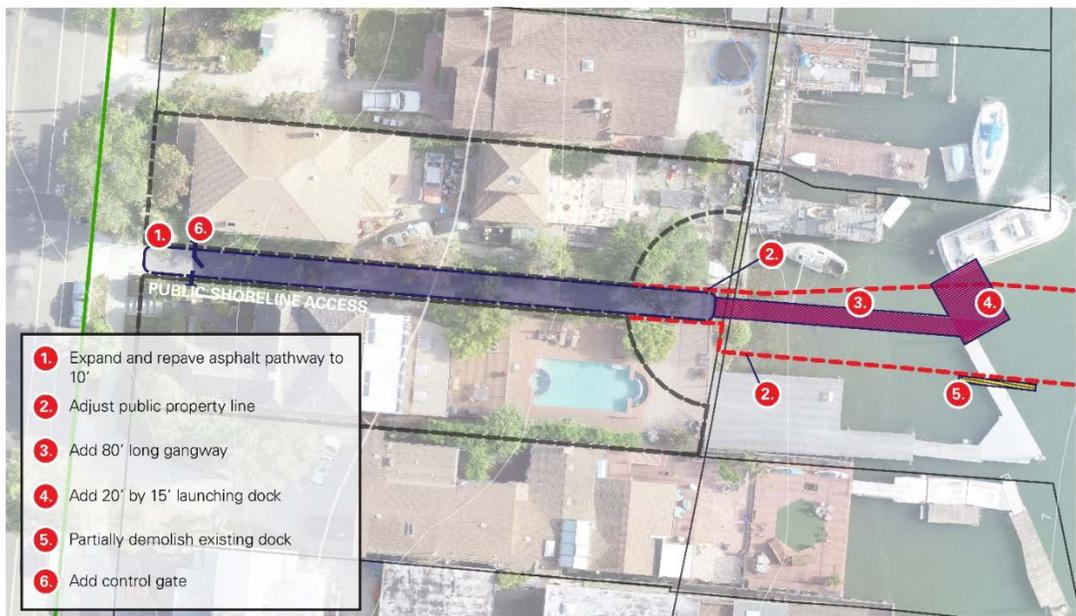
Figure 27: 3335 - 3341 Fernside Blvd Public Shoreline Access Improvement Concept

The team recommends a third option to adjust property boundaries and improve this site with both land and water-based amenities. Recreational amenities such as walking path and kayak launch could be considered for future improvements. To address safety and accessibility, a controlled gate with safety lighting is recommended to place at the entry. This allows private owner's vehicle that share the access and use as a driveway during and after public access operation hours.

This site presents a good opportunity for a kayak launch dock due to its close proximity to deeper water and adequate available space between the existing floating docks at adjacent properties. There is sufficient space for an 80-ft long accessible gangway to be installed, leading to a 15' by 20' floating dock with an area of approximately 300 sf.

In the scenario the City intends to maintain ownership and opts to implement the launching dock, the estimated construction cost for 3335 - 3341 Fernside public access would be \$567,000.

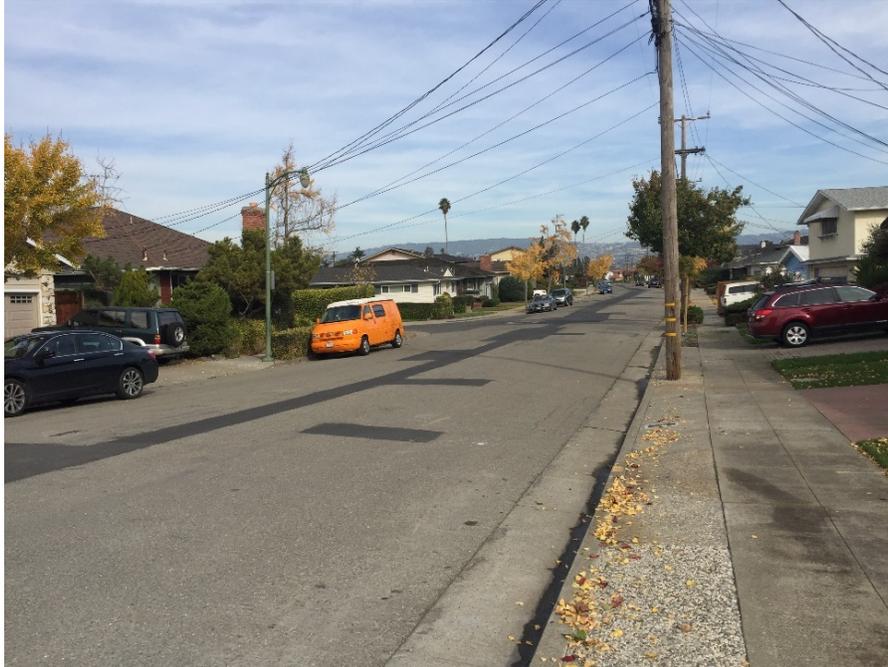
Eastshore Drive is a neighborhood street approximately 36 feet wide with a posted speed limit of 25 mph. There is no marked bike lane on Eastshore Drive. With the homes further apart with fewer driveways, on-street parking does not appear to be an issue. During the site visit in April, the area seemed quieter with much less vehicle traffic than seen on Fernside Avenue. Thursday afternoon street sweeping occurs.

*Figure 29: Eastshore Drive (Looking North)*

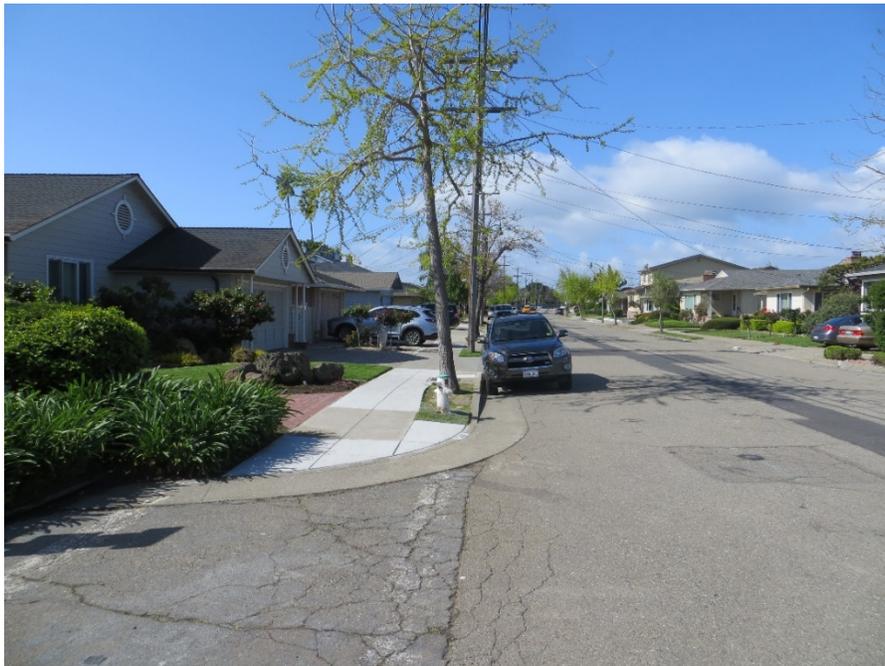
*Figure 30: Eastshore Drive at Central Avenue*

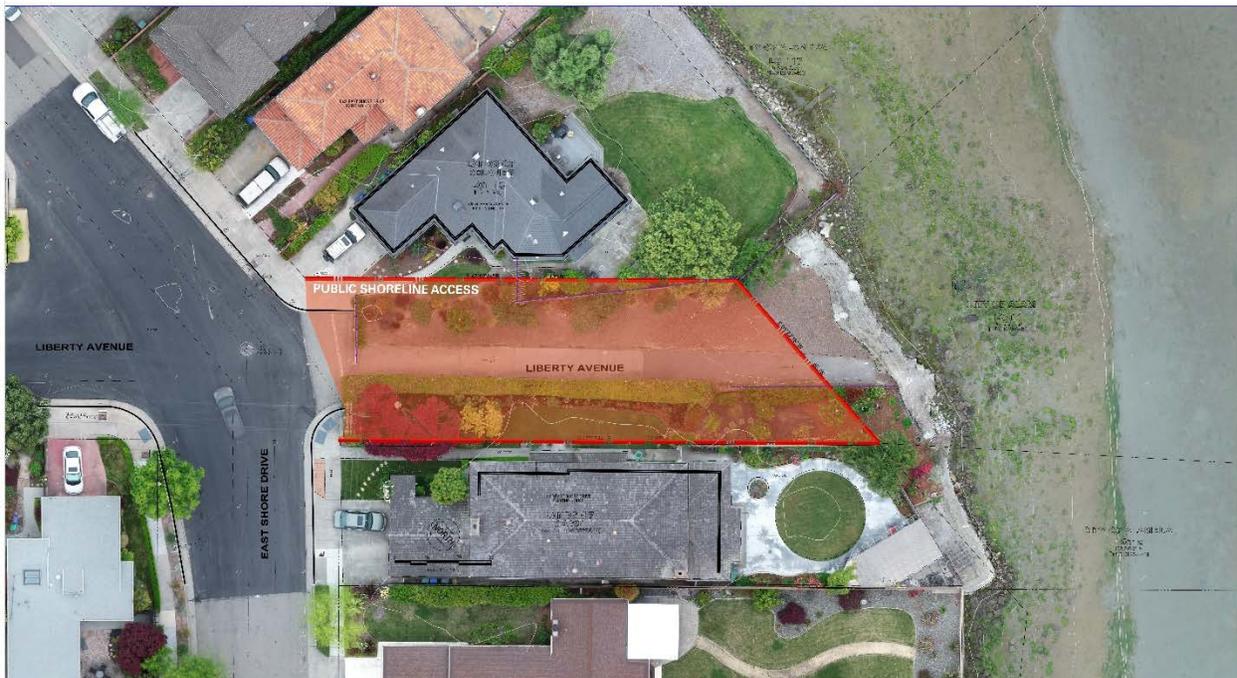
The public access between 3335 Liberty Avenue and 1450 Eastshore Drive is a 50-foot wide lot located at the intersection of Eastshore and Liberty Avenue, approximately 680 feet south of the Eastshore / Fernside intersection. Due to privately built structures on the public property, actual access width is between 25 and 35 feet. San Leandro Bay is visible from the street or public sidewalk. Extended roadway and access ramps from Liberty Avenue would allow maintenance and emergency vehicle access. There appears to have sufficient vertical clearance for emergency vehicles. Overhead utility appears to be located on public property that is currently occupied by the private owner. Connections to water, power, and sewer are possible in the street in front of the site.

*Figure 31: 3335 Liberty and 1450 Eastshore Drive Site Plan*

Existing development adjacent to the site consists of two single-family residence, with a wooden fence along Eastshore Drive. Both residential parcels are currently occupied. The site is quite flat, and development with ADA-compliant access to the embankment can be accomplished with little to no additional grading. The embankment where the path meets the water is a shotcrete earthen berm that rises about 2 ½ feet above grade then drops sharply approximately 6 feet to the water. During the site visit observation, the water is shallow here at high tide and goes to mud flat at low tide.

By partially divesting the public properties to abutting neighbors, the study team recommends the City of Alameda retain this site as public shoreline access and not demolish an excessive amount of sidewalk, driveway, fencing, and landscape on public property. Reducing the publicly owned area by approximately 35% also has the potential to save the annual maintenance cost while maintaining an appealing public access area. With its attractive view to the Bay, land-based recreational amenities such as a walking path, overlook, and seating benches should be considered for future improvements. With adequate space at the entry, the team recommends the City to place ADA accessible parking spaces. To address safety and accessibility, the study team recommends a controlled gate to be placed approximately 15 feet from the entry. Existing shotcrete wall at the shoreline edge shall be replaced with an earthen berm.

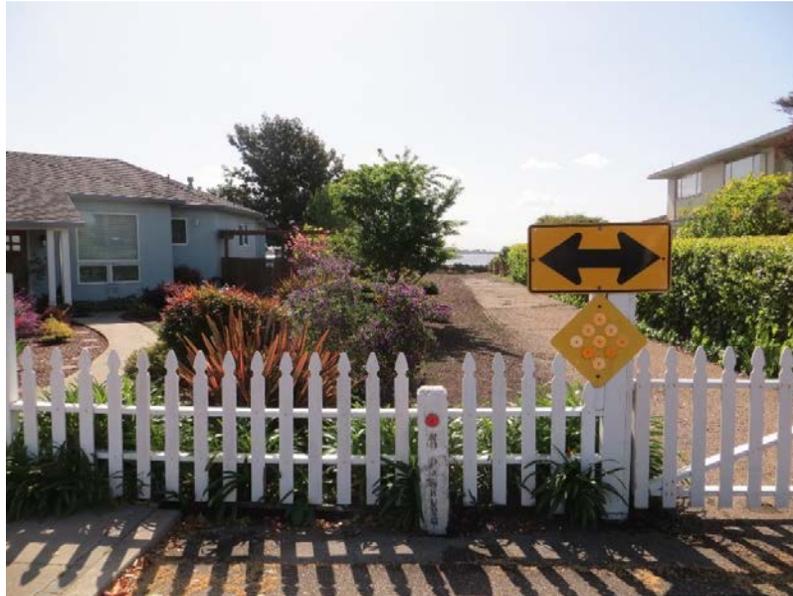
Shoreline Park can be seen from a distance. This site provides one of the better opportunities for providing passive and active recreation and appears to currently be used for this purpose.

*Figure 32: View from Entrance to the Bay*

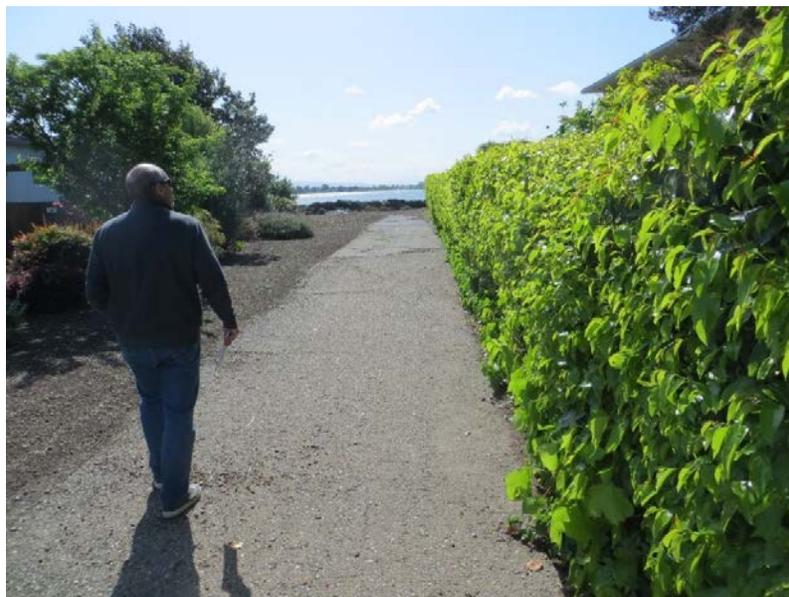
Modest landscaping has been done between the residential fences and the 10-foot wide asphalt pathway. The landscape area is predominantly covered by bark mulch, with low shrub and hedges adjacent to fences. A dense hedge that forms a visual barrier along the southern edge of the pathway appears to encroach approximately 20 feet into the City property providing the abutting property owner with a significantly enlarged yard. Other encroachments from adjacent private properties include a patio, front walk, driveway, fruit trees, and private landscape area. During the site visit, the Stadium complex and

*Figure 33: 10-foot Wide Asphalt Pathway*

Alternatively, the City may choose to further adjust the property boundary to where existing privately built landscape is located. In this option, the City only expands and repaves the 10 feet wide pathway from Eastshore Drive to the shoreline edge. The team recommends passive recreation amenities such as overlook and seating in this option. Public access users can share on-street parking with adjacent residences. Under the second scenario, the estimated construction cost would be \$215,000.

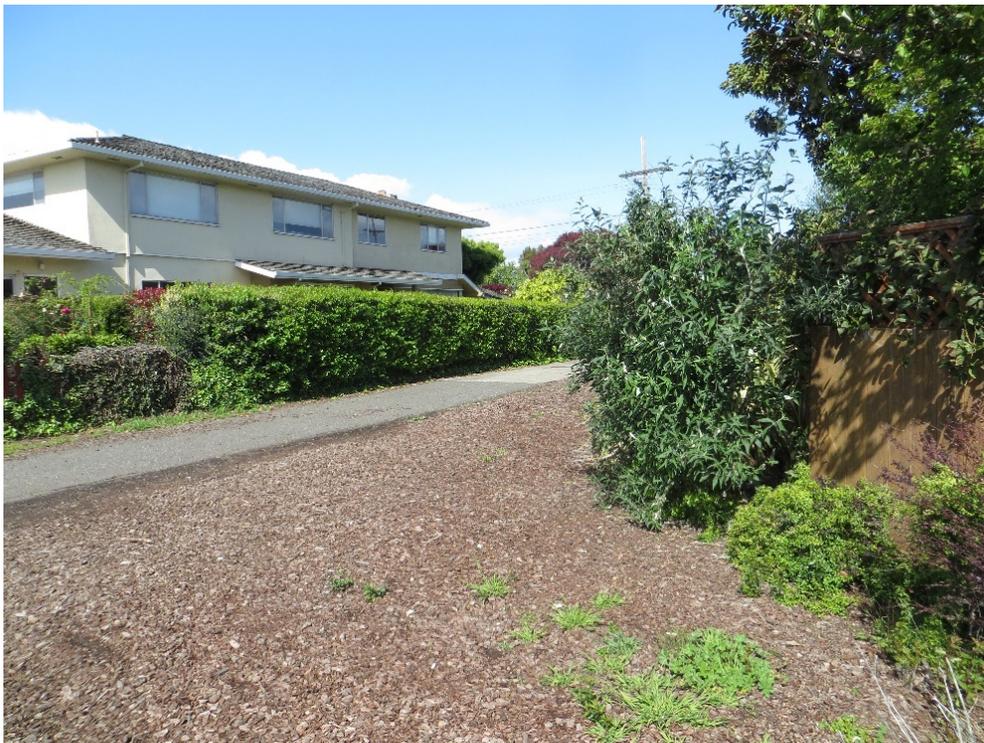
*Figure 35: Landscaping Area*

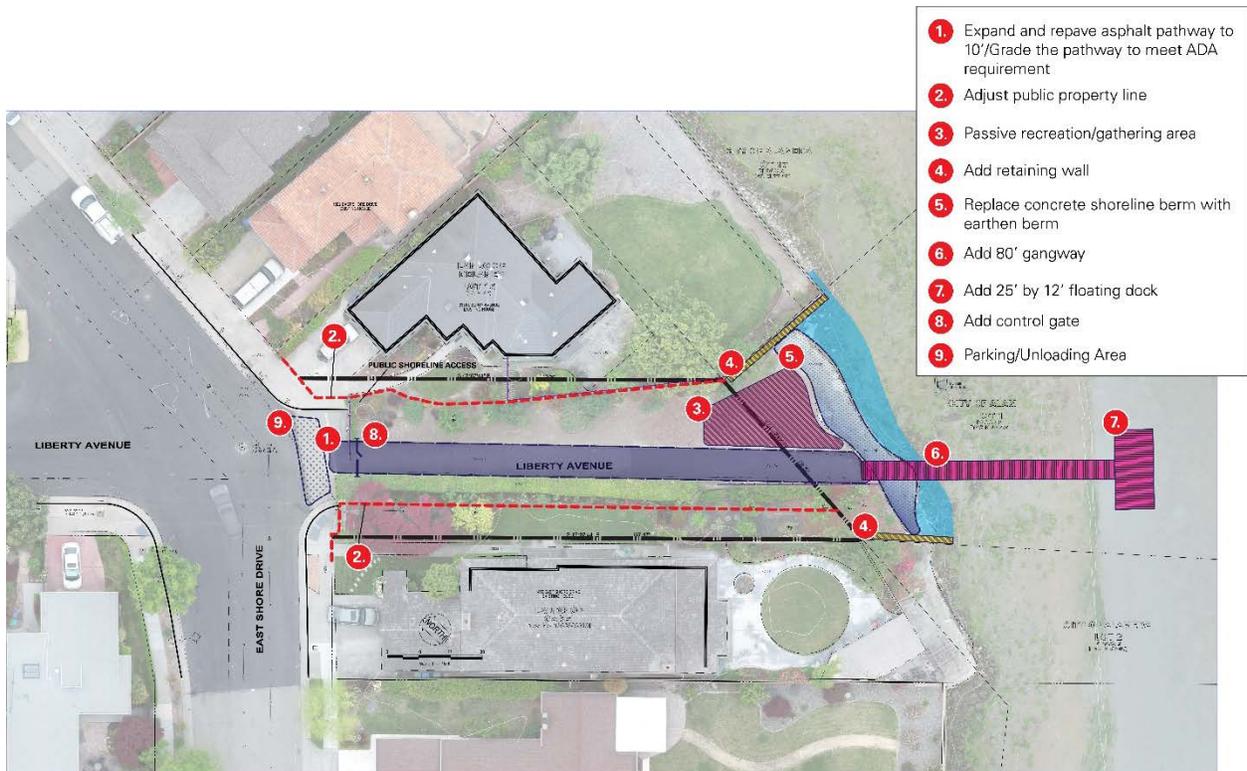
Figure 36: 3335 Liberty / 1450 Eastshore Drive Public Shoreline Access Improvement Concept

This site presents the best opportunity for a kayak launch dock for several reasons. First, the access to the shoreline from the roadway is wide and will not require significant efforts to provide access. Second, deeper water is relatively close to shore and the mudflat is very narrow. Last, this location does not have conflicts with adjacent existing facilities. For these reasons, the study team recommend a floating dock at this site. An 80-ft long accessible gangway will be installed, leading to a floating dock with an area of approximately 300 sf. A minor amount of work will be needed to remove an existing concrete berm along the shoreline edge to allow construction of the concrete abutment. Among all six public access pathway the 3335 Liberty / 1450 Eastshore Drive site presents the most feasible location for kayak launch.

In the scenario the City intended to implement a floating dock for kayak and other non-motorized craft use, the estimated construction cost for 3335 Liberty / 1450 Eastshore public access pathway would be \$573,000.

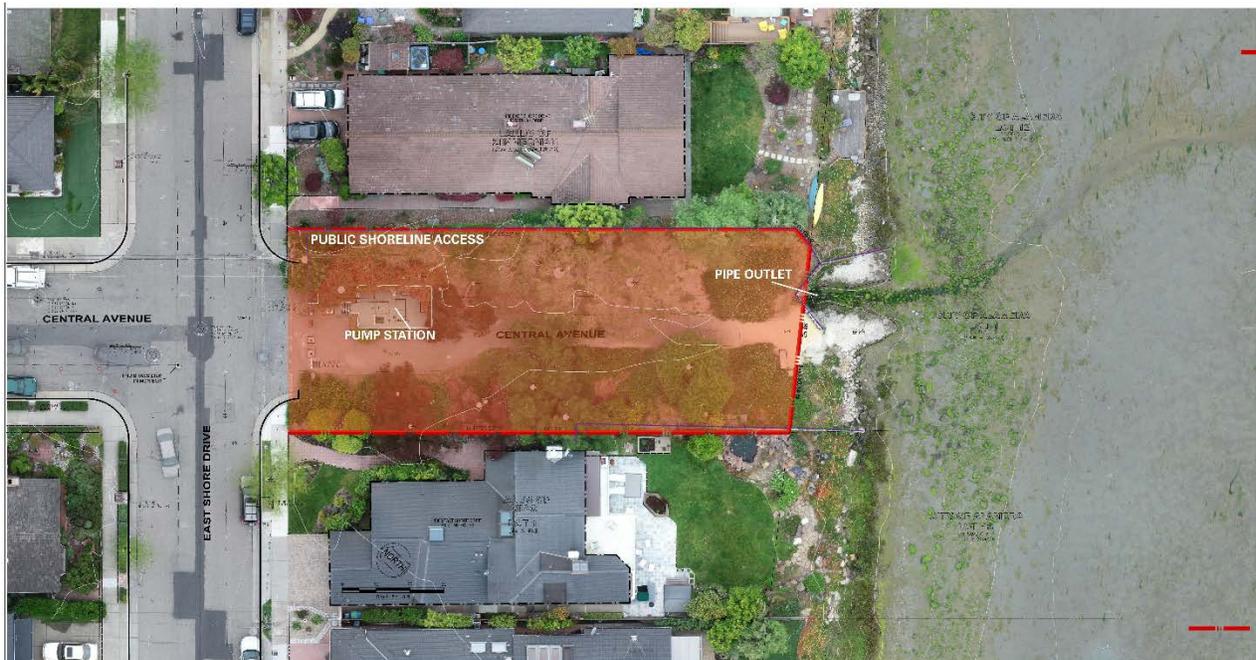
An existing storm drain pump station is located at the northwest corner of the site. This pump station discharge pipe is underground and runs offset from and parallel to the northern property line toward San Leandro Bay, terminating at a concrete headwall at the shoreline. The pipe appears to be 18-inches in diameter with an invert elevation of +3.42' NAVD.

Figure 37: 1380 - 1400 Eastshore Drive Site Plan

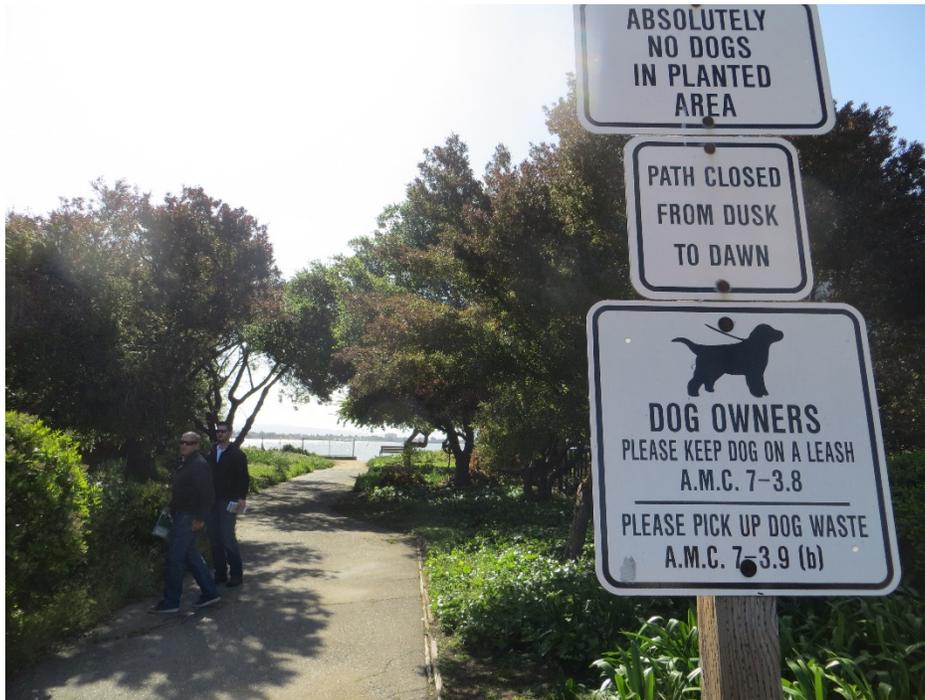
This site currently is being used for public access to the shoreline. An asphalt path, approximately 10-foot wide provides access from the street to the waterfront. It is in fair condition but will require a modest amount of regrading to achieve an ADA-compliant path-of-travel all the way to the embankment. There is a 3-foot high chain link fence at the top of the headwall and along part of the embankment, but it does not continue to the fence at the southeastern corner of the property. A dog waste station, a place for exchanging books, a park bench and the mature landscaping provides the amenities for passive recreation use. There is unimproved access to the water and wide expansive views of the Estuary, the Stadium Complex, and Shoreline Park.

*Figure 38: Asphalt Path and Visual Corridor to the Bay*

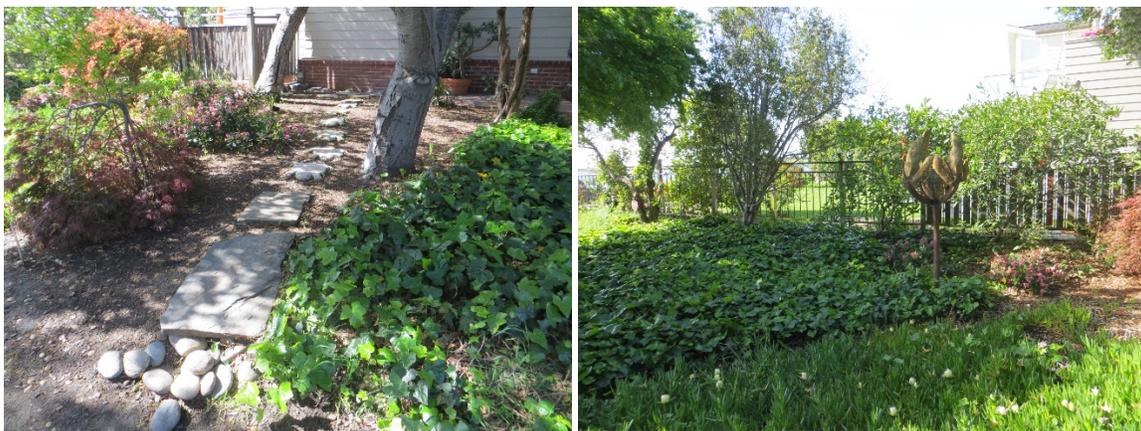
*Figure 39: Stepping Stone and Sculptures at Public Access*

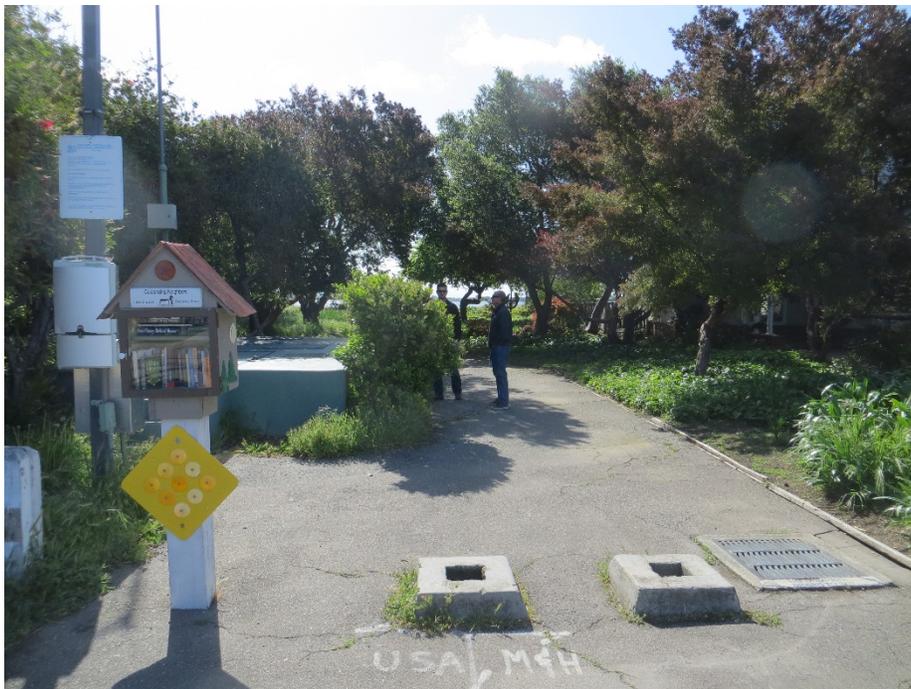
Well-maintained landscaping area covers a majority of the site. The neighbor to the south appears to have a small portion of their fence encroaching on public property. However, development of this site as a public shoreline access point is possible without demolition of any encroaching components. Overall this public access site can be improved for recreational use with minimum grade, large canopy trees, and direct visual corridor to the water.

*Figure 41: Components and Overall Landscape Viewing from the Entrance*

By keeping the existing property line, the study team recommends the City maintain this site as public shoreline access. All current landscape features shall be preserved. With its appealing view to the Bay, land-based recreational amenities such as walking path, overlook, and seating benches should be considered for future improvements. With adequate space at the entry, the team recommends the City place ADA accessible parking spaces. To address safety and accessibility, a controlled gate is recommended to be placed at the entry.

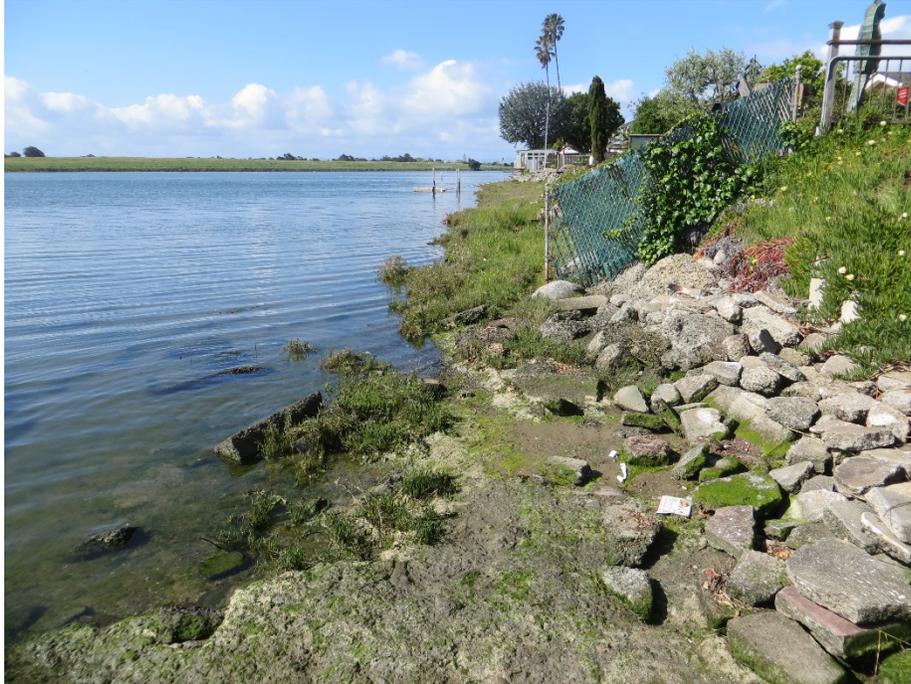
*Figure 42: Embankment and View to the Bay*

This site also presents an opportunity for a fixed pier for fishing and viewing. A launch dock would not be feasible due to the wide mudflat (approximately 700-ft wide) along this portion of the shoreline. The mudflat would only allow usage of the floating dock at high water levels; effectively rendering a floating dock at this location to be usable only during the upper half of the tidal range. Accordingly, this site is recommended to include a fixed pier overlook extending into the water approximately 50-ft to the toe of the shoreline slope. The pier will be supported on concrete or composite (fiberglass) piles, with a concrete pile cap; the pier deck may be concrete or composite lumber and a continuous guardrail will ensure public safety along the exposed perimeter of the pier. The team recommends scenic viewing, fishing, or other passive recreation use at the pier structure.

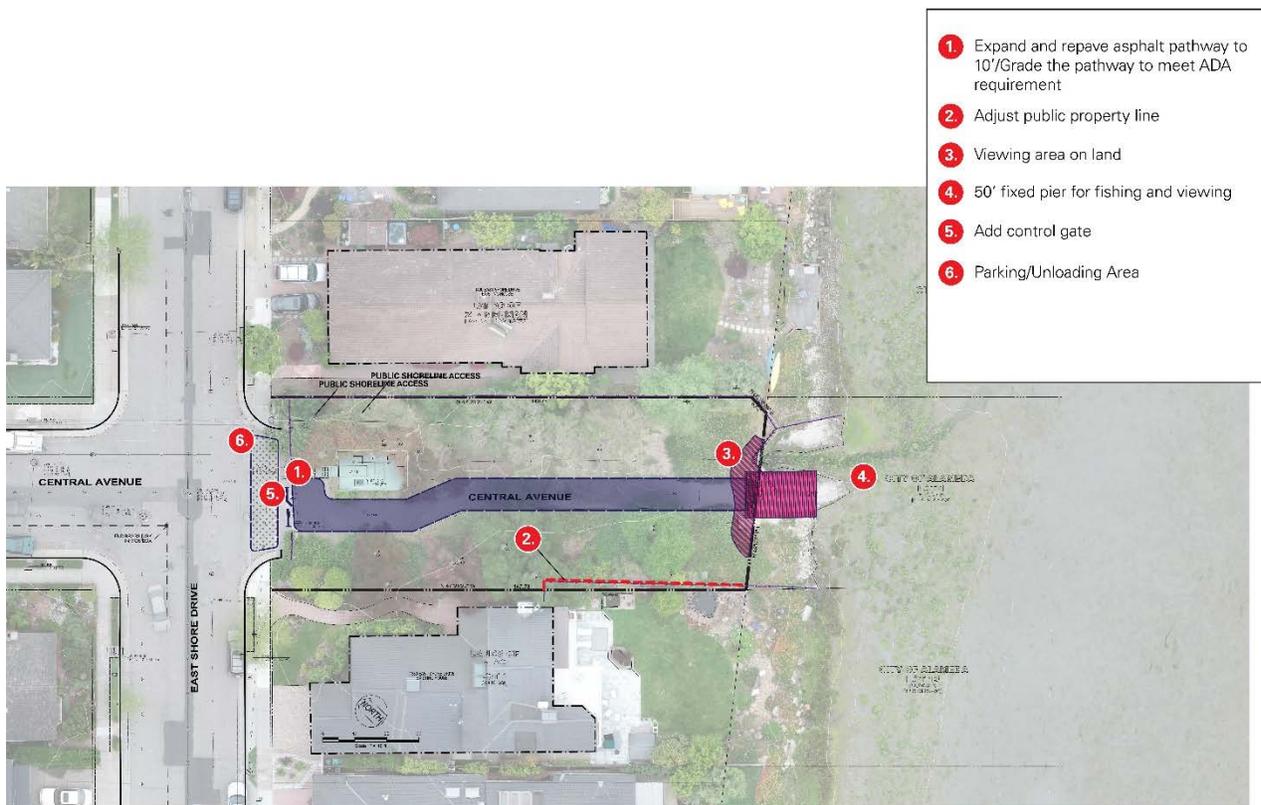
Figure 43: 1380 - 1400 Eastshore Drive Public Shoreline Access Improvement Concept

Under this scenario, the estimate construction cost for 1380 - 1400 Eastshore Drive public access would be \$658,000.

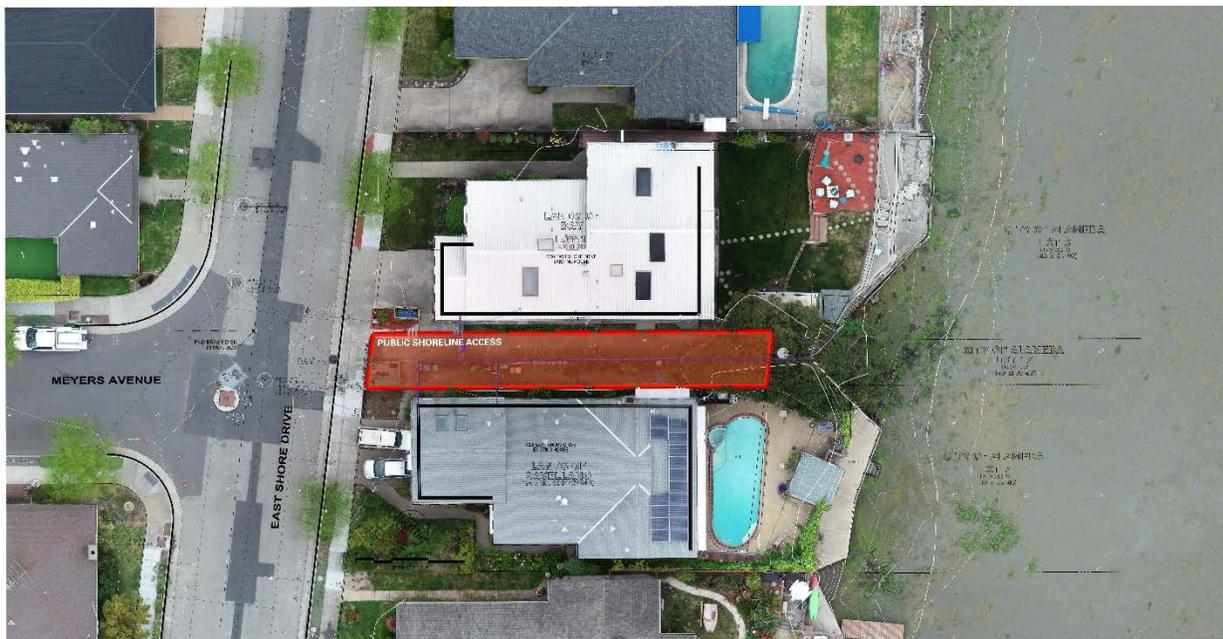
The pathway between 1328 – 1350 Eastshore Drive is located at the intersection of Eastshore and Meyers Avenue, approximately 400 feet north of the Encinal Ave. / Eastshore intersection. The existing public property is a 15-foot wide, 110-foot long lot from the edge of the sidewalk to the water. There is not an existing curb cut/ driveway that will allow for maintenance and emergency vehicle access. An existing power pole will need to be relocated to provide this public access. Connections to water, power, storm drain, and sewer are possible near the site. In 1967, a public sewer pump station was constructed on the southeastern portion of the parcel. In 2017, the wet well for the sewer pump station was moved to the intersection of Eastshore and Meyers and the pump station control cabinets and meter pedestal were renovated in their existing location and enclosed by newly constructed redwood fencing. Mapping shows there is an 18-inch storm drain running through the site. Storm runoff is conveyed to the Central-Eastshore pump station before being discharged to the Bay.

*Figure 44: 1328 - 1350 Eastshore Drive Site Plan*

Existing development consists of two single-family residences, with private development on public property. Both residential parcels are currently occupied. The site has a slight rise from the street to waterfront infrastructure that is consistent with ADA-compliant grades to top of the seawall. The seawall drops about 4 feet to the water surface at high tide with less than a foot of water over the mud flat.
