# FEASIBILITY STUDY OF SIX PUBLIC ACCESS PATHWAYS ON FERNSIDE BLVD. AND EASTSHORE DR.

ASSESSMENT REPORT

AUGUST 31, 2018

**City of Alameda, California**

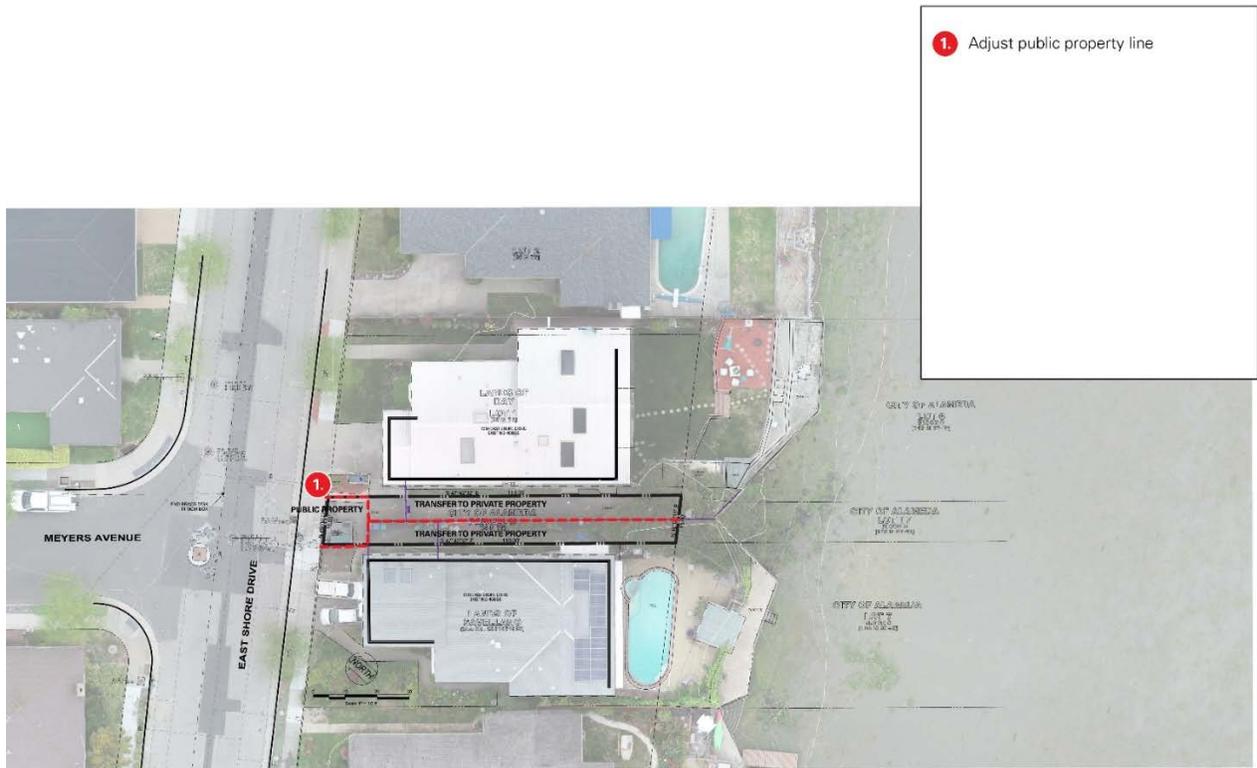
*Figure 48: 1328 - 1350 Eastshore Drive Public Shoreline Access Property Transfer Option*

Due to its existing condition, the City should consider transferring or leasing this public access pathway to adjacent private owners. This public access pathway has been inaccessible to the public for over 15 years and the cost to improve access outweighs the public benefit to reconstruct a narrow pathway when there are other public access pathways nearby. This option allows the City to avoid the demolition of privately built infrastructure and minimize recreational facility construction cost. The City shall adjust the property boundary and maintain a 20' by 20' space from the edge of the roadway. There will be minimum improvement cost under this scenario. Refer figure 48 for the property transfer option.

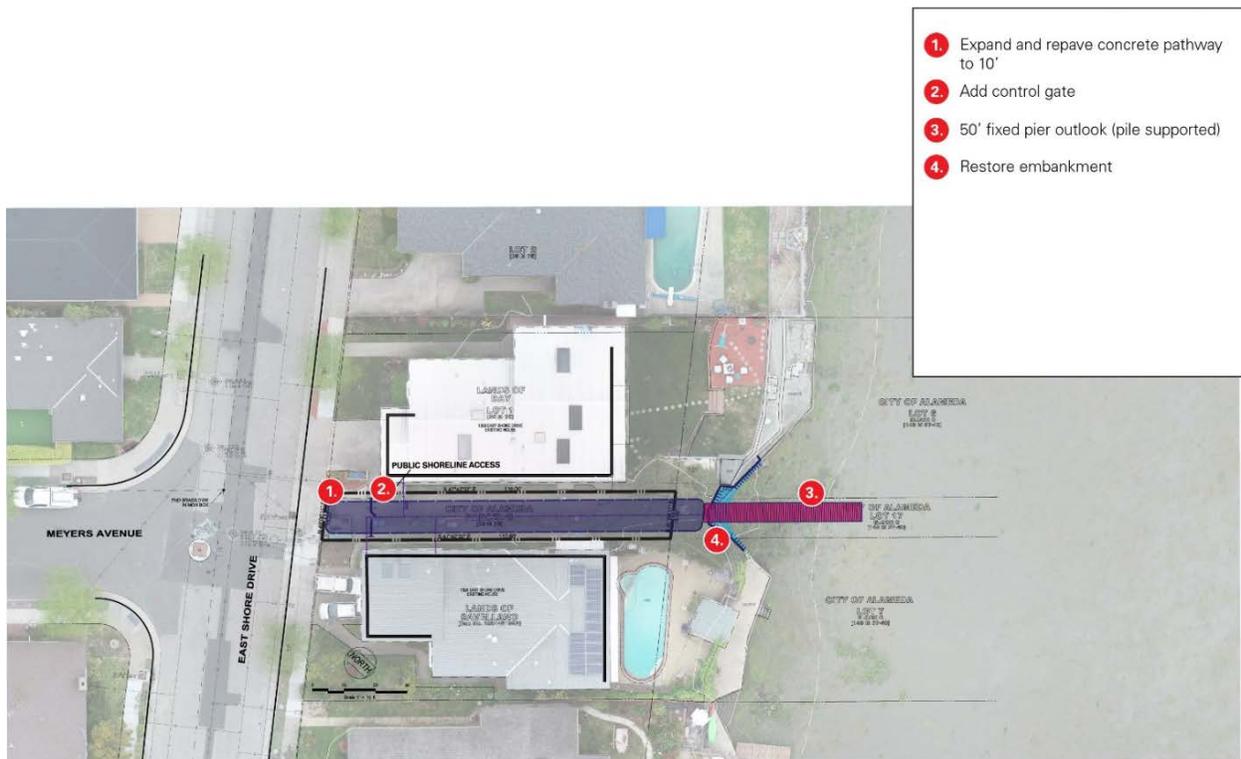
Figure 49: 1328 - 1350 Eastshore Drive Public Shoreline Access Improvement Concept

If enforcing the existing encroachments is not an issue, the study team then recommends that the City maintains ownership and improves this site as a public shoreline access pathway. Recreational amenities such as a walking path and pier for fishing and viewing should be considered for future recreation use. The following improvements are required to allow public access to the shoreline from the street:

- Entirely remove the existing fence and propose new fence at the public property line.
- A control gate shall be placed approximately 26 feet from the entry.
- Remove existing pine tree at shoreline edge to allow water access.
- Repave existing pathway and expand to minimum 10-foot wide.

This site presents an opportunity for a fixed pier structure. A launch dock would not be feasible due to the very wide mudflat (approximately 800-ft wide) along this portion of the shoreline. The mudflat would only allow usage of the floating dock at high water levels; effectively rendering a floating dock at this location to be usable only during the upper half of the tidal range. Accordingly, this site is recommended to include a fixed pier overlook extending into the water approximately 50-feet to the toe of the shoreline slope. The pier will be supported on concrete or composite (fiberglass) piles, with a concrete pile cap; the pier deck may be concrete or composite lumber and a continuous guardrail will ensure public safety along the exposed perimeter of the pier. Refer to Figure 49 for the improvement option.

In the scenario the City intended to maintain ownership and opted to implement the pier for fishing and viewing, the estimate construction cost for 1328 - 1350 Eastshore Drive public access would be \$782,000.
