008 – Dublin Pump Station

Summary

017 – Willow Pump Station

025 – 8th Portola Pump Station

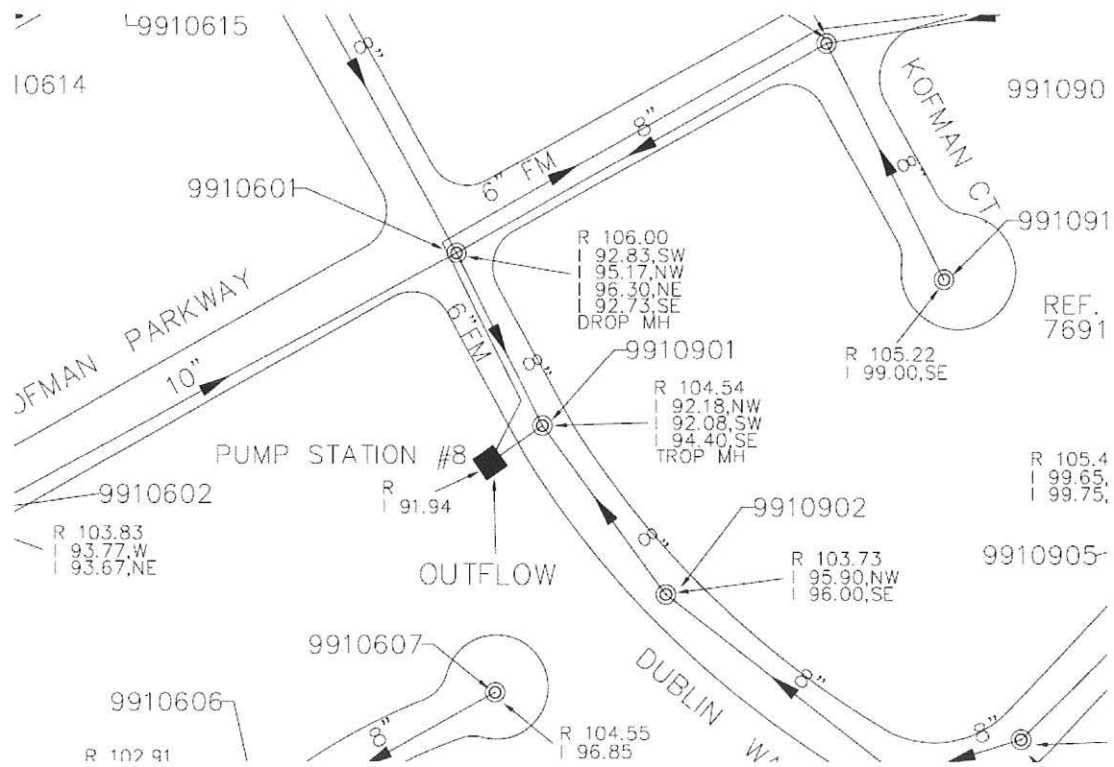
Figure 008-2: Dublin Pump Station Location and System Map

The pump station has a 6-inch diameter, 950-foot long force main which discharges to a manhole on Kofman Parkway.

At the time of inspection there was standing water in the valve vault, the valve vault should either be replaced, or a drain should be added to the existing small valve vault.

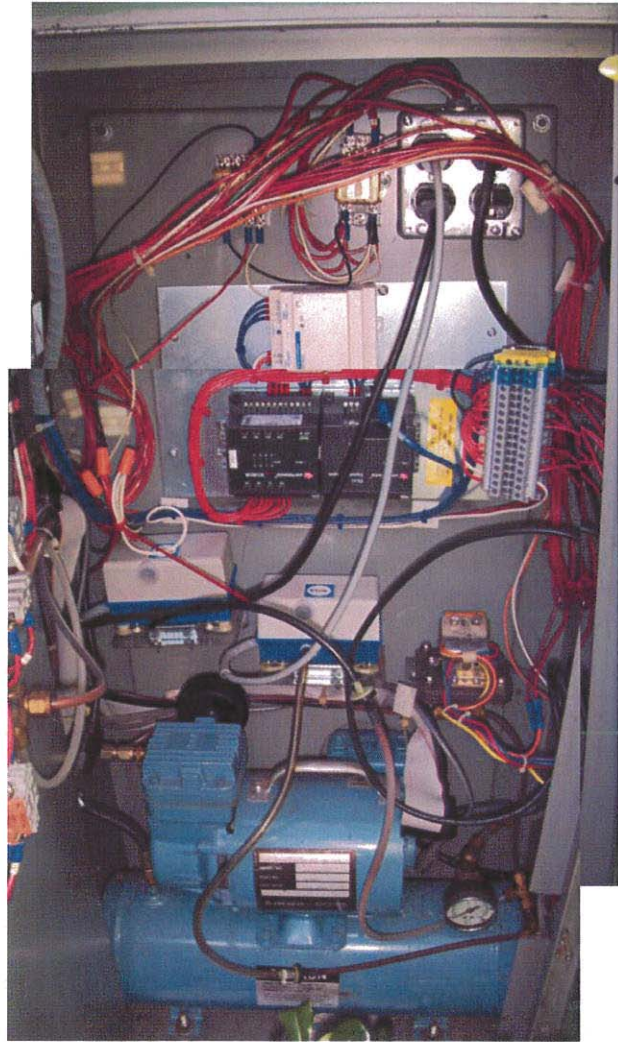
Photo 008-4: Electrical Panel (Interior)

• Wires not protected from the sharp edge of the conduit at the stub-up in the panel	2
	• Non-explosion-proof level switch in the wet well with no intrinsically safe relay	2
Safety	• Door mounted operating handles detached from the breakers when door is opened	1
NFPA 820 Violations	• Elect pull box not explosion-proof which is required due to close proximity (only 31-1/2") to wet well opening	1
Control or Instrumentation	• No individual control circuit for each pump	3

• Panel bottom area corroded	3

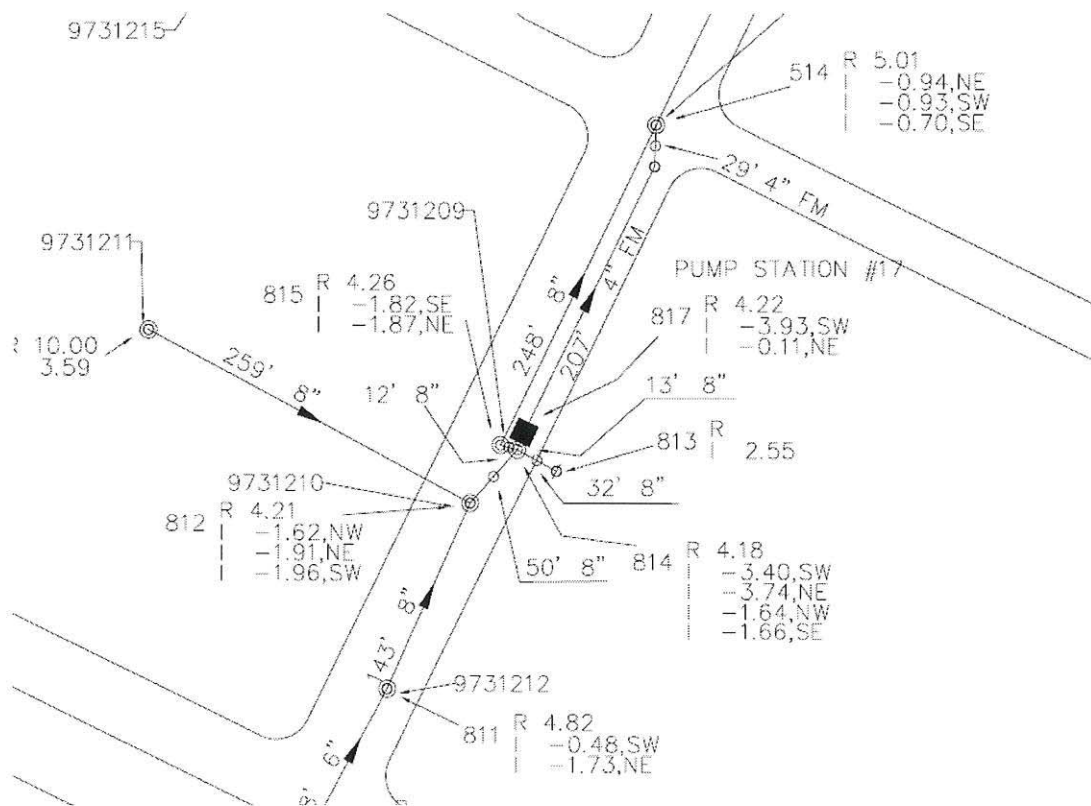
Figure 017-2: Willow Pump Station Location and System Map

Figure 017-2 shows the existing sewer piping surrounding the Willow Pump Station. Figure 017-3 shows a profile of the wet well, which is approximately 11 feet deep and has a 5 foot inside diameter. The wet well is in descent condition.

The pump station has a 4 inch, 200 foot long force main that discharges to a manhole at the intersection of Willow and Franciscan. The sewage then flows by gravity another block north until it reaches the Willow Whitehall Pump Station (018).

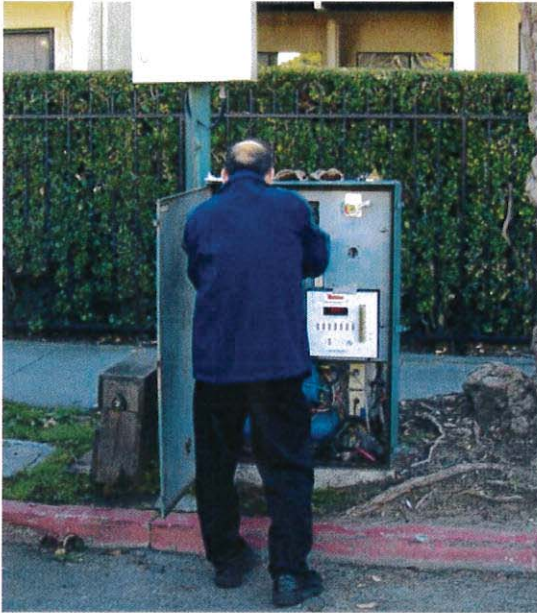
Photo 017-3: Electrical Panel Location

The Willow Pump Station is located in Willow Street in a manhole about half way between Shoreline Drive and Franciscan Way. Willow Street is a 60 foot wide street with lane of parking. The electrical panel and backflow preventer and on the east side of the street, near the wet well, and positioned between the curb face and sidewalk facing west (see Photo 017-3).

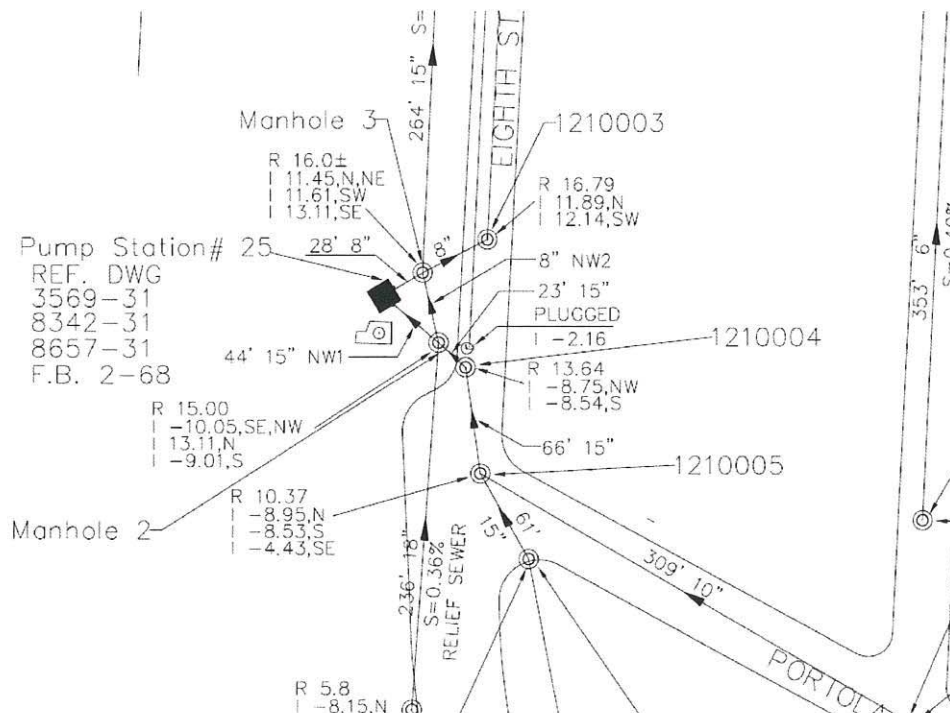
Figure 025-2: 8th-Portola Pump Station Location and System Map

Sewage enters the station from a manhole southeast of the station in 8th Street, and discharges to a manhole northeast of the station (in 8th Street). A high-level bypass pipe connects the two manholes; however, if sewage backs up to the bypass elevation, the upstream manholes will overflow. Figure 025-2 shows the existing pipe layout surrounding the pump station. The station services the sewershed along Portola Avenue.

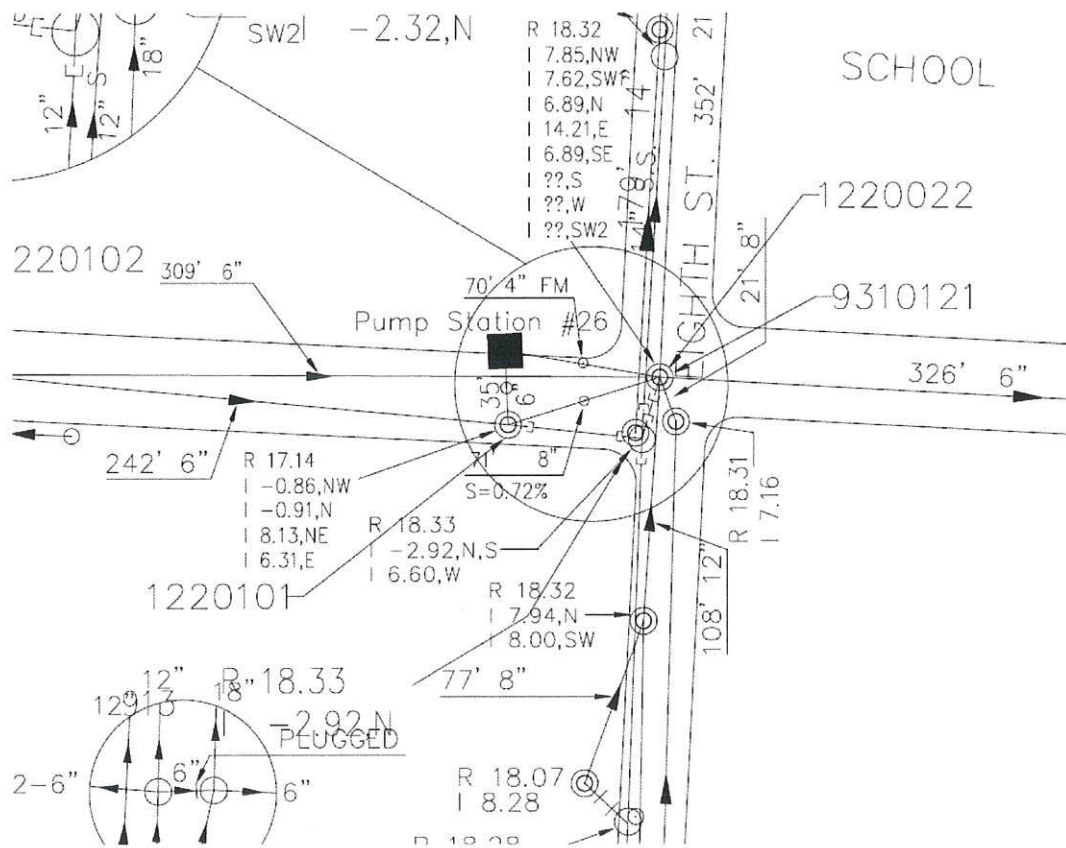
Figure 026-2: 8th-Taylor Pump Station Location and System Map

The station has an 8 inch high-level bypass pipe to a manhole in the intersection of 8th Street and Taylor Avenue. The station has a relatively short (70-feet) 4-inch force main. Figure 026-2 shows the existing piping adjacent to the pump station.

The site does not have sufficient room to add a backup generator and has a short time to overflow; therefore, additional storage should be added to the system. 2,300 cubic feet of storage is required to increase the time to overflow to 2-hours. A connection for a portable backup generator should also be added during the next rehabilitation.

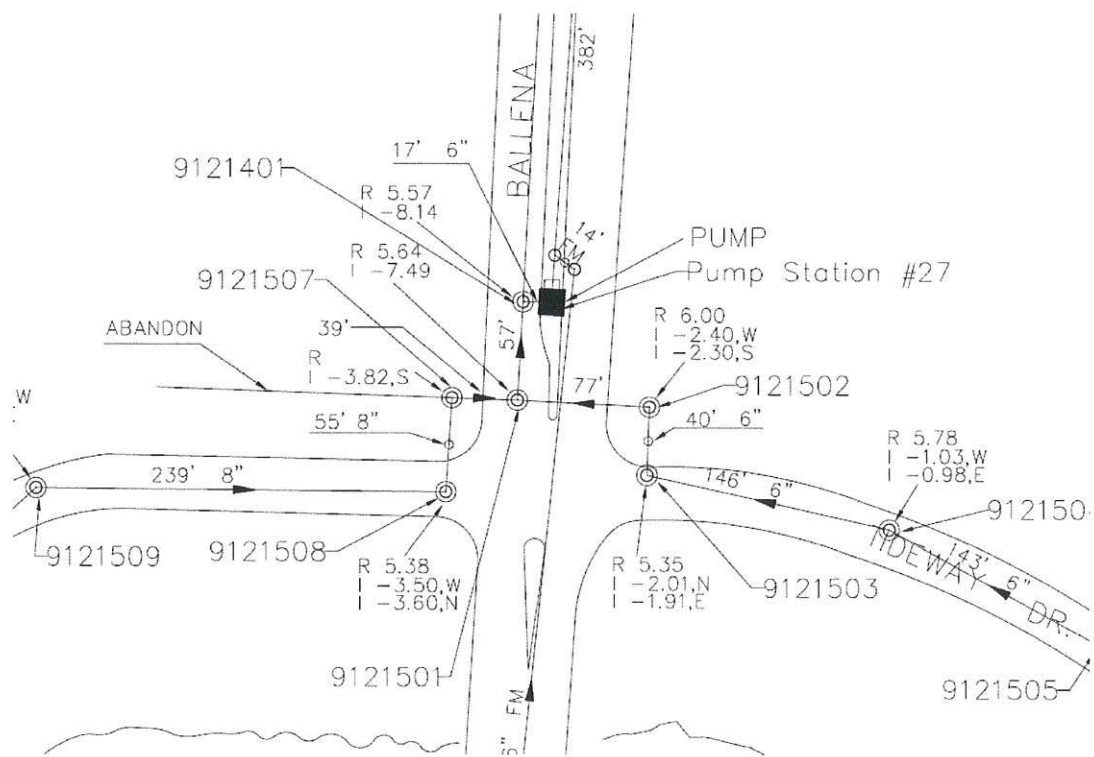
Figure 027-2: Tideway Pump Station Location and System Map

The Tideway Pump Station receives sewage from a manhole on the west side of Ballena Boulevard. The 8-inch force main joins with the Cola Ballena pump station(#028) force main and runs approximately 800-ft north on Ballena Boulevard and east on Central Avenue. Figure 027-2 shows the existing layout and piping near the pump station.
