CITY OF ALAMEDA

THE RESPONSE OF THE SHALLOW GROUNDWATER LAYER AND CONTAMINANTS TO SEA LEVEL RISE September 2020

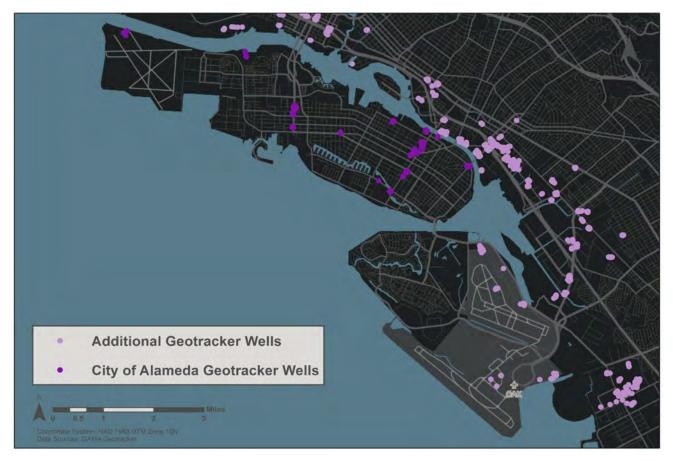
Figure 2.2 Groundwater Monitoring Well Locations

² Each contaminated site often includes multiple wells to better characterize the concentration and movement of contaminants; therefore, it may be difficult to identify 144 individual well locations at the scale of the map presented in Figure 2.2.

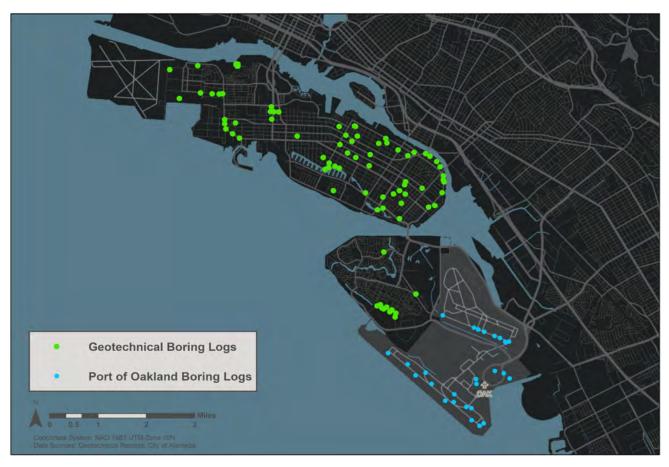
Figure 2.5 Location of Soil Boring Logs

Although the SWRCB GAMA data provides information on 144 wells across Alameda, the well data is limited to areas where contaminants are most likely present. Several areas have limited well coverage, including areas on the Main Island and Bay Farm Island that are primarily residential. To fill these data gap areas, 51 recent geotechnical reports (i.e., completed post 2000) were reviewed to identify soil borings with depth to water information. The reports were provided by the City of Alameda and the Port of Oakland for the Oakland International Airport on Bay Farm Island (see Section 7.2). The geotechnical reports were originally prepared to support construction and infrastructure projects. In total, the reports include data for 115 soil boring logs in the data gap areas. This information was not available in digital format, and the soil boring locations were hand digitized in ArcGIS as part of this study. Figure 2.5 presents the soil boring locations that were combined with the SWRCB GAMA data to better define the existing shallow groundwater layer surface.

Several of the geotechnical reports reference and include information on historical soil borings from the same general location. This allowed for a comparison of groundwater levels over many years and seasons. However, only depth to water measurements collected post 2000 were used in the analysis. In general, the geotechnical reports consistently note that groundwater levels in the City of Alameda fluctuate with seasonal precipitation and Bay tides.

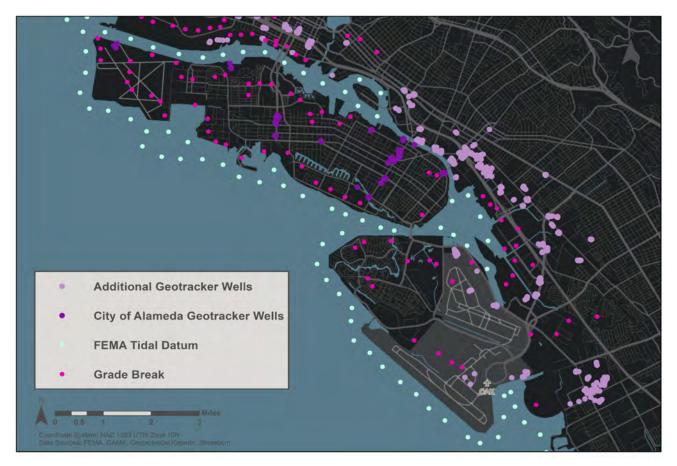
Figure 3.2 Well Points, Tide Points, and Grade Break Points

Similar to the regional approach, the refined approach also incorporates tide level elevations along the shoreline from the FEMA study (May et al, 2016). In areas where significant grade changes (e.g., hills) occurred between inland monitoring wells and the Bay shoreline, breaklines¹⁶ were used to constrain the groundwater with the topography. Figure 3.2 presents the wet winter season well points, FEMA tide points, and the grade break points that were used to develop the existing shallow groundwater surface for the City of Alameda and the surrounding areas. Figure 3.3 presents the final existing shallow groundwater surface layer.

¹⁶ Breaklines are imaginary lines created from a sudden increase or decrease in the ground surface elevation (e.g., at the base or crest of a hill). Breaklines are critical for creating an accurate surface model. Breaklines constrain the interpolation, preventing interpolation across the breakline to better represent grade changes.

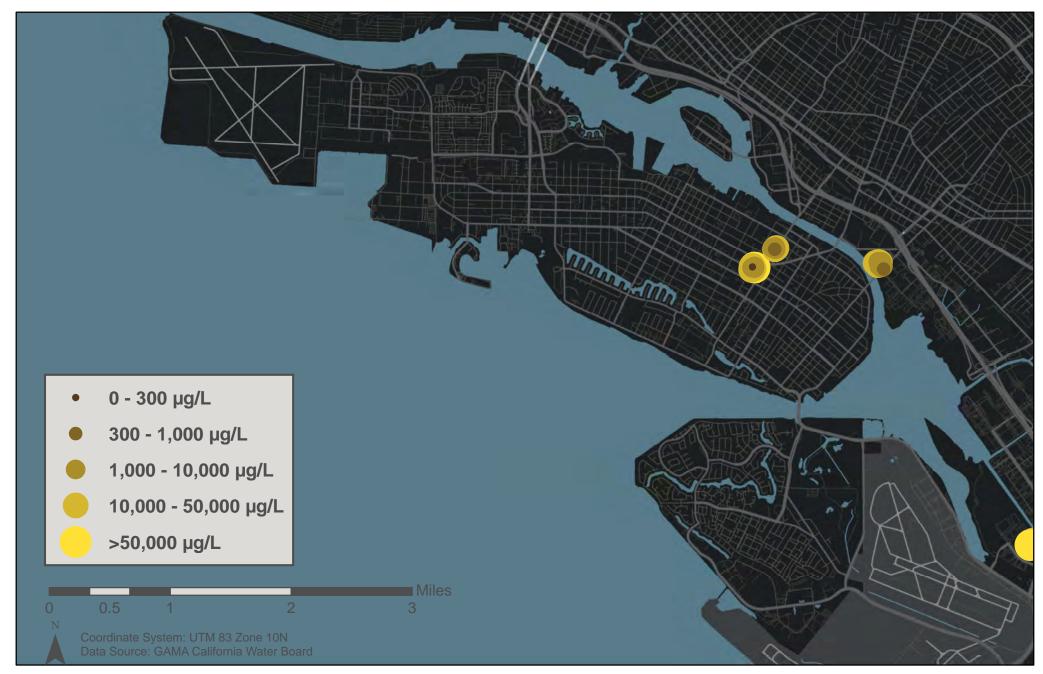
Figure 3.5 Current Period (2015 – 2019) Average Iron Concentration

Unlike the creation of the groundwater surface, a "contamination surface" was not created. Instead, the average concentrations were mapped at the well location where they were measured. Not all contaminants were measured at each well. Appendix A includes tables for each contaminant, including information for each well where the contaminant was measured, the number of measurements taken, the historic high measurement and the date it was recorded, the historic average measurement (2000 - 2019), and the current average (2015 - 2019).
