Appendix F Detailed Flood and Sea Level Rise Risk Assessment

June 2022

This appendix provides detailed assessment of how existing and future people, economy, buildings and infrastructure may be impacted by flooding and sea level rise in Alameda.

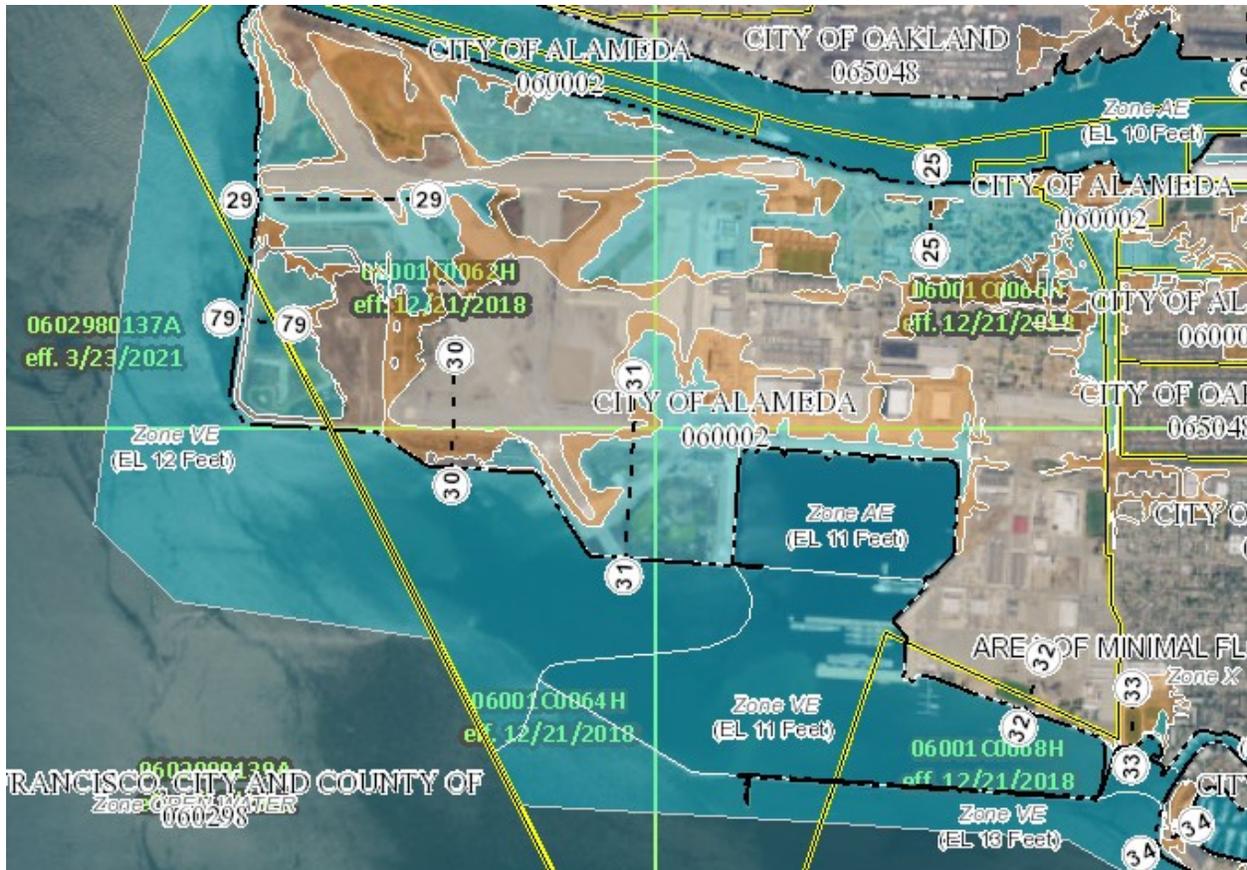
Figure F-1. FEMA FIRM Showing VE and AE Flood Zones with Varying Base Flood Elevations and Wave Heights Around Alameda Point and the Southerly Shoreline of Alameda's Main Island

On the main island, 59% of shoreline protection consists of riprap, including Ballena Isle. The largest presence of riprap occurs along the Alameda Point shoreline and Ballena Isle shoreline where exposure to the Bay’s wave effects is greatest. The Alameda Point shoreline is mainly within or adjacent to the 100-year VE Flood Zone (wave heights greater than or equal to 3 ft) that extends into the Bay, with a BFE = 12 ft NAVD88. Moving eastward along the southern shoreline, the BFE varies and reaches as high as 13 ft NAVD88 along the Ballena Isle perimeter and within crab cove, as the Zone designation shifts to AE (wave heights less than 3 ft). See **Figure F-1**.

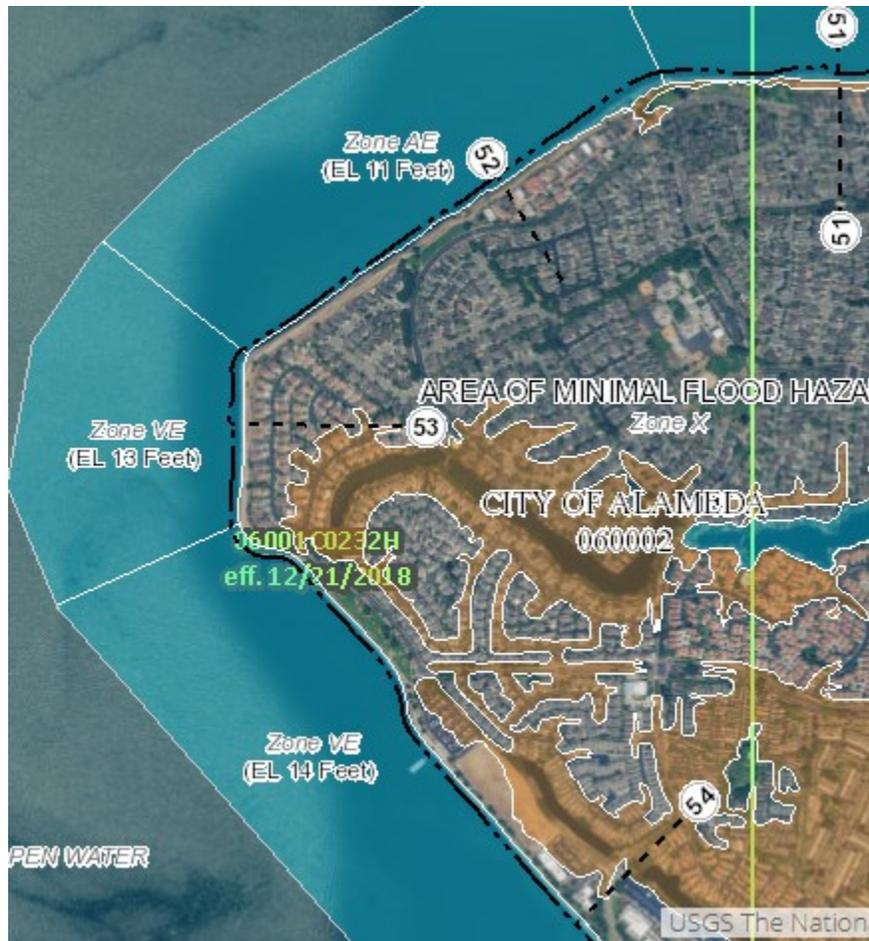
Figure F-2. FEMA FIRM Showing VE and AE Flood Zones with Varying Base Flood Elevations and Wave Heights Around Bay Farm Island's Shoreline

Large diameter riprap is used along 77% of Bay Farm Island’s shoreline in order to buffer it from the impacts of wave action since it is directly exposed to the Bay’s wave effects from the south and west. As shown on **Figure F-2**, the southernmost portion of shoreline has the highest BFE within the City of Alameda, at 14 ft NAVD88 in elevation, and is in the VE Zone that extends out into the Bay. As you move northerly up the coastline and eastward, the BFE values decrease, and the flood zone changes from VE to AE as exposure to the Bay decreases.

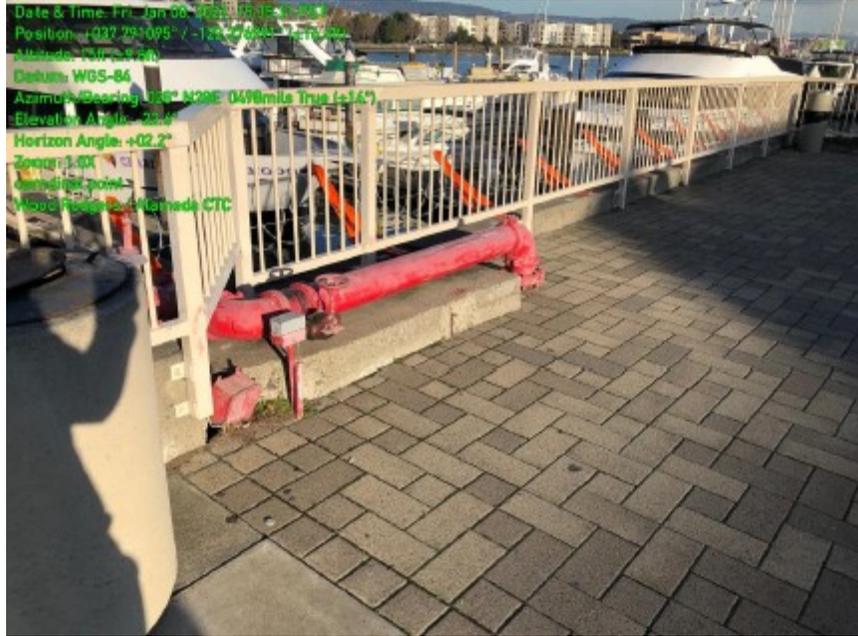
Figure F-3. Seawall Along Northern Shoreline in Flood Zone

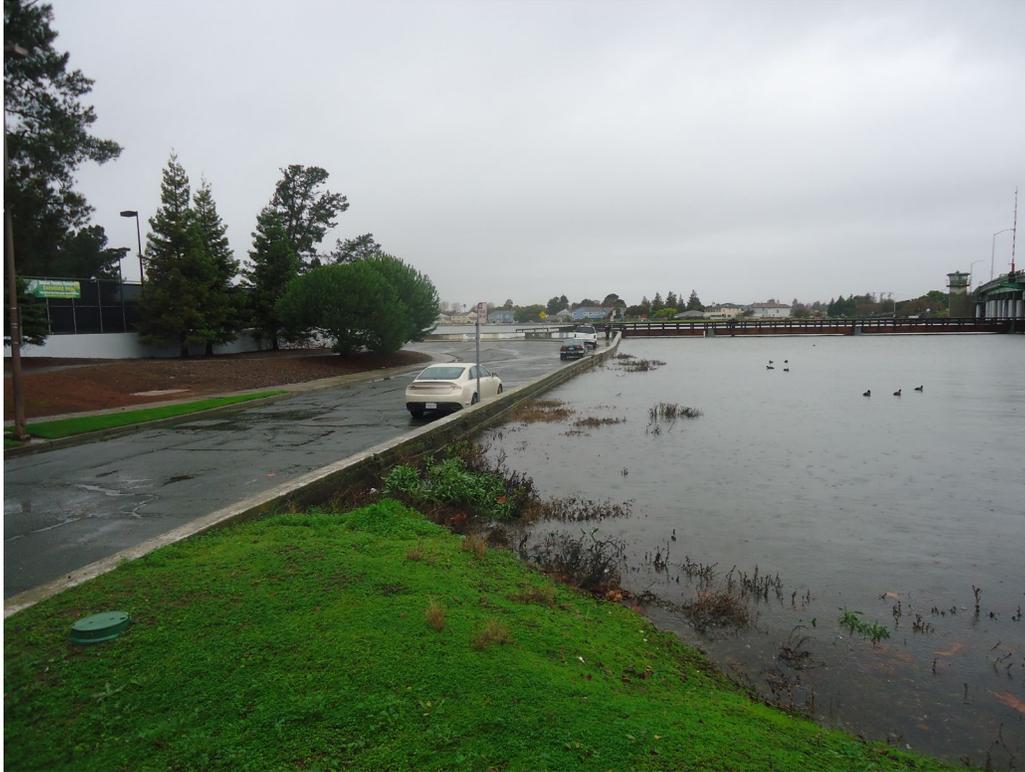
Figure F-4. Looking North Along Veterans Court Seawall at King Tide Event, January 2017

Shoreline Location	Flood Zone and BFE (NAVD88)	Type of Shoreline	Approx. Top Elevation of Unaccredited Seawall at Location, if Present (NAVD88)	Approx. Ground Elevation at Lowest Point (if Seawall is Present, then Behind/Landward of it) (NAVD88)	Approx. Depth of Flooding at Shoreline at Current 100-yr Flood Event Assuming No Seawall (Total Water Level = 10ft NAVD88)	Approx. Depth of Flooding at Shoreline at 36-in Sea Level Rise Assuming No Seawall (Total Water Level = ~ 9.5ft NAVD88)	Approx. Depth of Flooding at Shoreline at Current 100-yr Flood Event + 36-in Sea Level Rise Assuming No Seawall (Total Water Level = 13ft NAVD88)
Alameda Point's Southern Shoreline on Federal Property	VE, 12 ft	Riprap	n/a	7 ft	3 ft	2.5	6 ft
Bay Farm Island:							
Lagoon System 1 North Outfall	AE, 10 ft	Concrete Seawall	11.5 ft	9.5 ft	0.5 ft	Less than 0.5 ft	3.5 ft
Veterans Court	AE, 10 ft	Concrete Seawall	9 ft	6 ft	4 ft	3.5 ft	7 ft

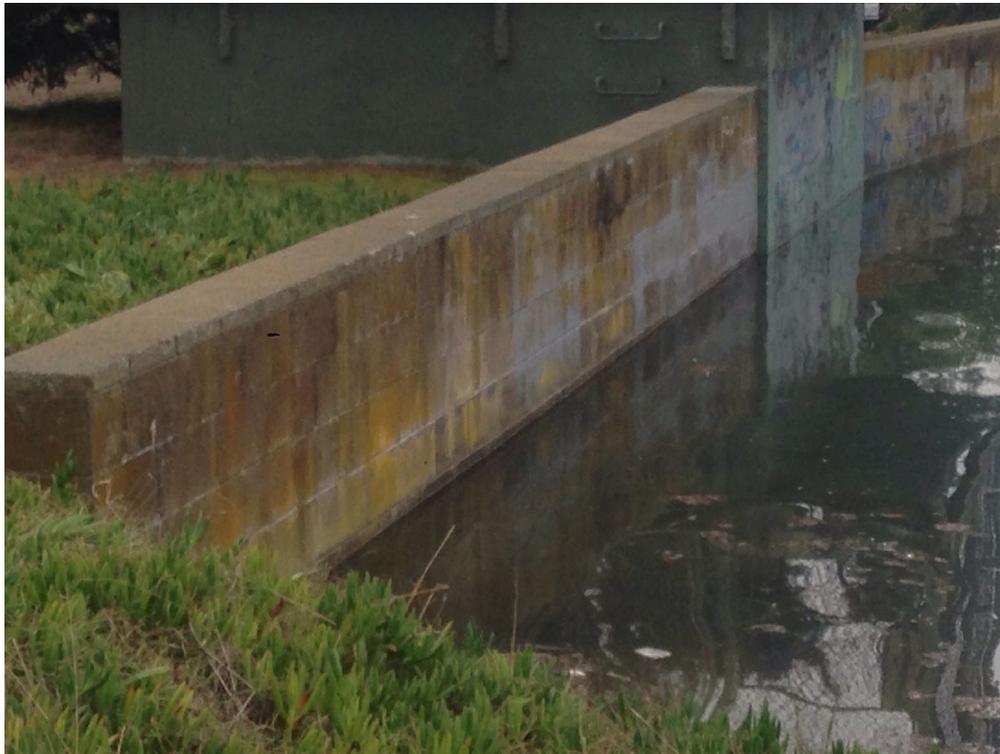
Figure F-5. Lagoon System 1 North Outfall Seawall at King Tide Event, January 2018

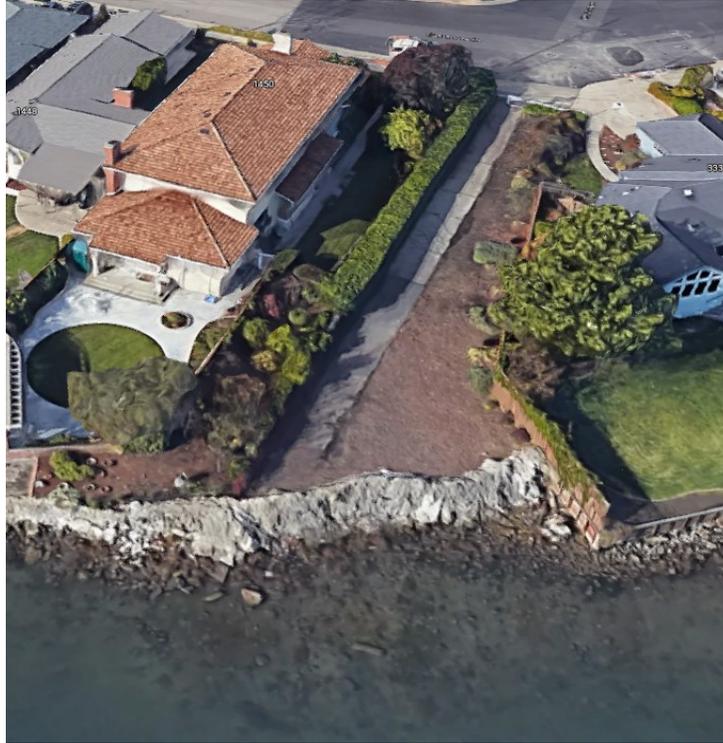
Figure F-6. Concrete Windrow at End of Liberty Avenue, East End
