Citywide Executive Summary Report for Facility Condition Assessment Services

For
City of Alameda
Police Station
1555 Oak Street
Alameda,
California, 94501

Date of Report: May 4, 2016

Faithful+Gould, Inc

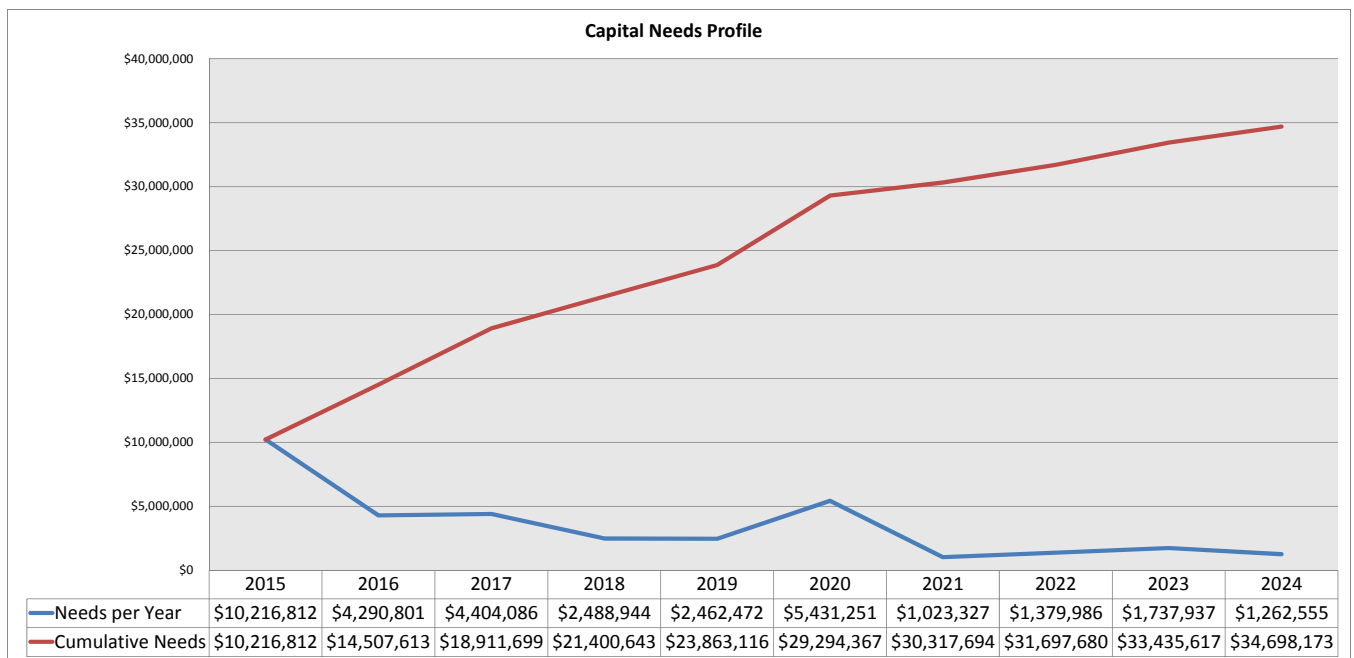
The chart below provides a summary of yearly anticipated expenditures over the ten year study period for the City of Alameda. Further details of these expenditures are included within each respective report section. The results illustrate a total anticipated expenditure over the study period of circa **\$34,698,173**.

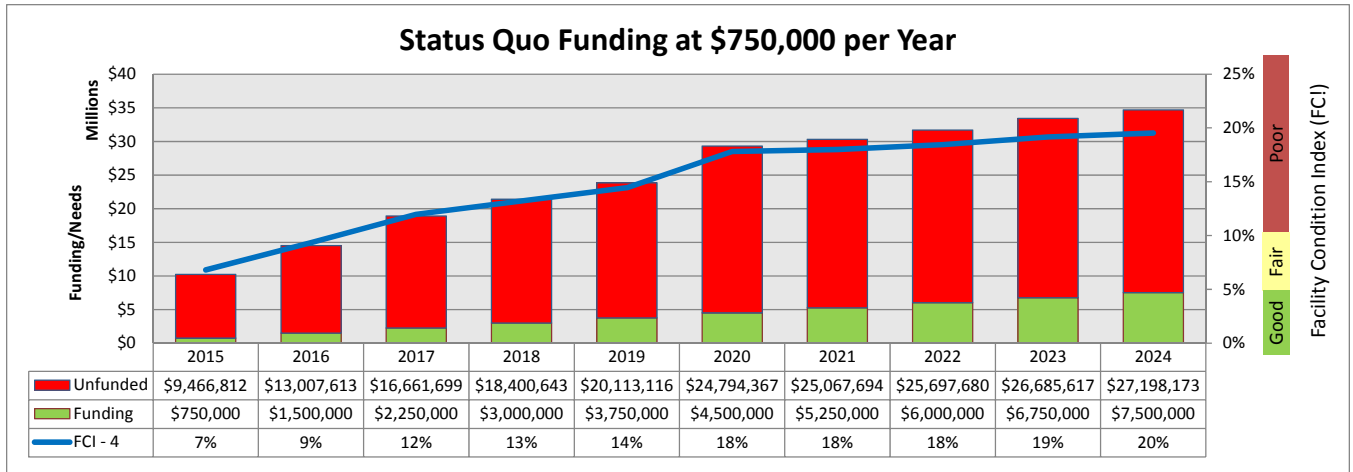
The chart below provides a summary of what impact the current funding level of \$750,000 per year will have on the accumulative yearly need over the ten year study period for the City of Alameda.

The chart illustrates that with current funding of \$750,000, year 1 will have an unfunded current deferred maintenance need of \$9,466,812. This unfunded need will grow over the next 10-years to over \$27 million of unfunded need.

A comparison if also made with the Facility Condition index and how the current funding level will impact the condition rating. We see that the facilities will go from a current 7% Fair condition and deteriorate over time to a citywide condition index score of 20% Poor condition.

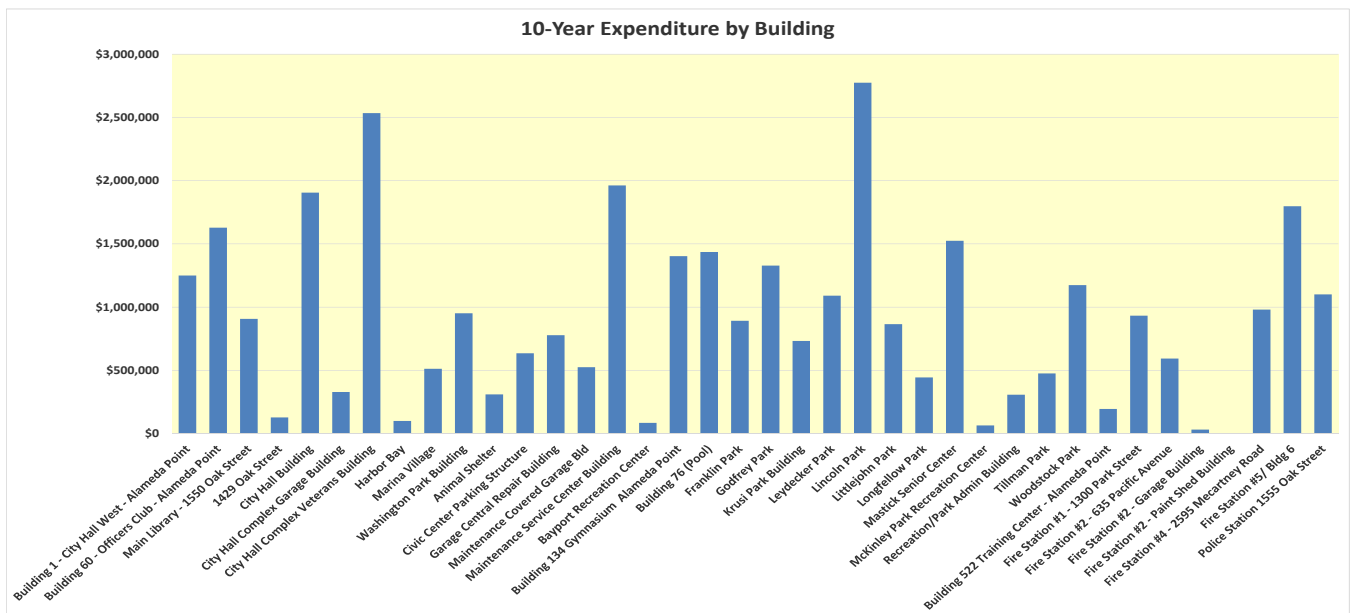
The chart below shows a 10 year cost expenditure by building. As can be seen the City Hall Complex Veterans Building has the largest anticipated spend of \$2,175,483 over the study period.

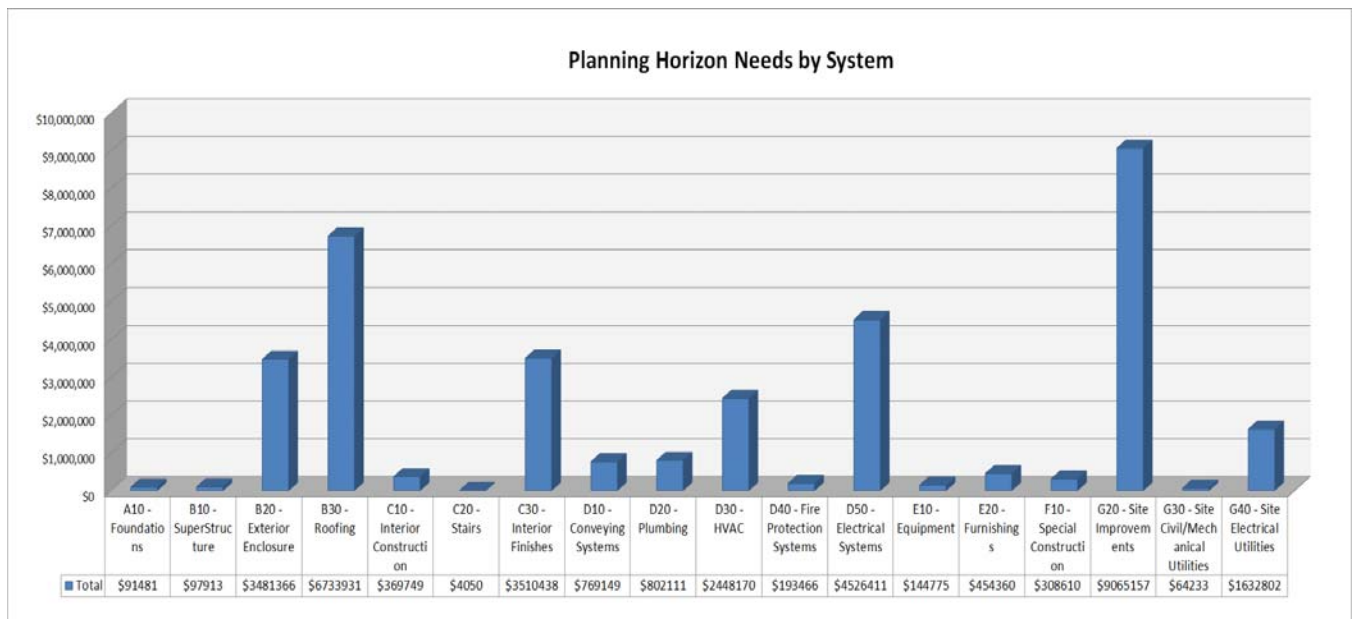
The below chart shows the distribution of expenditure by building system with Exterior Enclosure, Roofing, Interior Finishes, HVAC, Electrical Systems, and Site Improvements being the highest building system spend area over the study period.

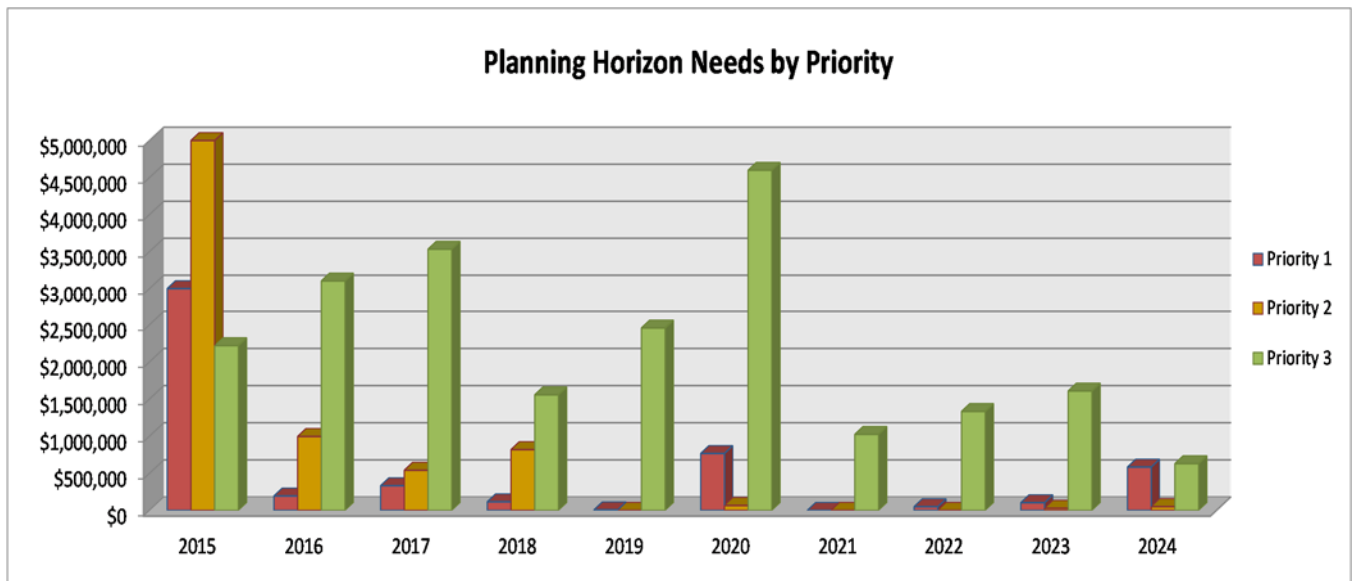
Faithful+Gould has prioritized the identified work in order to assist with analyzing the deficiencies found during the assessment. The baseline prioritization model is not just based on replacement year or criticality but uses four key data attributes to build an overall importance metric for every recommendation: System type, the cause or nature of the issue, timing and building mission incorporated into the model with relative weighting to provide an overall priority score. Priority categories are shown below:

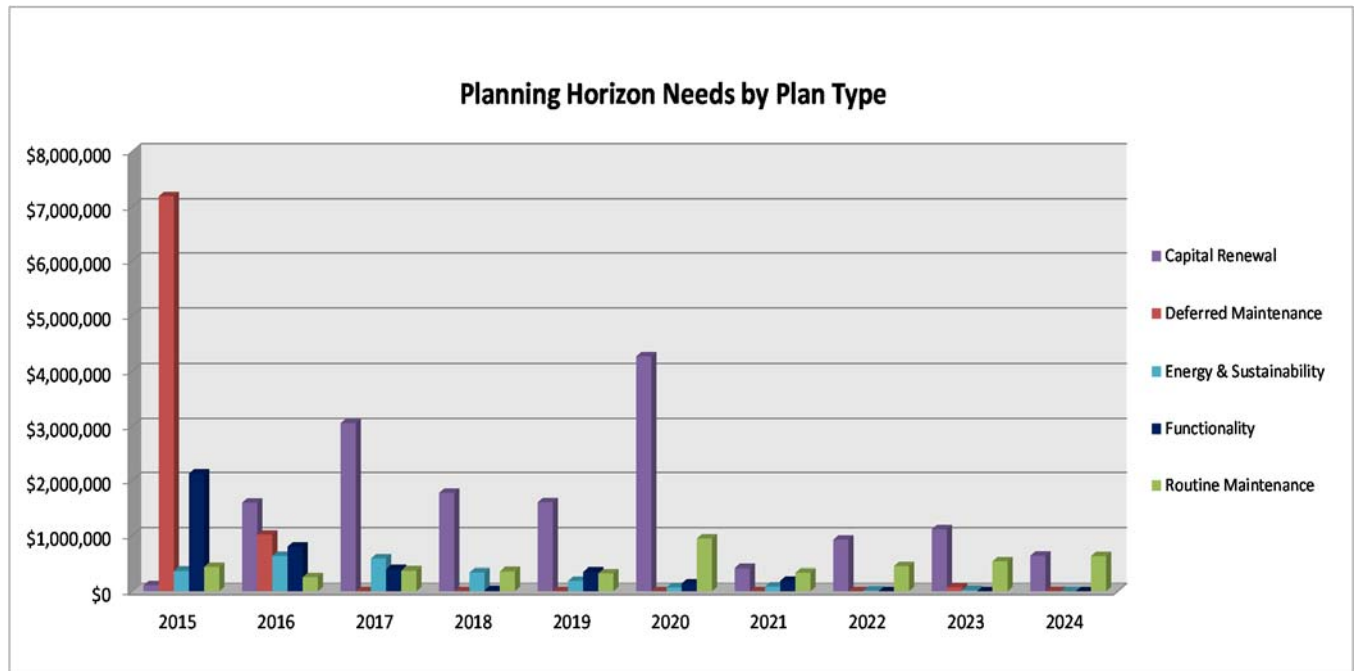
The chart below illustrates the breakdown of expenditure according to the Plan Type or deficiency categories providing an opportunity to strategically plan and effectively direct funding. As can be observed from the chart below Deferred Maintenance I is the highest expenditure during the study period.
