Access Compliance Survey Report

Transition Plan update Buildings, Facilities, and Parks City of Alameda

TRANSITION PLAN UPDATE
DISABLED ACCESS SURVEYS FOR FACILITIES AND RIGHT OF WAY.

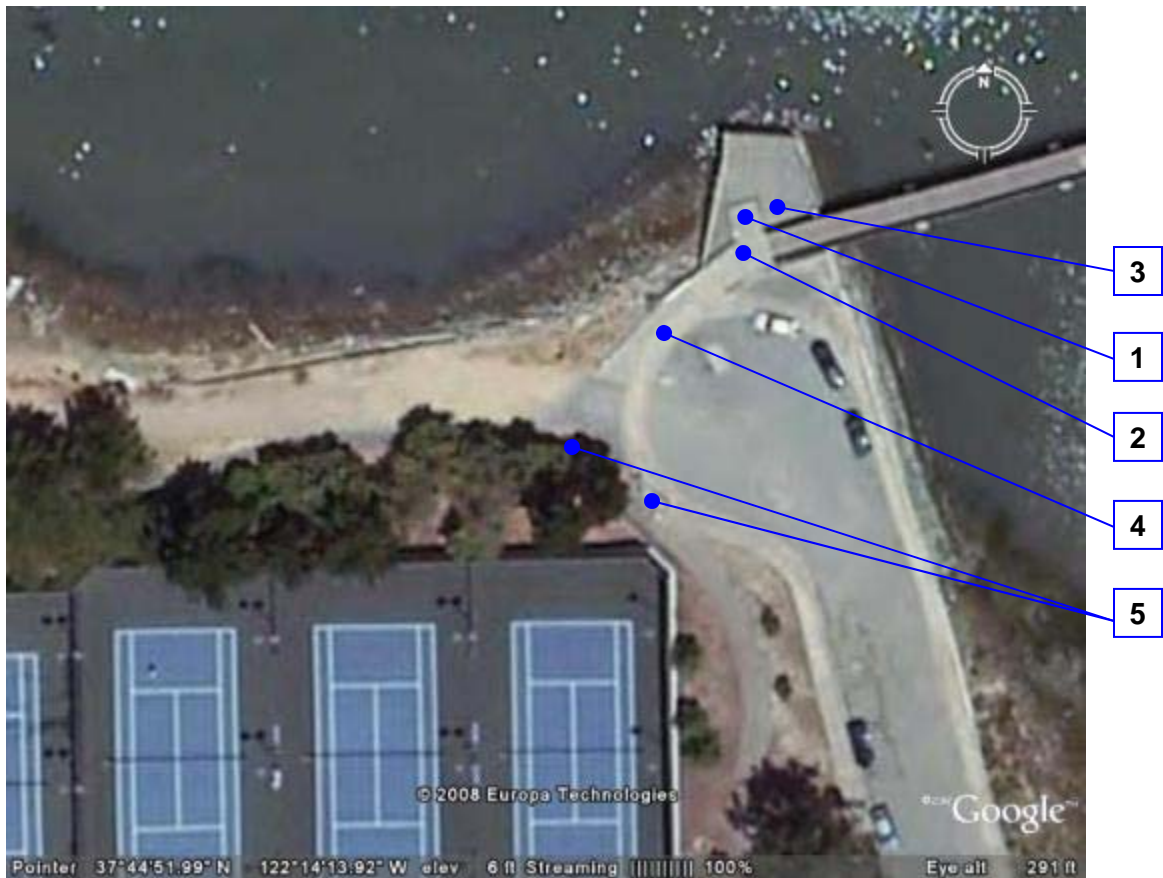
City of Alameda
Shoreline Park
On-Site, Exterior
53 - 0 - 1

Area# 1
Veteran's Ct.

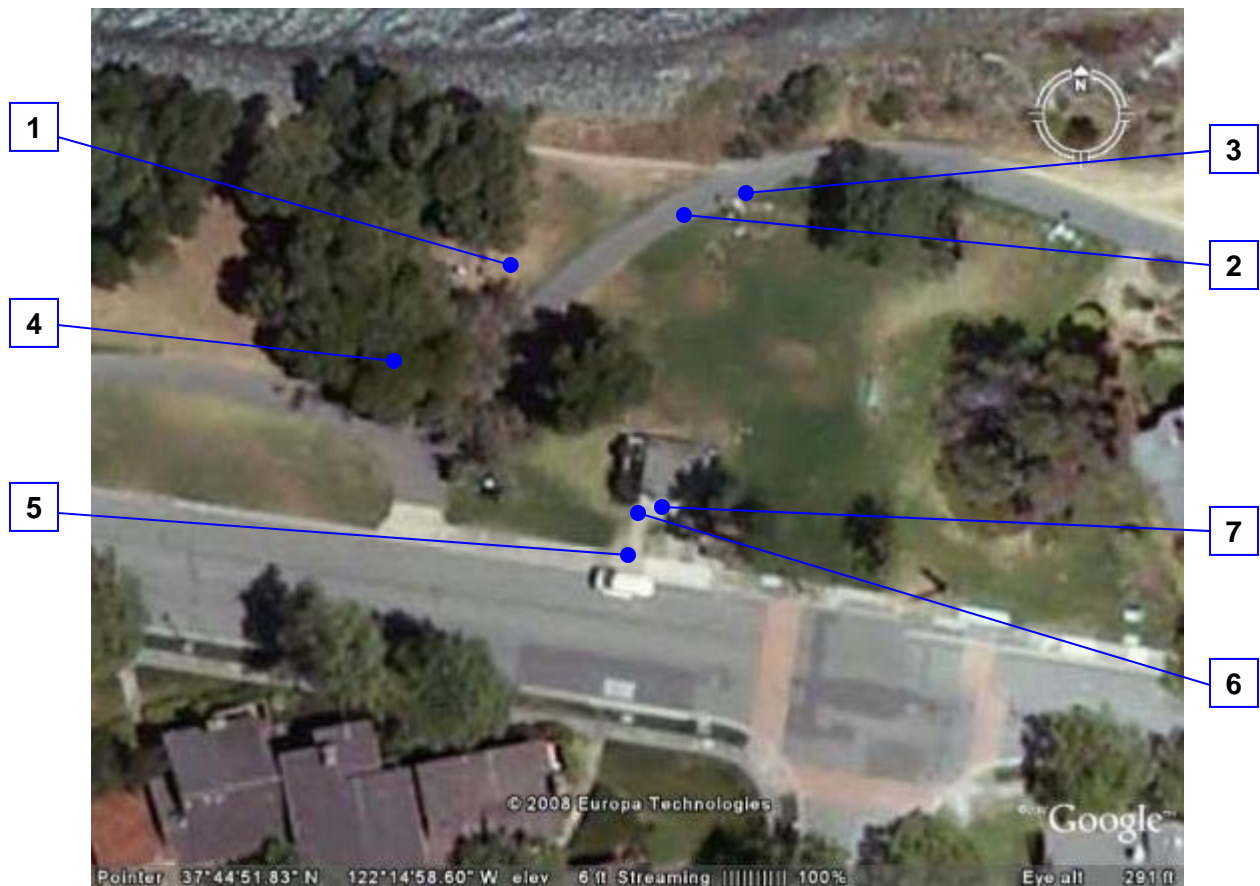
City of Alameda
Shoreline Park
On-Site, Exterior
53 - 0 - 1

Area# 2
Seaview Park Way & Brunswick Way

Facility: **Shoreline Park - Area # 2: Seaview/Burns Field** Floor: **On-Site**

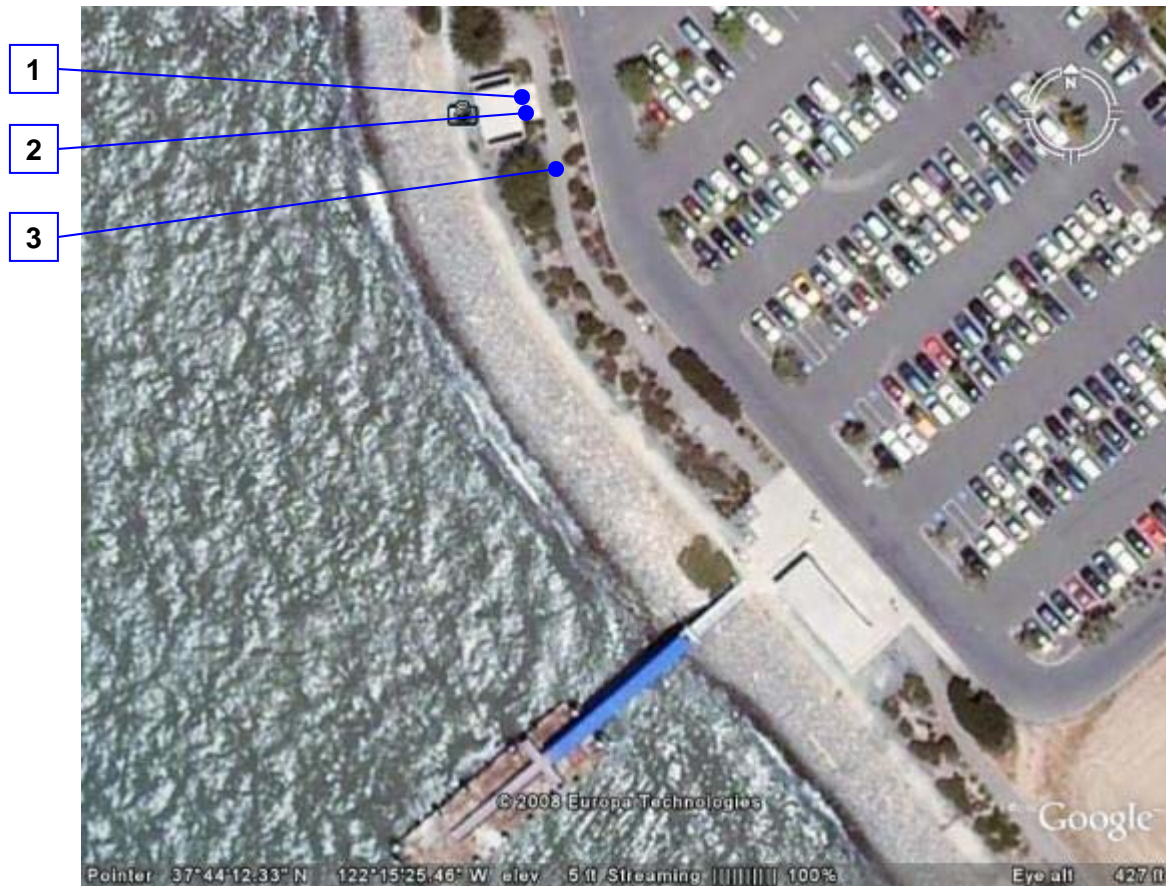
City of Alameda
Shoreline Park
On-Site, Exterior
53 - 0 - 1

Area# 5
Harbor Bay Ferry
