The Priority Coastal Inundation Locations appendix is adopted from Alameda's 2019 Climate Action and Resiliency Plan.

Priority Coastal Inundation Locations

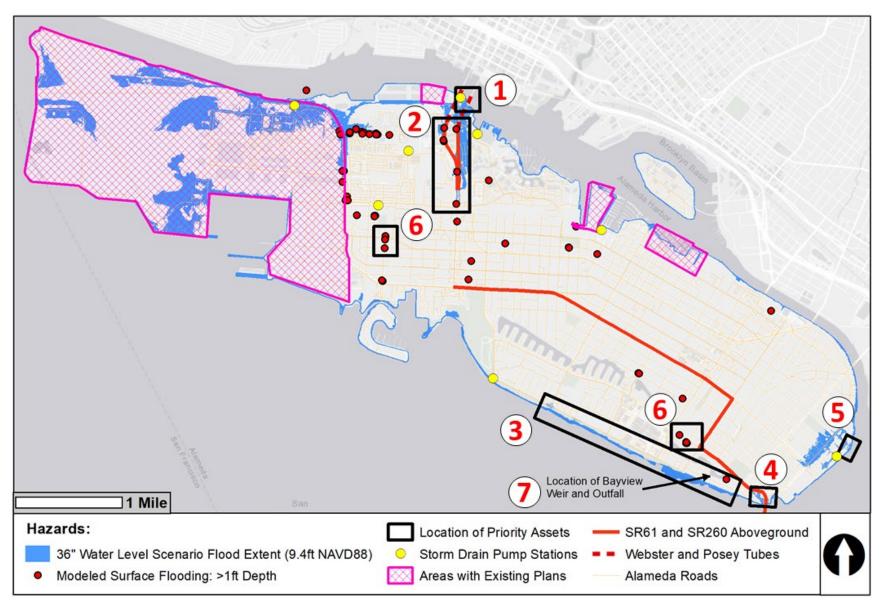
Figure G-1. Map showing the areas of location-based priority flooding on Alameda Island

The 11 priority flooding locations identified through this approach fall within three categories: shoreline, natural, and recreation areas; utilities; and transportation. A detailed map for each location showing 36, 48, and 52 inches of sea level rise, as well as a one-page description of exposure, sensitivity, consequence, and adaptive capacity, are included in Appendix H. These priority flooding locations are described further below.

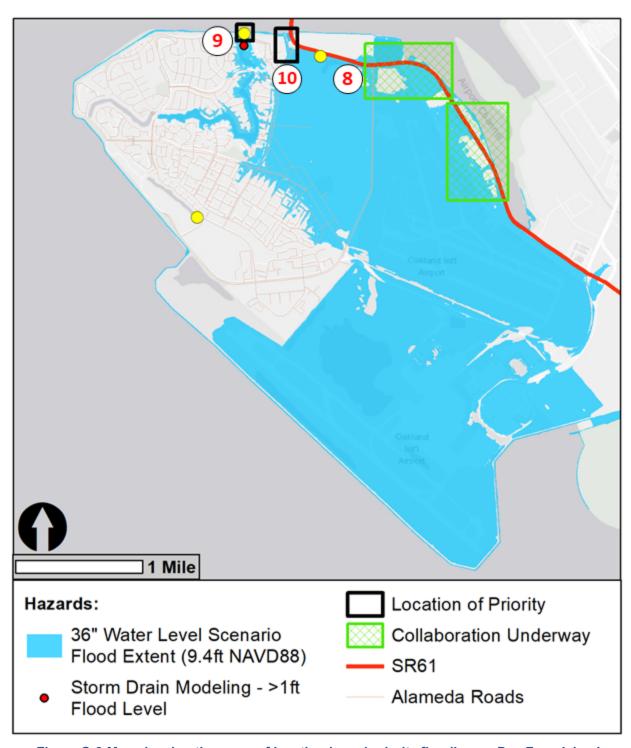
Figure G-2 Map showing the areas of location-based priority flooding on Bay Farm Island
